Applies To: **2004–05 TL – ALL**
2006 TL – From VIN 19UUA6...6A000001 thru 19UUA6...6A076363

August 16, 2007

Outer Door Handle Extension Falls Off

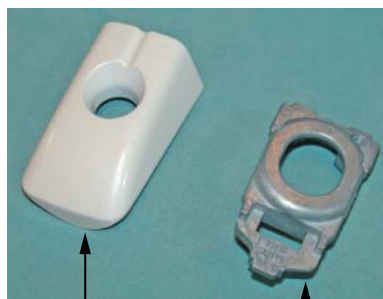
The outer painted cover of the door handle extension falls off.

The extension (cover) and its base (holder) do not fit correctly.

EXTENSION

BASE

Replace the affected extension (cover) and its base.

NOTE: The extension and its base *must* be replaced together.
