Repair Manual Supplement: Vehicle Pulling to One Side

Market USA

TSIB SUPERSESSION NOTICE

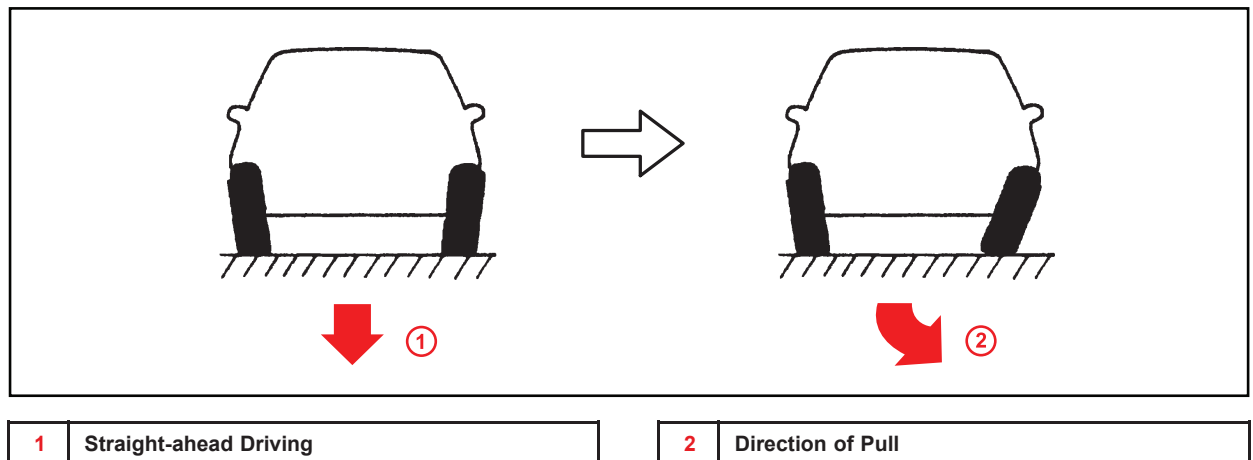
Figure 1. Camber

When the cross camber or caster of the front wheel alignment is large, it can cause vehicle pulling.

WHEEL ALIGNMENT	DIRECTION OF VEHICLE PULLING
Camber	Vehicle Pulls in Direction of Wheel with Large Camber Value (See Figure 1)
Caster	Vehicle Pulls in Direction of Wheel with Small Caster Value (See Figure 2)

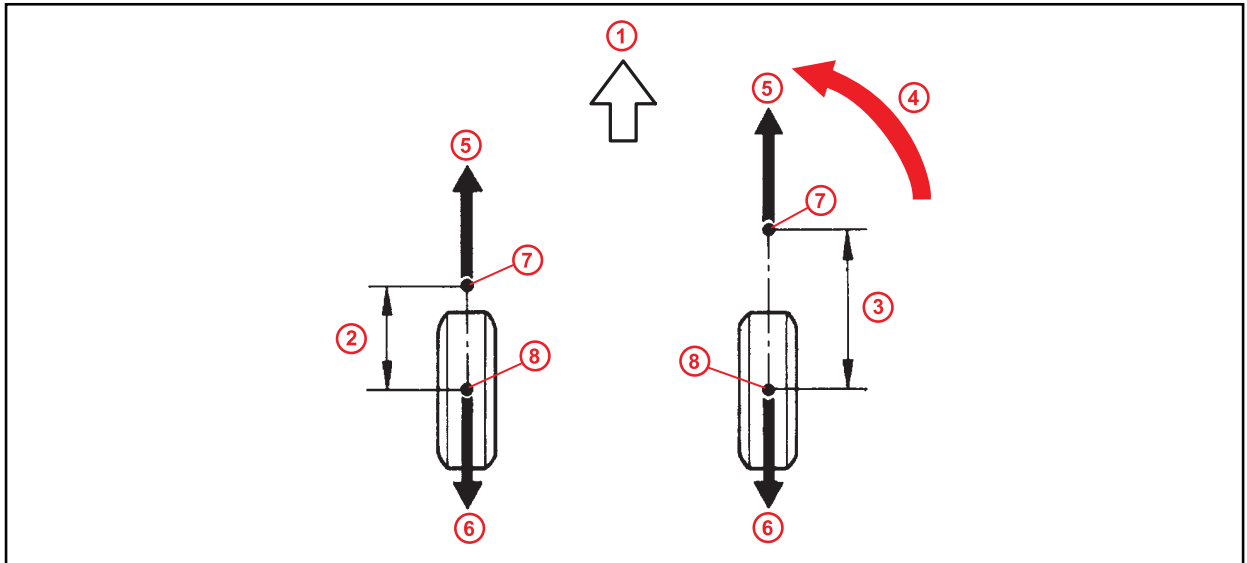
Figure 2. Caster

If the cross camber or caster is within the specified range (30' or less), noticeable vehicle pulling will not occur due to side-to-side differences in camber or caster.

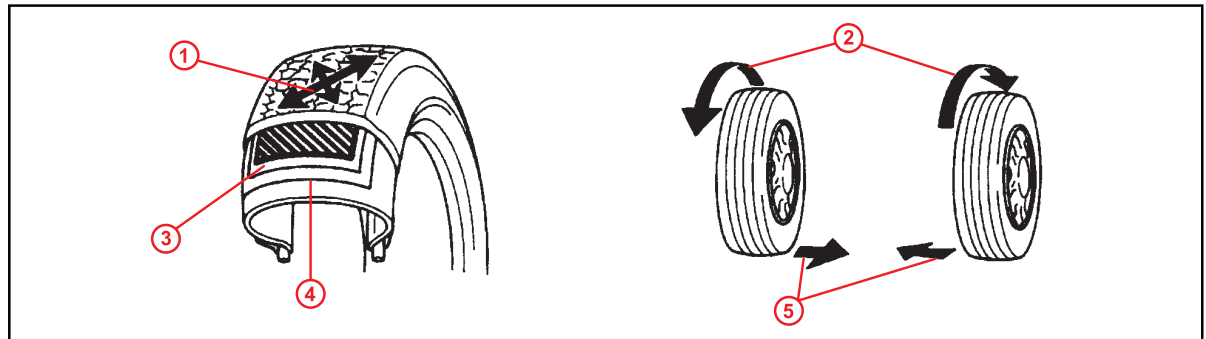
Figure 3.

Lateral force due to ply-steer is produced by the construction of the belts inside the tire tread. With radial tires, the wire of the belt is slanted as shown in the illustration below. Thus, it is in the lateral direction that tire tread easily changes shape (stretches), and lateral force is generated between the tire and the road surface in the lateral direction.

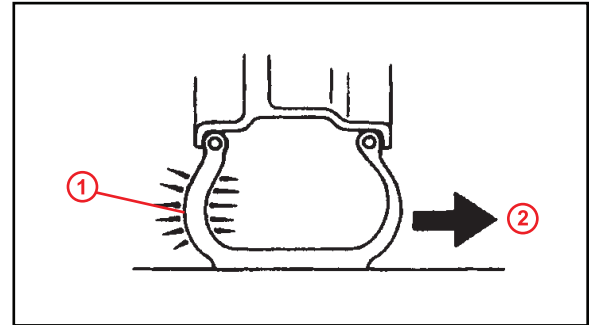
Figure 4.

Conicity is lateral force resulting from uneven formation of the left and right sides of the tire. The direction the lateral force is exerted depends on the hardness of the side walls and the difference in height between the left/right sides of the tire.

- In the case of vehicle pulling caused by tires, the lateral force which is exerted as a result of conicity has the greatest effect. On a flat road, if the steering wheel is held without exerting steering effort for 109 yards (100 m) when traveling at 62 mph (100 km/h), the vehicle may drift as much as 5 feet (1.5 m).
- When vehicle pulling is due to conicity, the amount of drift can be reduced and the direction of drift can be changed by changing the location of the tire or reversing the tire when installing it on the wheel.

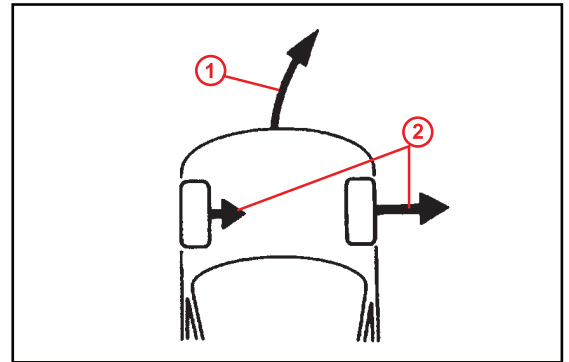
Figure 6. Original Tire Positions

- The direction of lateral force from tire conicity becomes reversed when the left and right tires are switched. Therefore, if the pulling direction changes when the tires are switched, it can be concluded that vehicle pulling is caused by tire conicity.
 - The vehicle is pulled to the right by the lateral force exerted to the right.

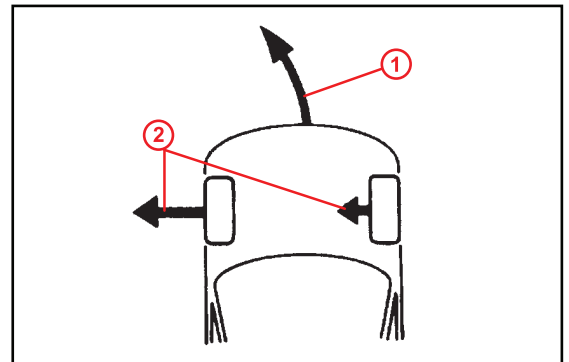
Figure 7. Tires Switched

- The direction of the tires which exerted lateral force to the right has been changed, so the tires now exert lateral force to the left and the vehicle now pulls to the left.

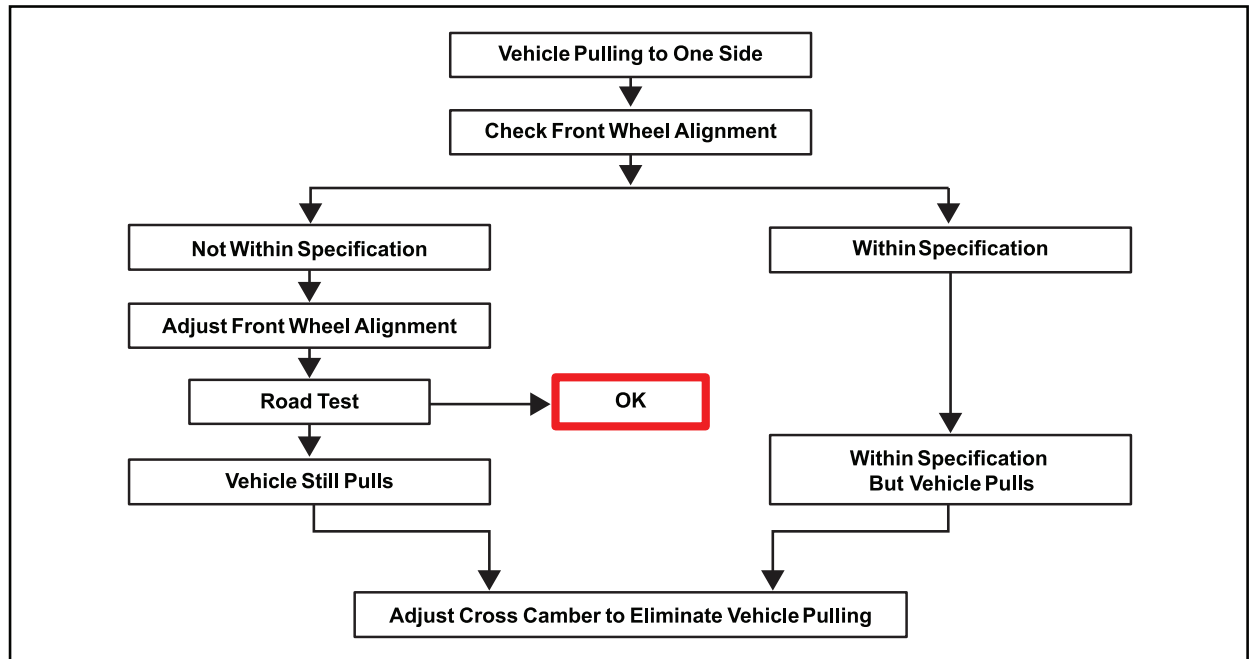
Figure 8.

When it is determined by troubleshooting that the vehicle pulling to one side is caused by wheel alignment, perform repairs according to the following procedure.

WHEN VEHICLE PULLS TO LEFT	WHEN VEHICLE PULLS TO RIGHT
Increase right front camber and decrease left front camber until vehicle pulling is eliminated	Increase left front camber and decrease right front camber until vehicle pulling is eliminated

- Keep the cross camber within 1° or less.
- Keep the camber of each wheel within specifications (+/-45' of center value).
- If adjustment exceeds the specifications, uneven tire wear will result.

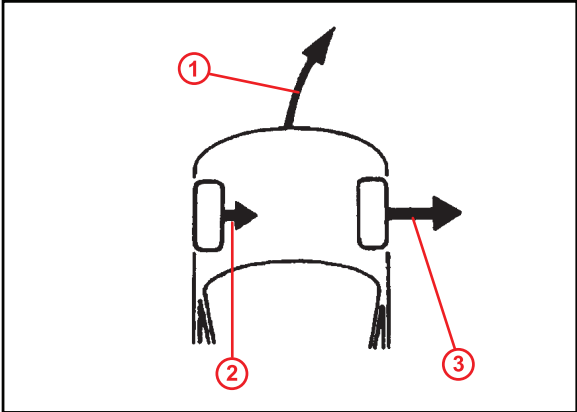
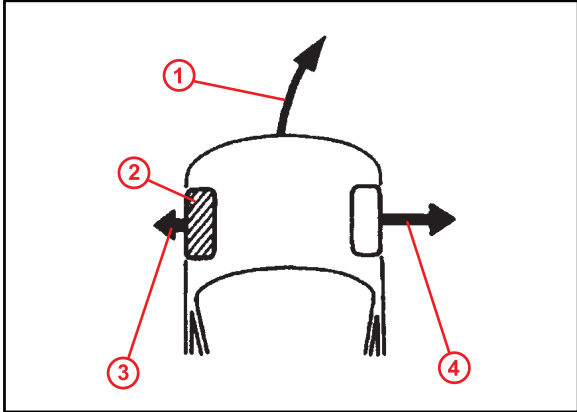
The lateral force generated by the right front tire is greater than the left tire, so the vehicle is pulling due to the lateral force of the right tire.

- A. Remove the front left tire from the wheel and reverse the tire. Then perform a road test and check for change in the pulling direction.

If Vehicle Pulls in the Same Direction: Go to step 3B.

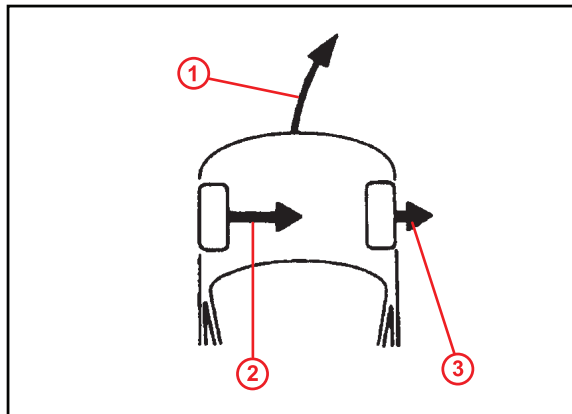
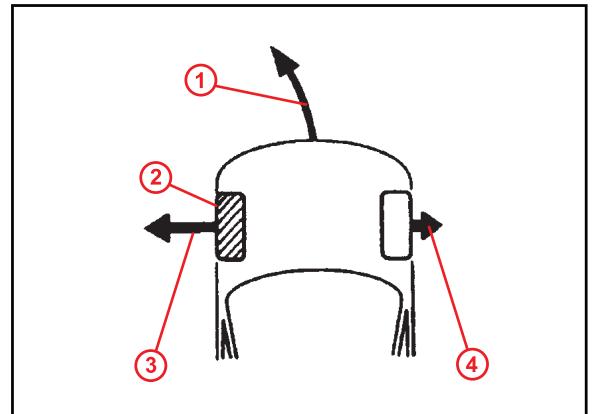
The lateral force generated by the left front tire is greater than the right tire, so the vehicle is pulling due to the lateral force of the left tire.

If Vehicle Pulls in the Opposite Direction: Go to step 3B.
