**Technical Service
Information Bulletin**

RATTLE NOISE FROM HEADLINER AREA

'07 ES 350

NVH
NV008-06

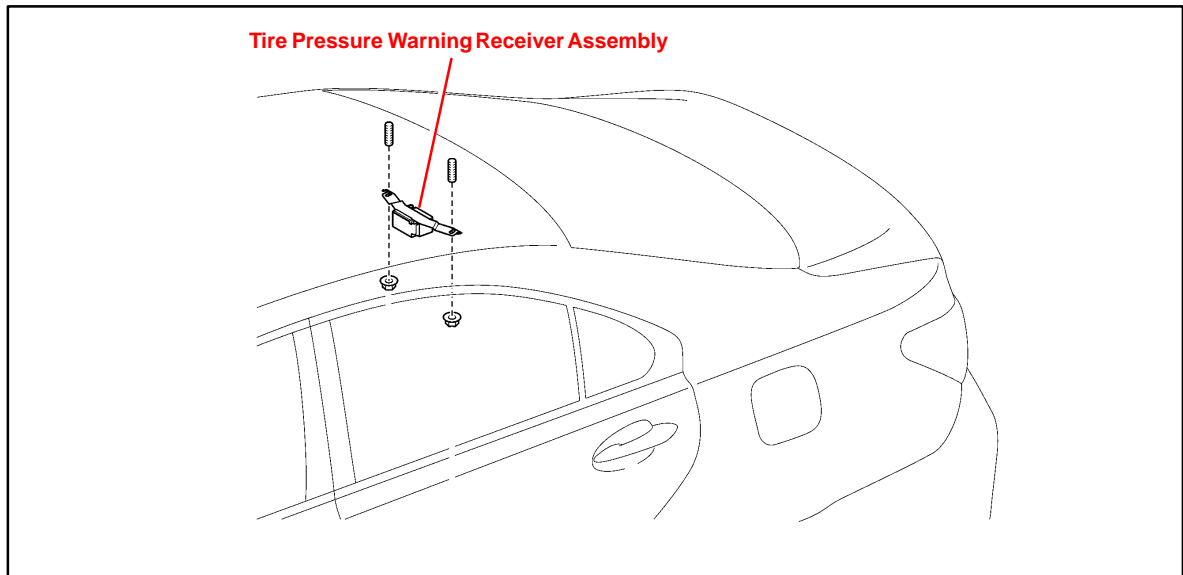
Components

Introduction Some customers may experience a buzz or slight rattle noise from the rear portion of the headliner when the vehicle hits small sharp bumps. It has been determined that the source of such a rattle may be the Tire Pressure Warning System (TPWS) antenna located above the headliner between the rear of the sliding roof opening and the top of the back glass.

To improve this condition, the rigidity of the bracket holding the TPWS Antenna to the roof cross brace has been increased. Replace the older style receiver assembly with the new type assembly on vehicles built PRIOR to the starting VIN shown below.
