**Technical Service
Information Bulletin**

Title:
**UPPER/LOWER WINDSHIELD
TICK NOISE**

Models:
'03 – '07 Lexus

REVISED
NV005-06
NVH

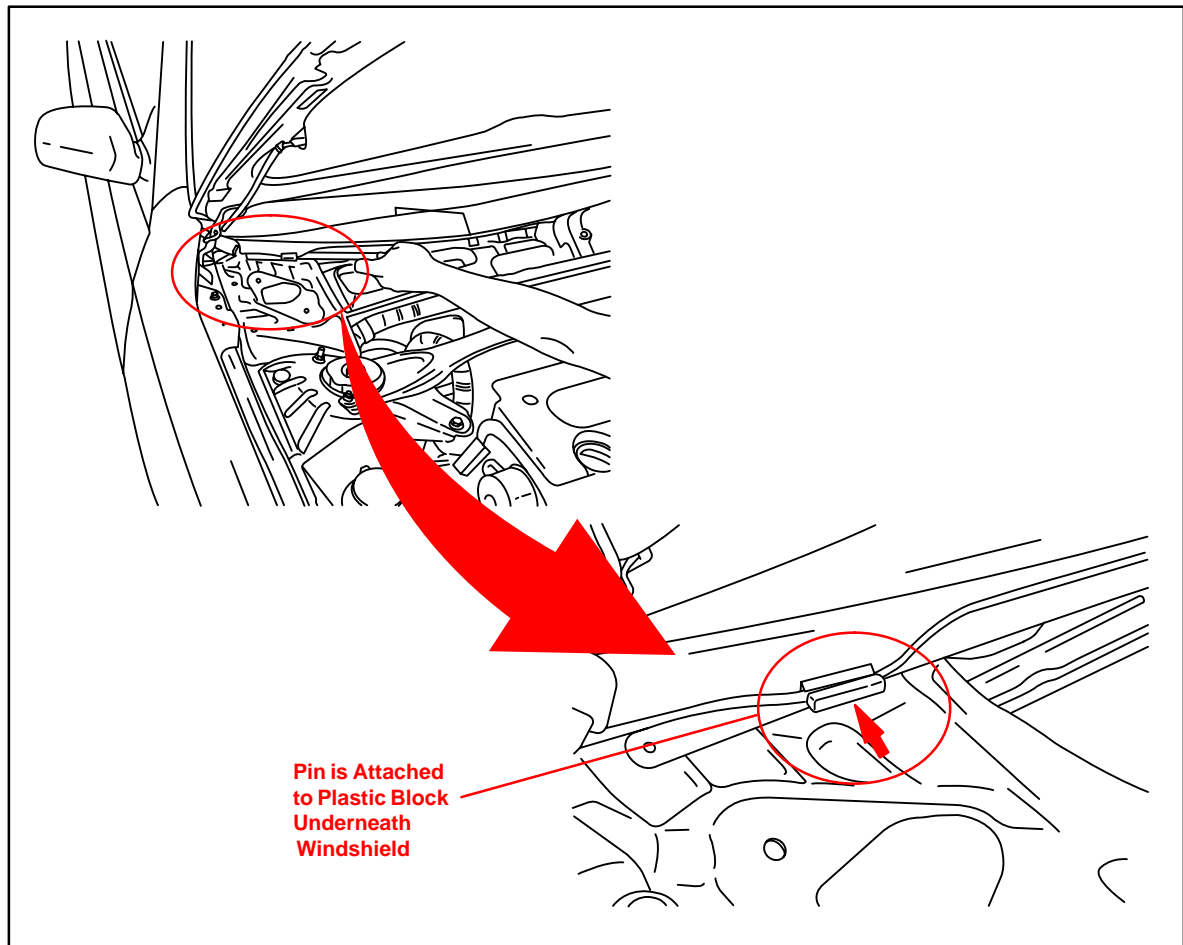
The retainers are typically located 140 – 200 mm (5.5 – 7.9 in.) inboard of the lower corners of the windshield. The flat portion of the retainer is adhered to the backside of the windshield with double-sided, foam-backed tape.

2. Locate the lower windshield retainers.
