The Mystery of the Rotating Bearing!

Toyota U660E shift problems traced back to case wear and damage; the fix requires replacing the case.

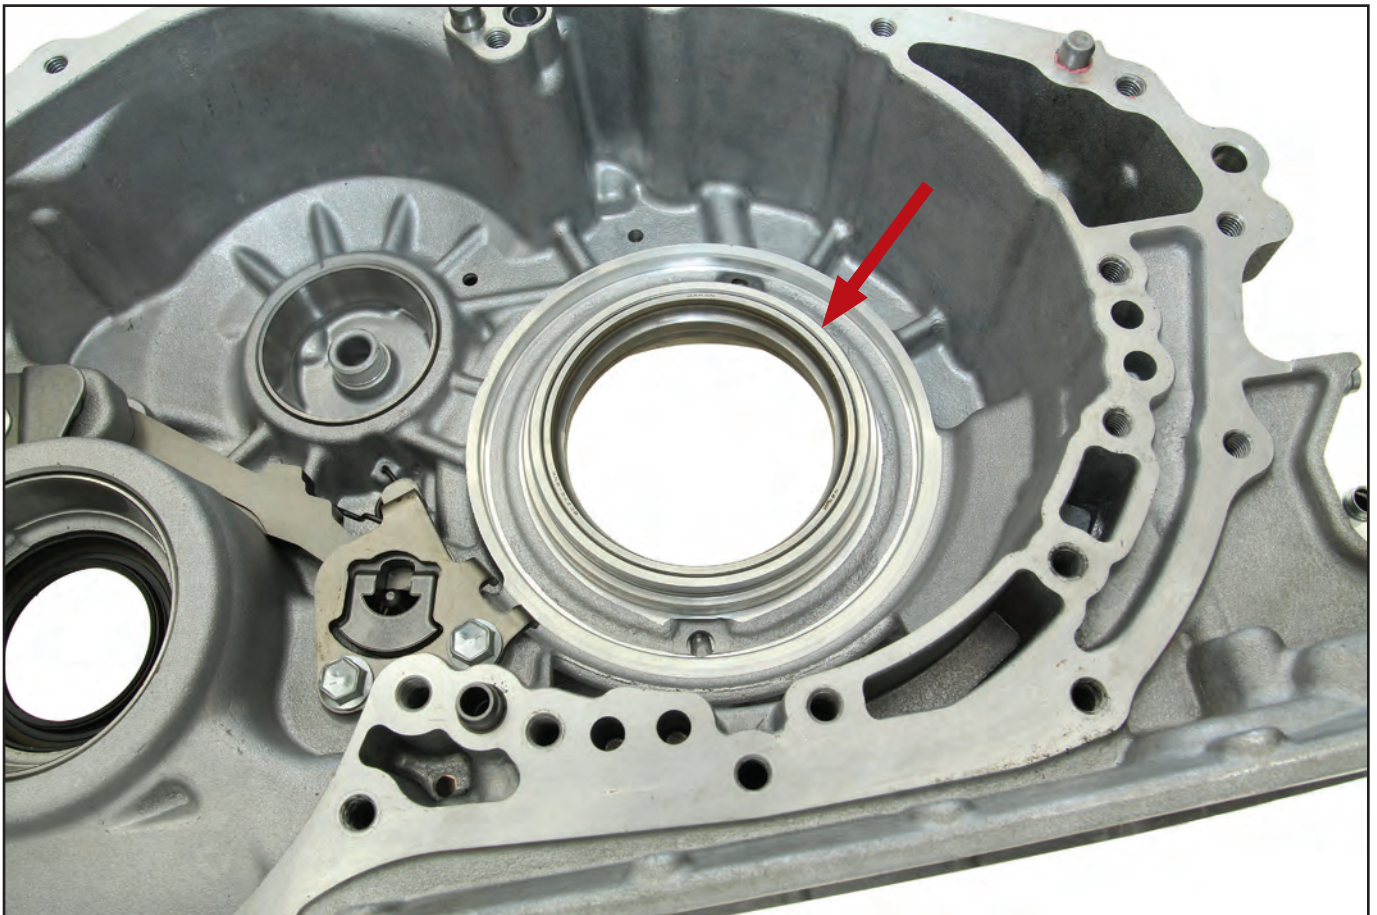
Figure 1

During the unit teardown I found a very interesting issue with the counterdrive gear double ball bearing in the case (figure 1). It moved! It rotated in the case, freely, without resistance. But, when I attempted to remove the bearing, it felt like something was holding it in place.

So the bearing was spinning in the case, which created the fine metal, which, in turn, caused the shifting issues and torque converter slip. But we hadn't discovered why the bearing was spinning in the case. It was time to dig a little deeper!

As it stands right now there's no aftermarket fix for this condition. It's a costly repair, requiring you to replace the case. And there's nothing to stop it from happening again.

For now you can get a used case for about \$175. Make sure the bearing is tight; if the bearing moves, that case is bad, too.

If a good used case isn't available, you'll need a new case from the dealer, part #35141-07011, at a cost of nearly \$1,200. You'll also need a bearing for about \$110, part #90369-72001, and a new snap ring for another \$2.43; part #90520-99110.

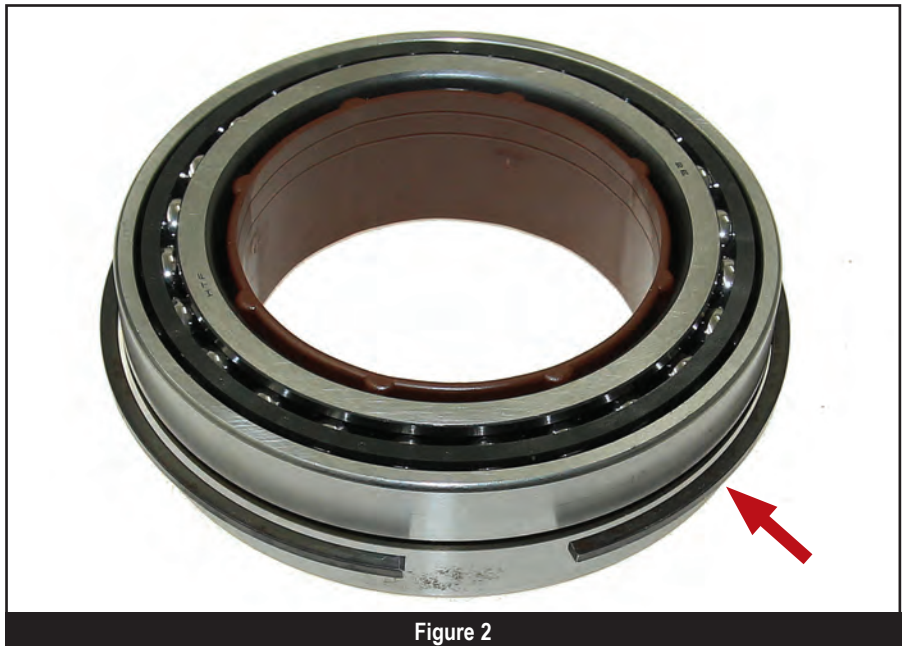
Figure 2

Turns out the bearing is installed in the case and has a snap ring to secure it (figure 2). It's supposed to be a non-removable bearing, but Toyota sells a replacement.

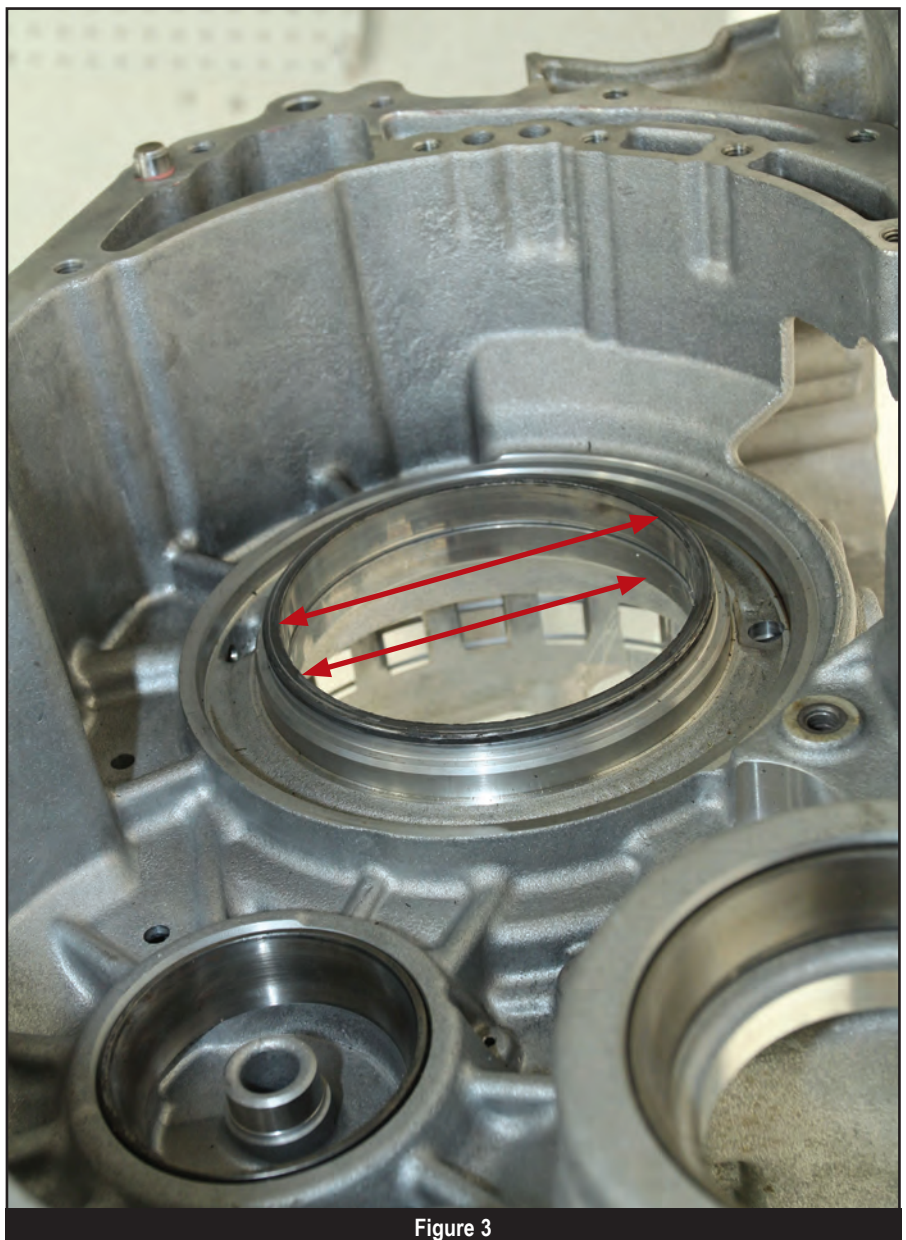
Figure 3

Then we noticed something even more interesting: Nothing was damaged except the case where the center bearing rides. A closer examination revealed the front of the case was close to specification but the rear was way off (Figure 3).

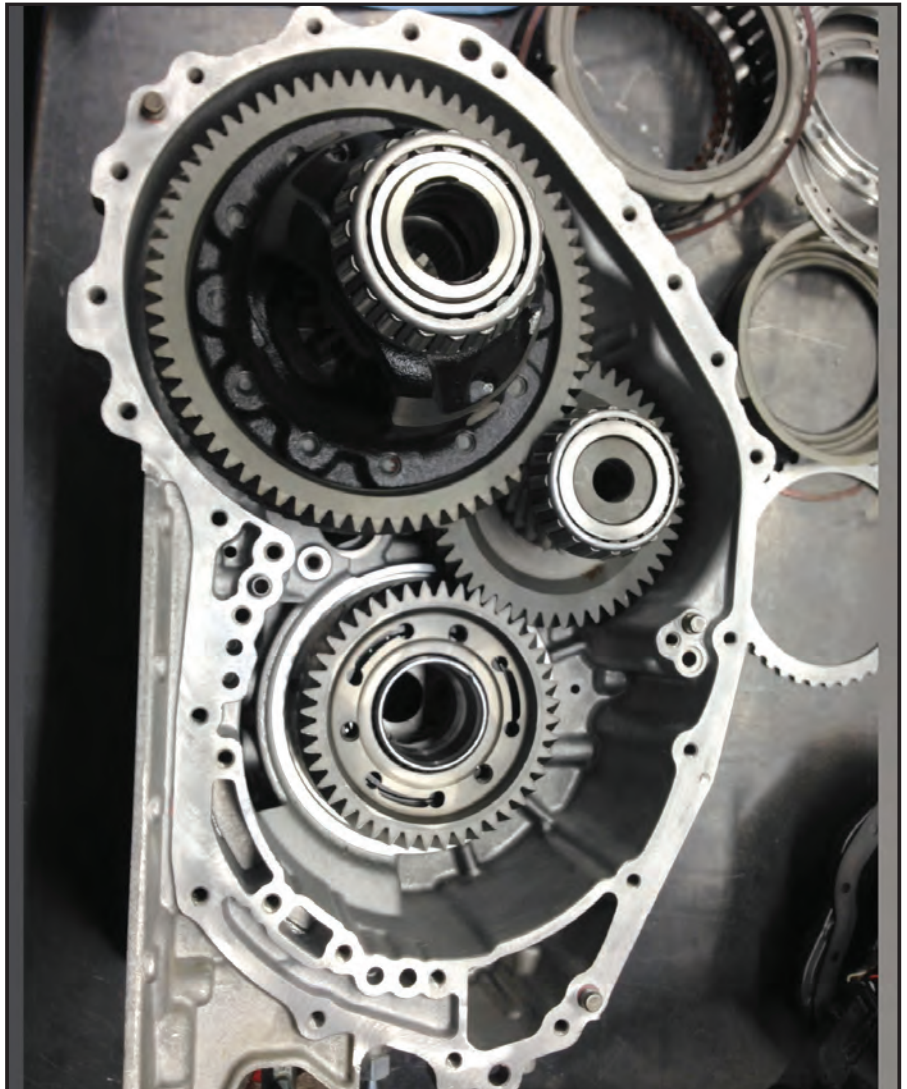
Figure 4

So what was happening was simply a torque issue. The unit is pretty beefy for a front wheel drive: The ring gear and carrier weigh 45 lbs. and the two transfer gears are fairly stout (Figure 4). That's all at the front of the transmission. It's the back half that's having the issue.

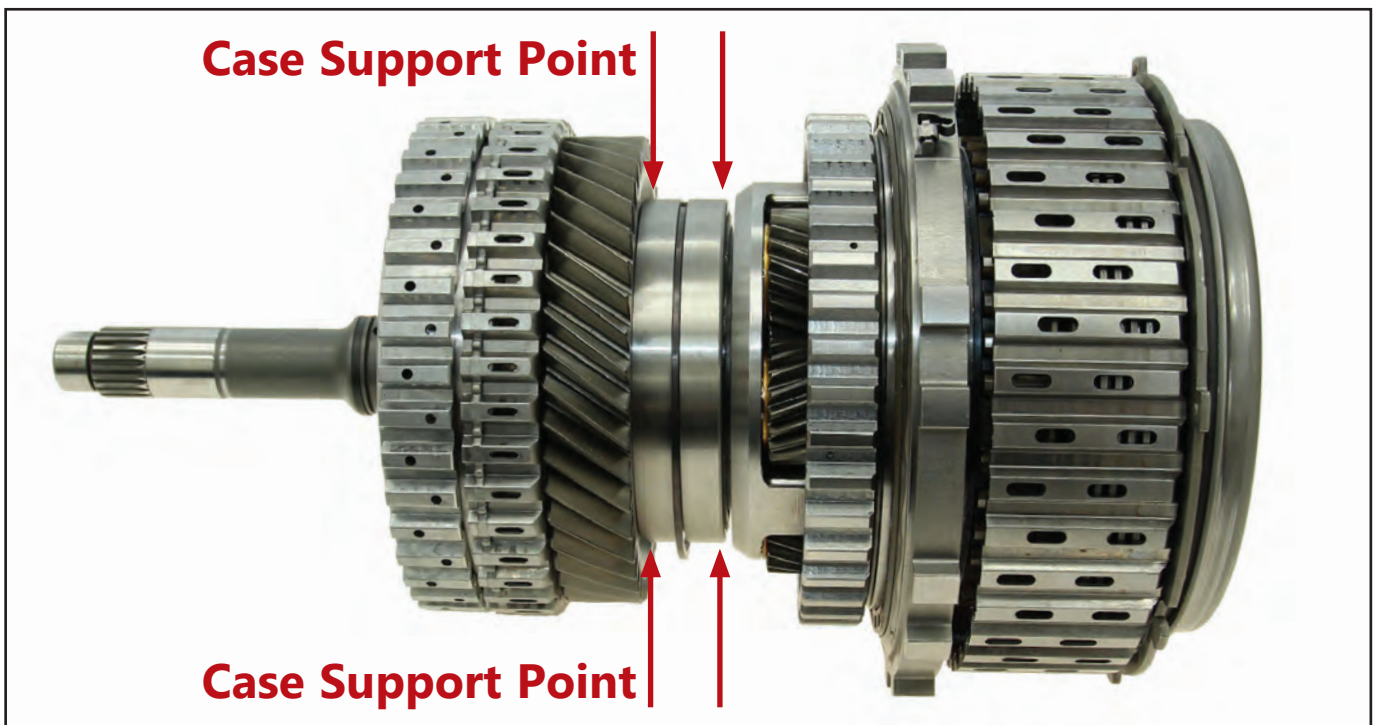
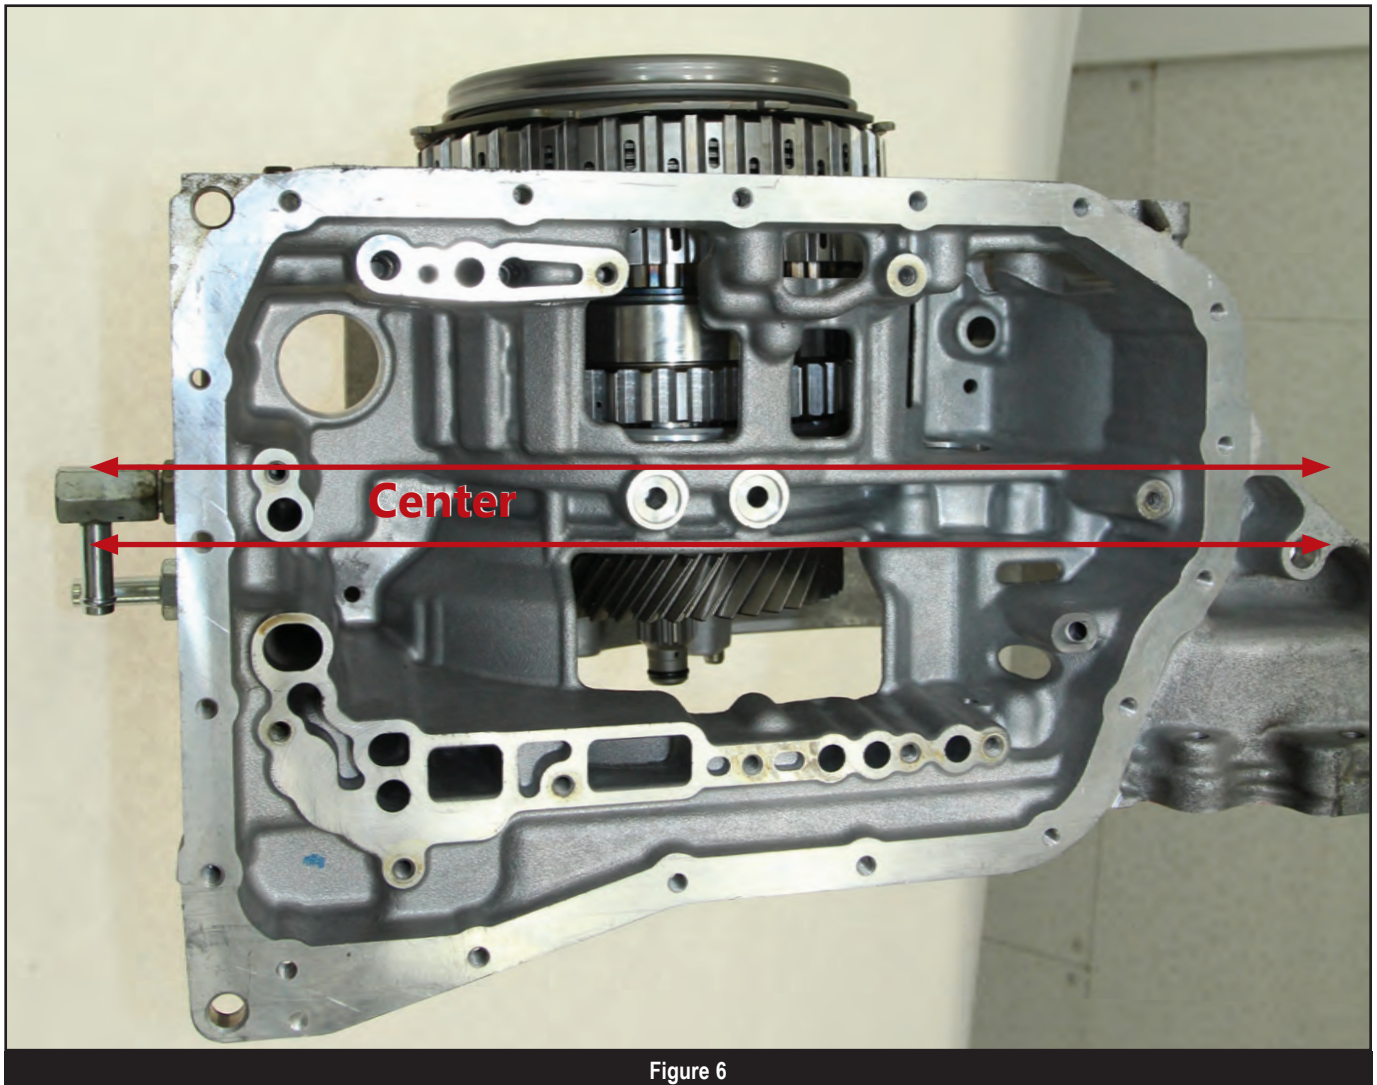
From the center of the case the planetary is connected to the transfer gear by splines and a lock nut. The planetary is then splined to the sun gear, direct ring gear, and finally to the end clutch (Figures 5 & 6). The sheer torque of the unit, especially those mated to

3.5L and 3.7L V6 engines, is what's causing the issue. It's literally flexing the case where the bearing contacts it.
