**Technical Service  
Information Bulletin**

**REPAIR MANUAL SUPPLEMENT:  
VEHICLE PULLING TO ONE SIDE**

'08 Lexus

SUSPENSION  
SU001-08

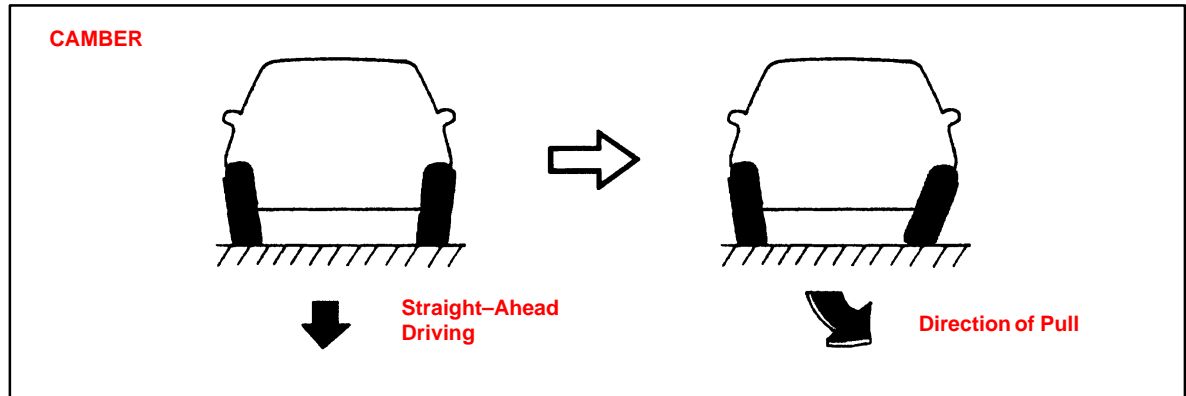
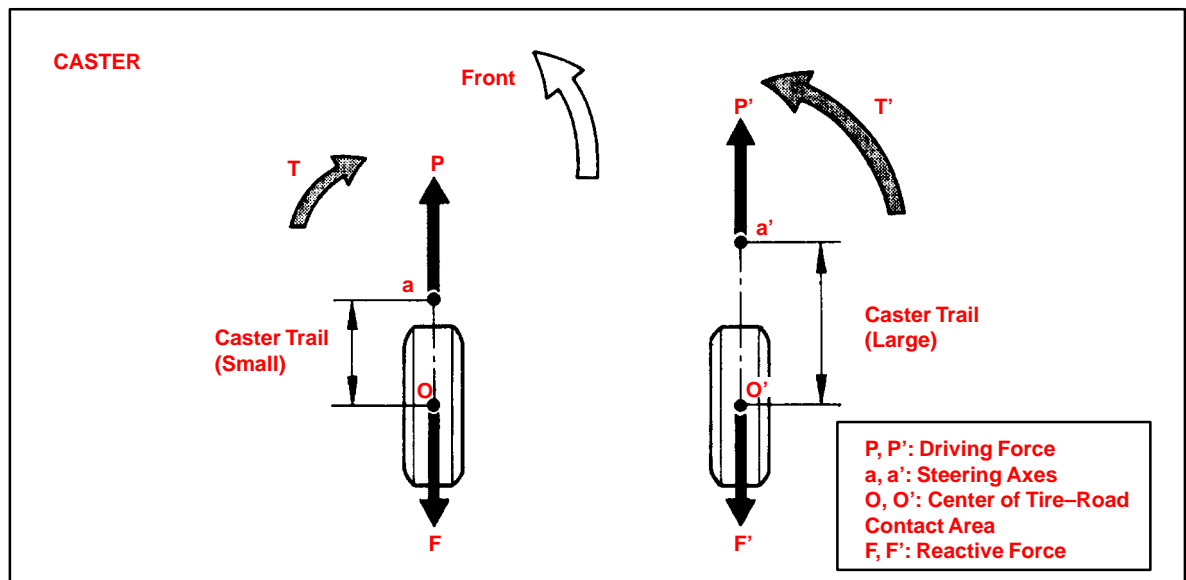
When the cross camber or caster of the front wheel alignment is large, it can cause vehicle pulling.

WHEEL ALIGNMENT	DIRECTION OF VEHICLE PULLING
Camber	Vehicle pulls in direction of wheel with large camber value
Caster	Vehicle pulls in direction of wheel with small caster value

If the cross camber or caster is within the specified range (30' or less), noticeable vehicle pulling will not occur due to side-to-side differences in camber or caster.

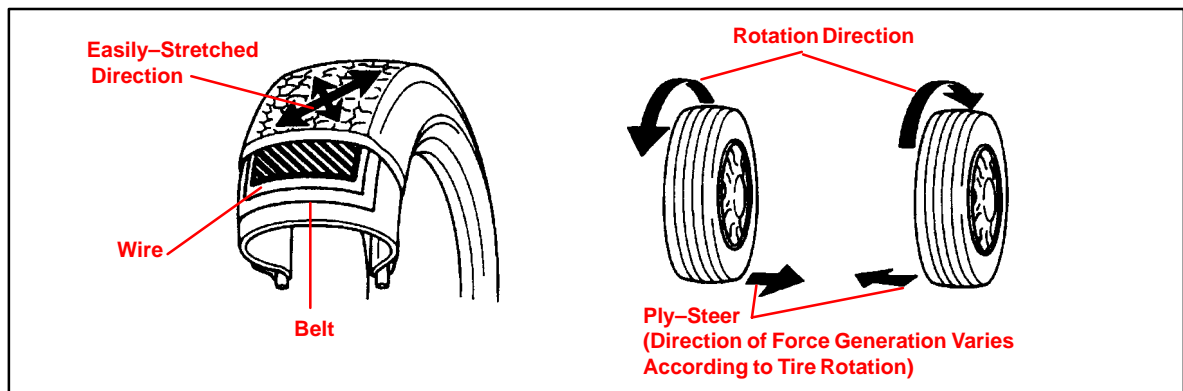
Lateral force due to ply-steer is produced by the construction of the belts inside the tire tread. With radial tires, the wire of the belt is slanted as shown in the illustration below. Thus, it is in this direction that tire tread easily changes shape (stretches), and lateral force is generated between the tire and the road surface.

Lateral force from ply-steer prevents vehicle drift caused by road slant, so in many cases lateral force to the left is provided to prevent or minimize vehicle drift.

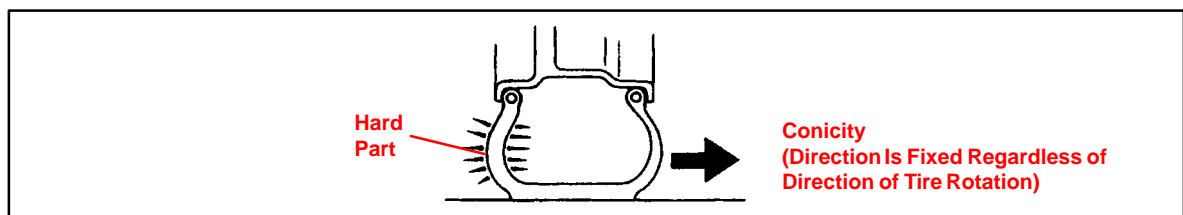
Conicity is lateral force resulting from uneven formation of the left and right sides of the tire. The direction the lateral force is exerted depends on the hardness of the side walls and the difference in height between the left/right sides of the tire.

- In the case of vehicle pulling caused by tires, the lateral force which is exerted as a result of conicity has the greatest effect. On a flat road, if the steering wheel is held without exerting steering effort for 109 yards (100 m) when travelling at 62 mph (100 km/h), the vehicle may drift as much as 5 ft (1.5 m).
- When vehicle pulling is due to conicity, the amount of drift can be reduced and the direction of drift can be changed by changing the location of the tire or reversing the tire when installing it on the wheel.

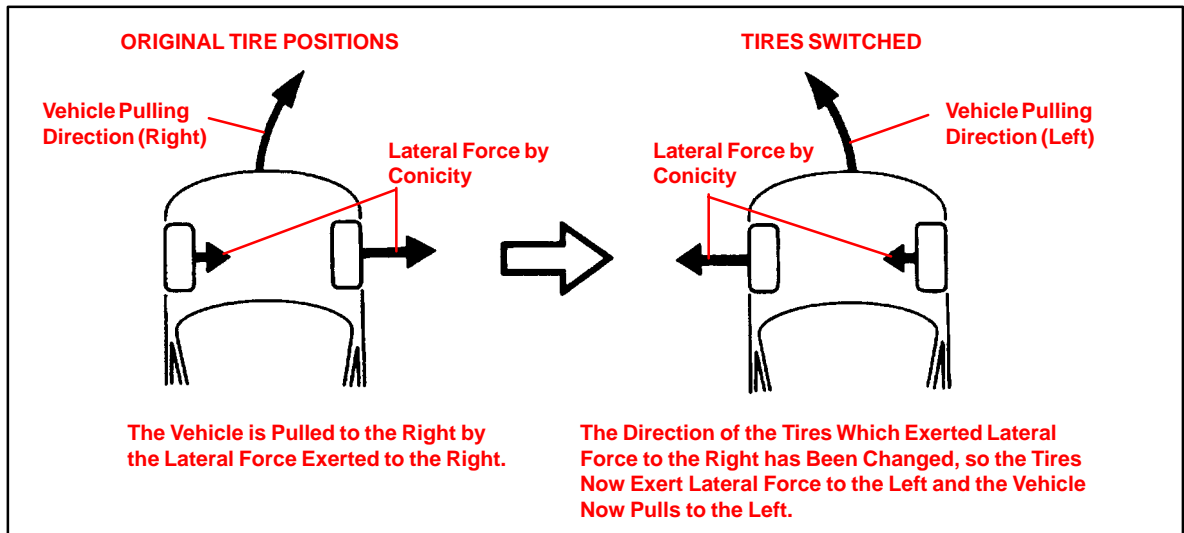
- The direction of lateral force from tire conicity becomes reversed when the left and right tires are switched. Therefore, if the pulling direction changes when the tires are switched, it can be concluded that vehicle pulling is caused by tire conicity.

- If the pulling direction does not change after the front tires are switched, the cause of vehicle pulling is not tire conicity. In this case, the likely cause is a front wheel alignment condition.

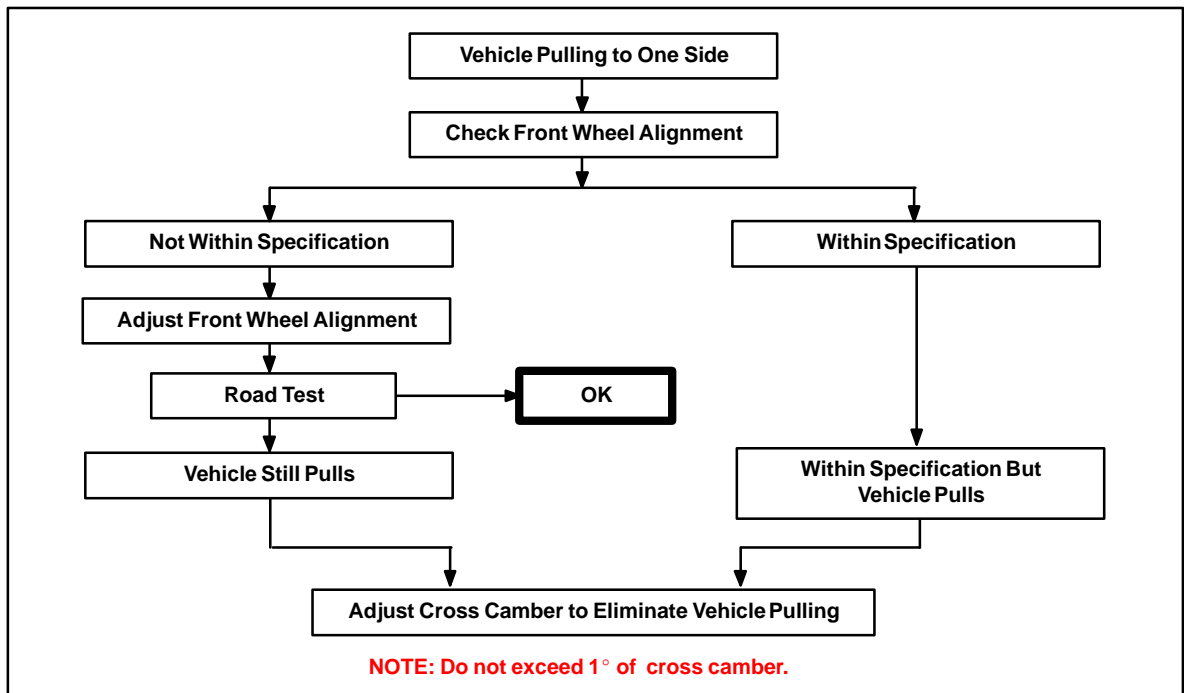
When it is determined by troubleshooting that the vehicle pulling is caused by wheel alignment, perform repairs according to the following procedure.

WHEN VEHICLE PULLS TO LEFT	WHEN VEHICLE PULLS TO RIGHT
Increase right front camber and decrease left front camber until vehicle pulling is eliminated	Increase left front camber and decrease right front camber until vehicle pulling is eliminated

- Keep the cross camber within 1° or less.
- Keep the camber of each wheel within specifications (+/-45' of center value).
- If adjustment exceeds the specifications, uneven tire wear will result.

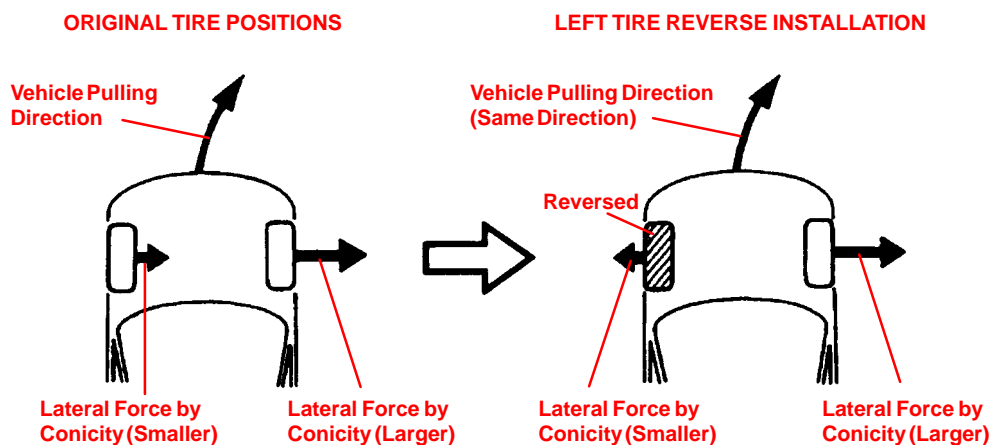
By performing this operation, it can be checked whether the left or right tire exerts a stronger lateral force. Either tire can be reversed. Shown here is an example of the left tire reversed.

**If Vehicle Pulls in the Same Direction: Go to STEP 2.**

The lateral force generated by the right front tire is greater than the left tire, so the vehicle is pulling due to the lateral force of the right tire.

Remove the front left tire from the wheel and reverse the tire. Then perform a road test and check for change in the pulling direction.

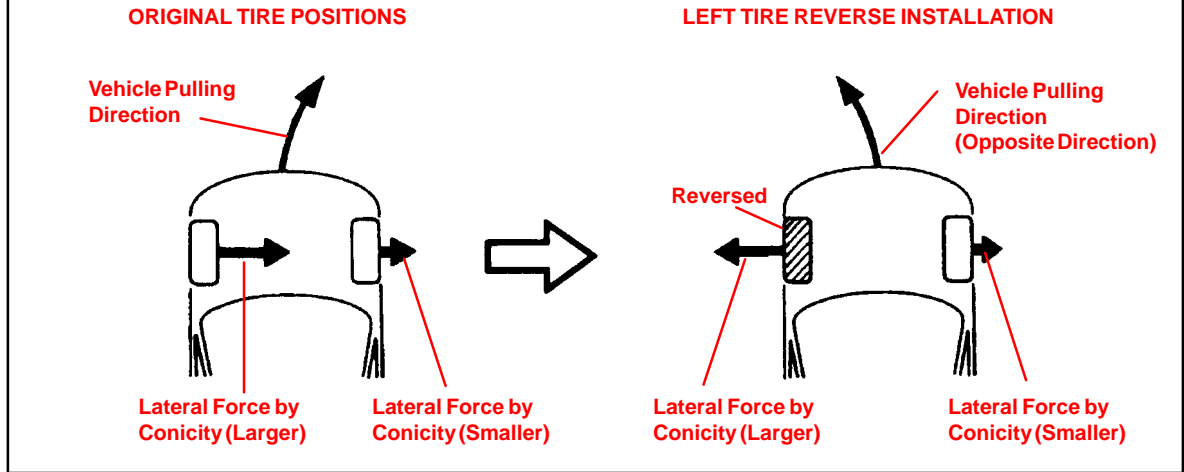
**If Vehicle Pulls in the Opposite Direction: Go to STEP 2.**

The lateral force generated by the left front tire is greater than the right tire, so the vehicle is pulling due to the lateral force of the left tire.
