Wind Noise From the Rear Left Door

Service Category Vehicle Exterior

Section Window/Glass **Market** USA

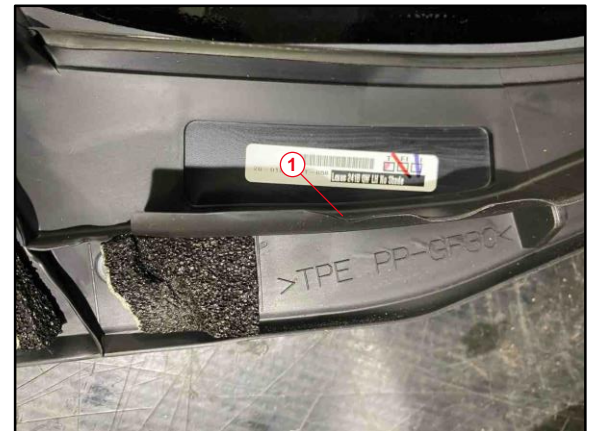
Figure 1. Example of Deformed Seal

Is the seal deformed?

1	Deformed Seal
----------	----------------------

4. Replace the rear left quarter window assembly with a NEW one.
Refer to TIS, applicable model and model year Repair Manual:

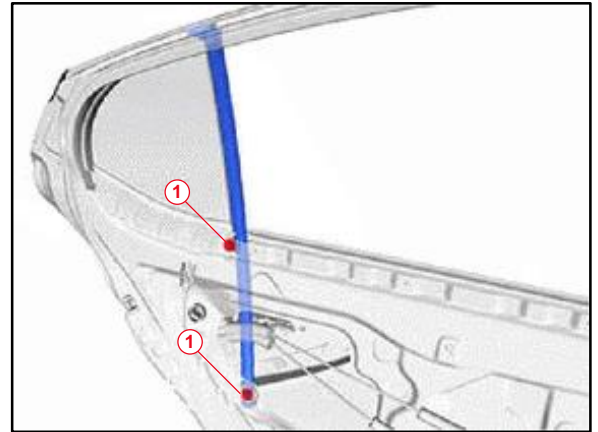
Figure 2.

1	Install Bolt Here
----------	--------------------------

6. Install the rear door window division bar sub-assembly.
 - A. Install the two bolts.
 Torque: **6.75 N*m (69 kgf*cm, 5 ft*lbf)**

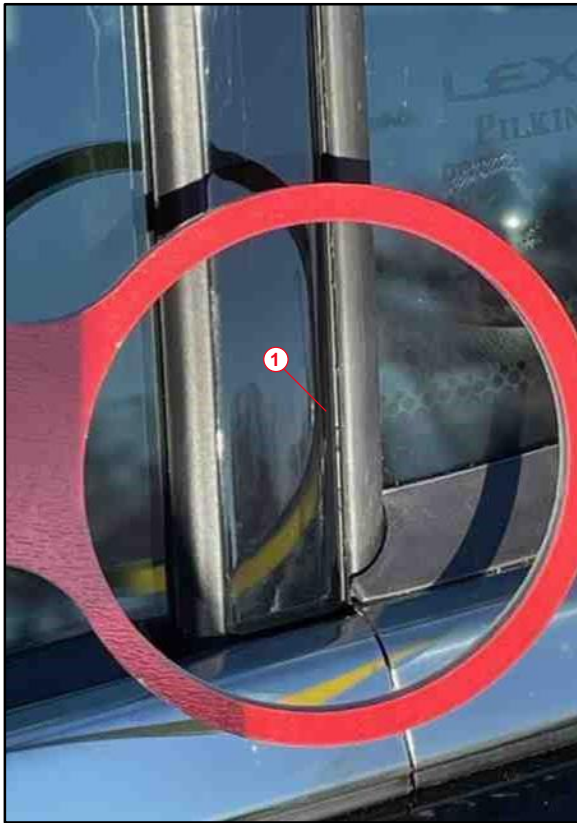
Figure 4.

1	Gap Between the Rear Division Bar and the Window Glass Sub-assembly
----------	--

- C. Confirm that there is NO gap between the division bar and the rear door quarter window glass sub-assembly.

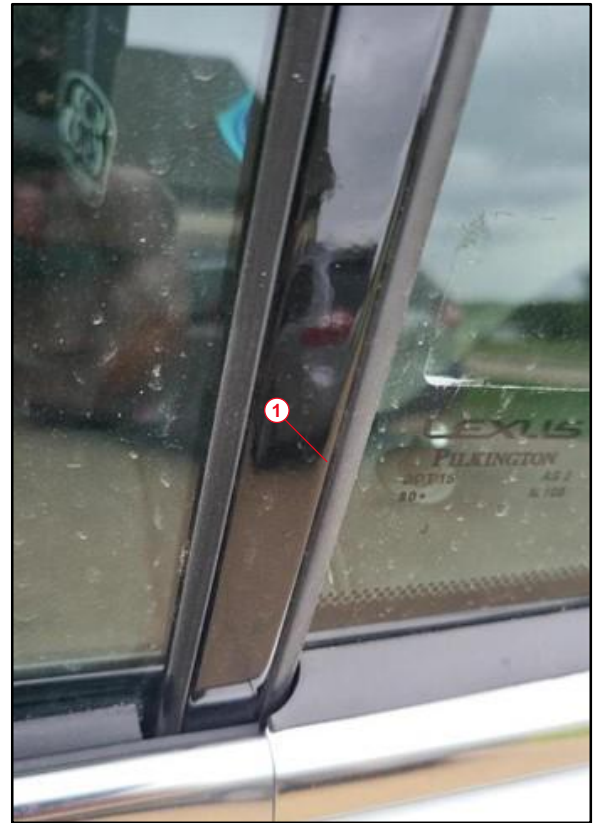
Figure 5.

1	No Gap Between the Rear Division Bar and the Window Glass Sub-assembly
----------	---

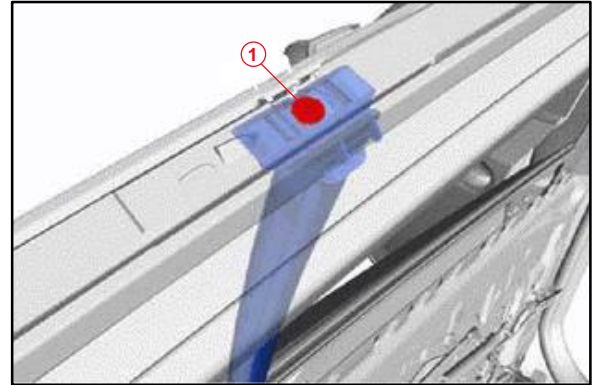
Figure 6.

1	Screw
----------	--------------

- D. Install the rear door window division bar sub-assembly with the screw.
