**Technical Service
Information Bulletin**

Title:
**UPPER/LOWER WINDSHIELD
TICK NOISE**

Models:
'03 – '07 Lexus

REVISED
NV005-06
NVH

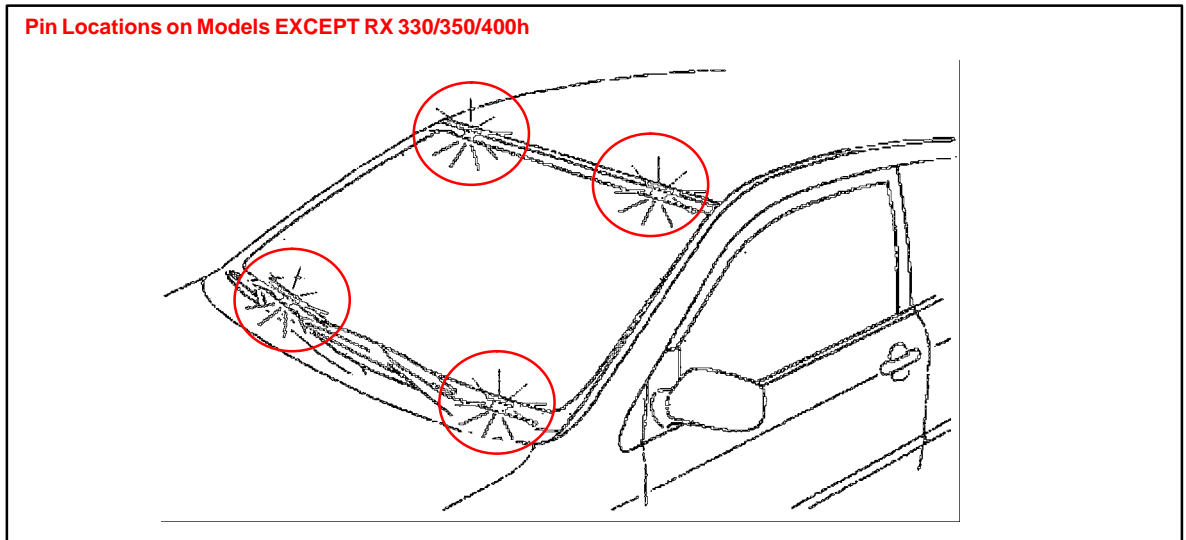
Pin Locations on Models EXCEPT RX 330/350/400h

MODEL	PIN LOCATION			
	TOP OF WINDSHIELD	QTY	BOTTOM OF WINDSHIELD	QTY
IS 250/300/350	Yes	2	N/A	N/A
ES 300/330/350	Yes	2	Yes	2
GS 300/350/430/450h	Yes	2	Yes	2
GX 470	Yes	2	N/A	N/A
LS 400/430/460	Yes	2	Yes	2
LX 470	Yes	2	N/A	N/A
RX 300	Yes	2	N/A	N/A
RX 330/350/400h	Yes	2	Yes	1
SC 430	Yes	2	N/A	N/A

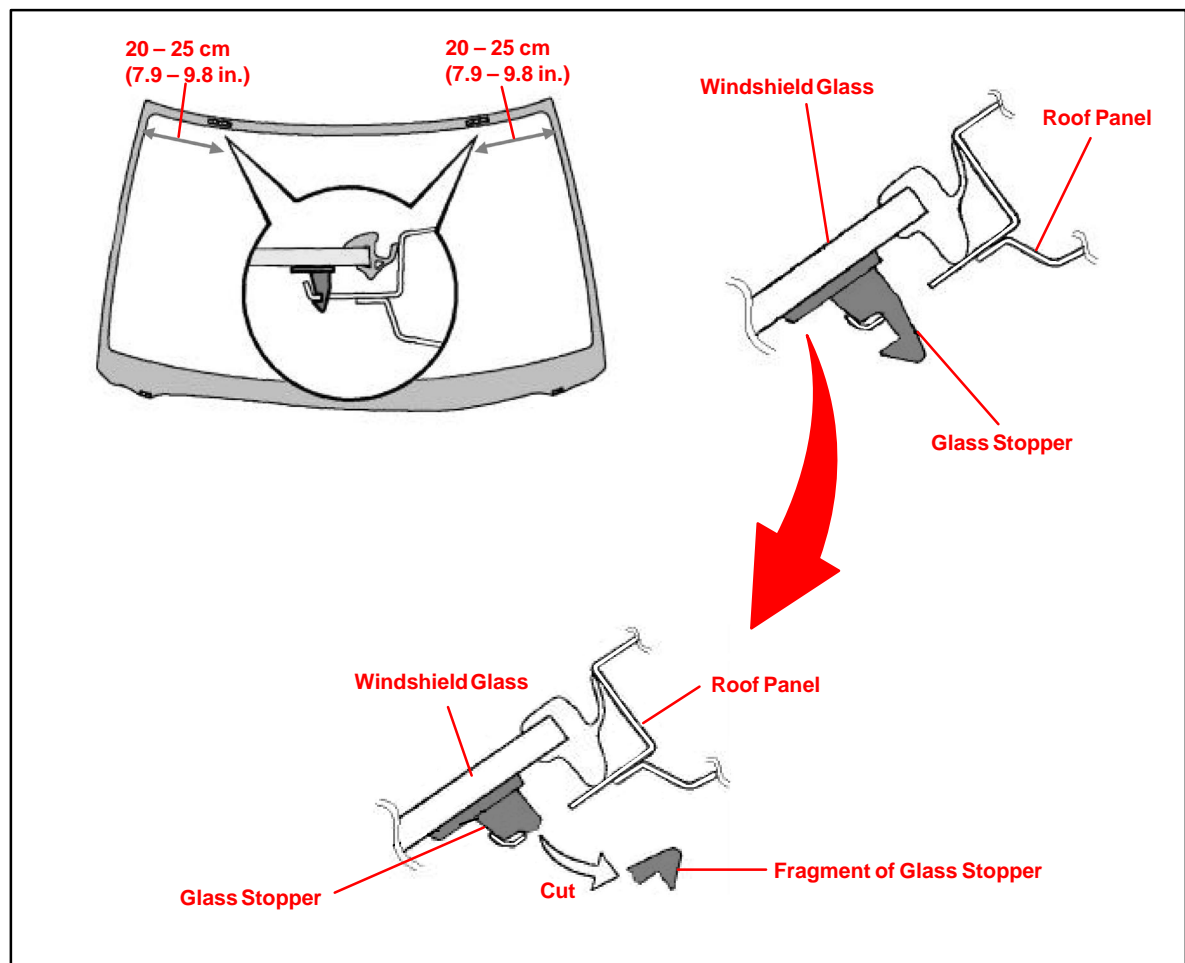
The stoppers are located on the inside of the passenger compartment behind the windshield glass blackout section (near the top front edge of the metal roof opening). The stoppers are typically located 20 – 25 cm (7.9 – 9.8 in.) inboard of the top corners of the windshield glass.

2. Cut OFF the tip of the plastic stopper as shown in the illustration.

It is sometimes necessary to bend the metal body tab down to gain access to the shaft of the stopper.

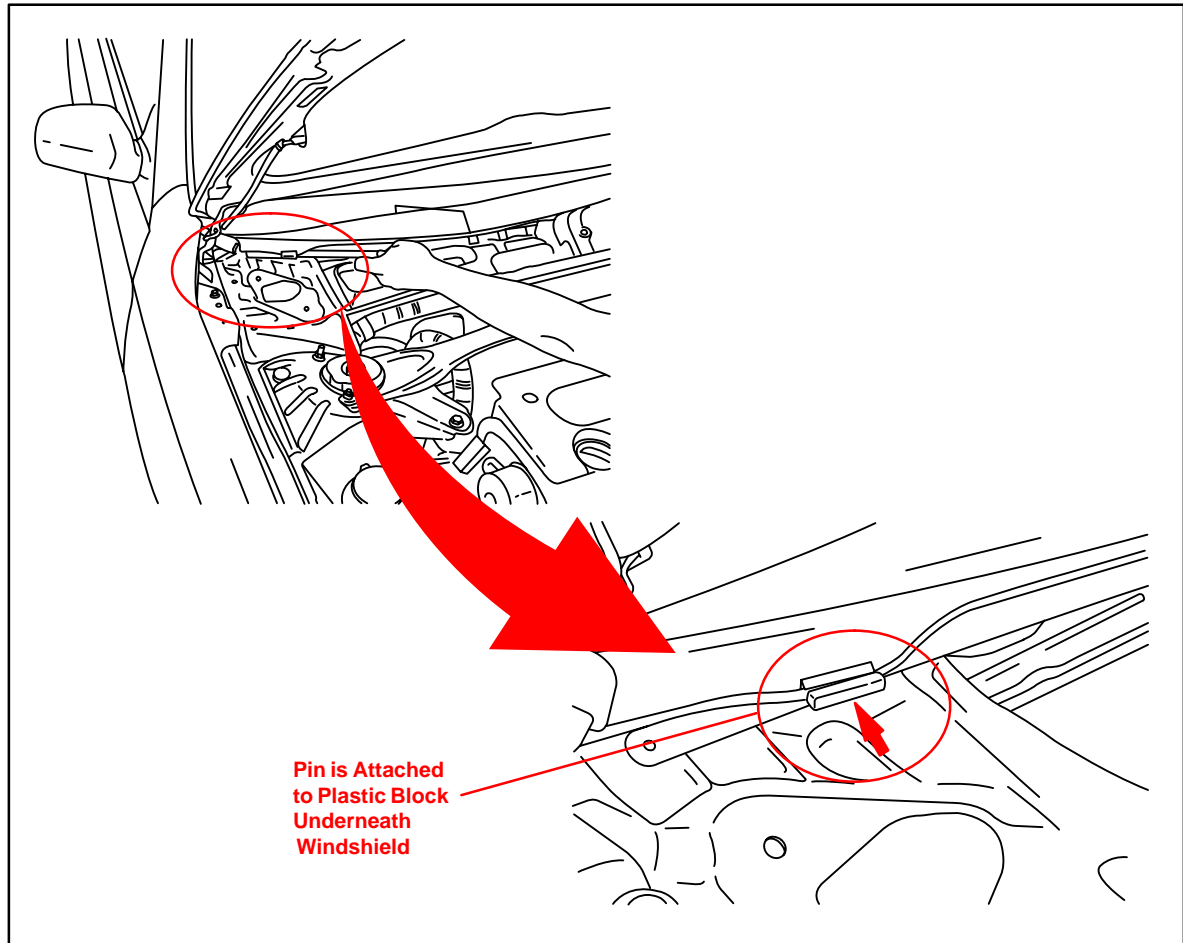
2. Locate the lower windshield retainers.
The retainers are typically located 140 – 200 mm (5.5 – 7.9 in.) inboard of the lower corners of the windshield. The flat portion of the retainer is adhered to the backside of the windshield with double-sided, foam-backed tape.
