**Technical Service
Information Bulletin**

Title:
INSTRUMENT PANEL RATTLE
Models:
'06 GS 300, GS 430, & '07 GS 450h

NVH
NV004-06

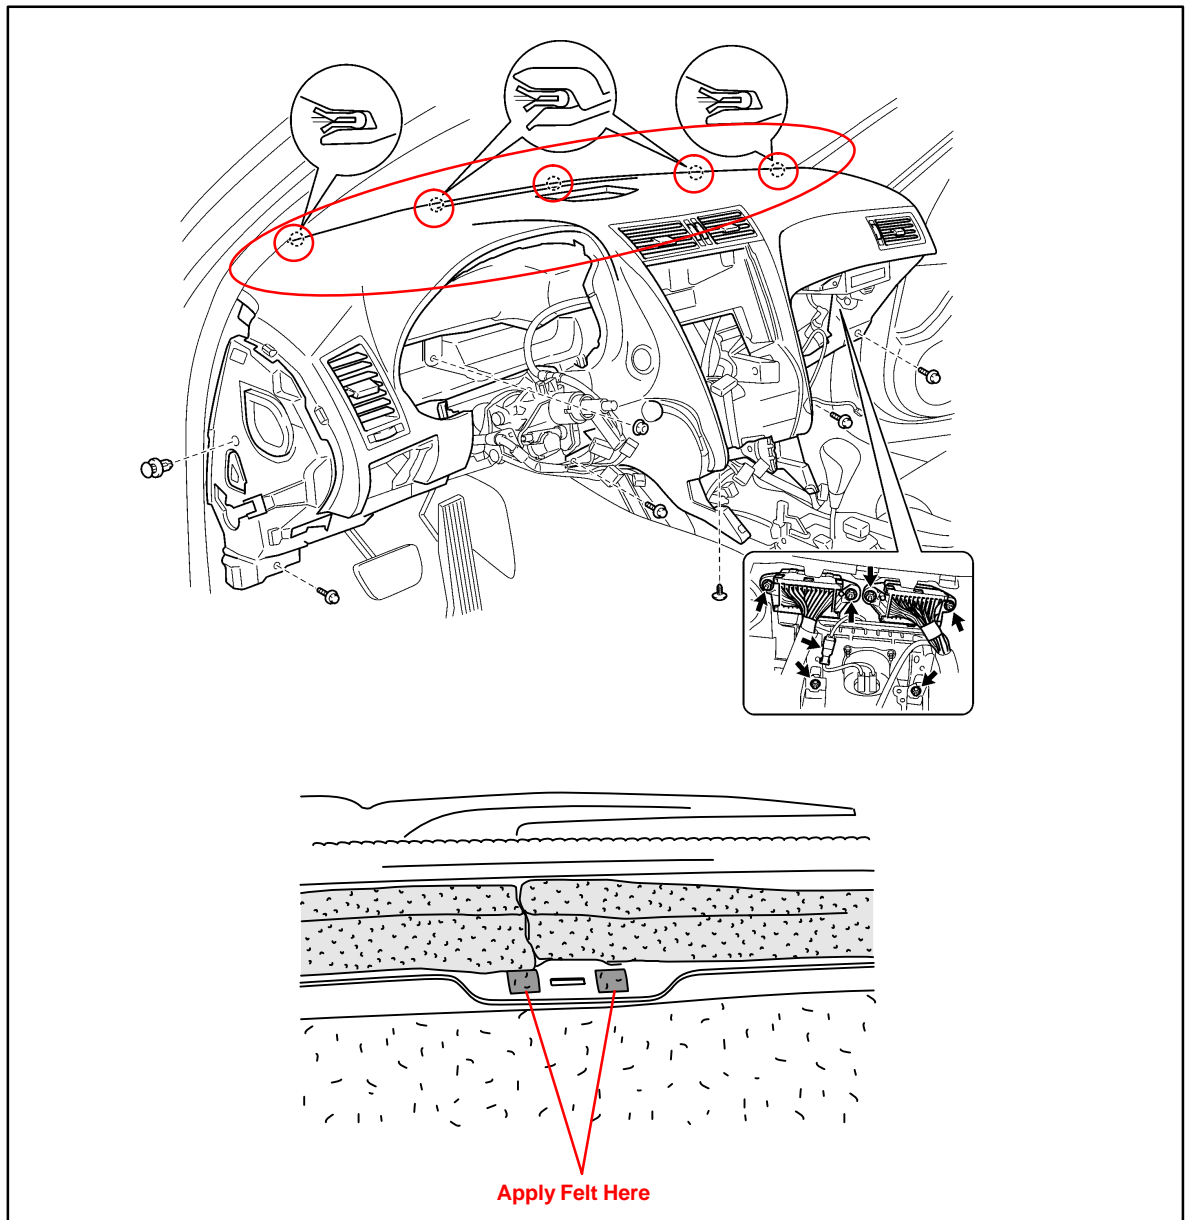
Introduction Some customers may complain of rattle noises coming from the front of the instrument panel at the base of the windshield. The following procedures have been developed to improve this condition.

1. Remove the instrument panel sub-assembly.
Refer to the Technical Information System (TIS), applicable model and model year Repair Manual: *Instrument Panel: Instrument Panel Safety Pad: Removal*.
2. Remove the instrument panel sub-assembly to expose the instrument panel attachment clips.
3. Remove the instrument panel attachment clips and apply two (2) felt squares to the cowl side attachment points as shown in the following illustration.

Felt Size:**Length: 10 mm (0.39 in.)****Width: 10 mm (0.39 in.)****Thickness: 0.5 mm (0.02 in.)**
