**Technical Service
Information Bulletin**

Title:
BACK WINDOW GLASS CREAK
Models:
'06 GS 300 & GS 430

NVH
NV002-05

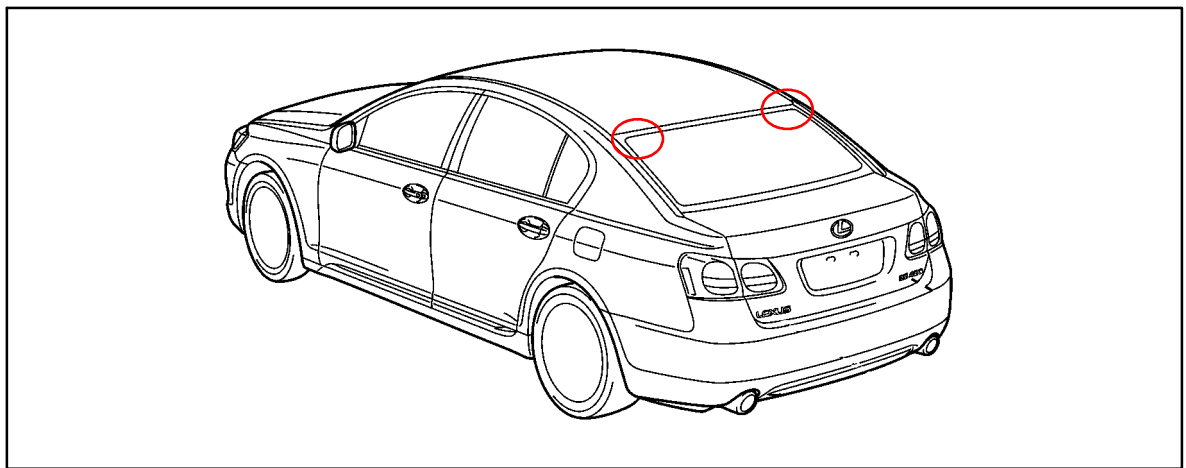
Introduction Some 2006 model year GS 300 and GS 430 vehicles may experience a creak noise coming from the upper portion of the back window glass. The source of this noise may be the two glass stoppers (locating pins) bonded to the top of the glass, rubbing against the body. A production countermeasure has been implemented beginning with VIN numbers listed below. Vehicles prior to the countermeasure VIN can be corrected by removal of a portion of each stopper.
