# Technical Service Information Bulletin

## Title: **BACK WINDOW GLASS CREAK** Models: **'06 GS 300 & GS 430**

NVH  
NV002-05

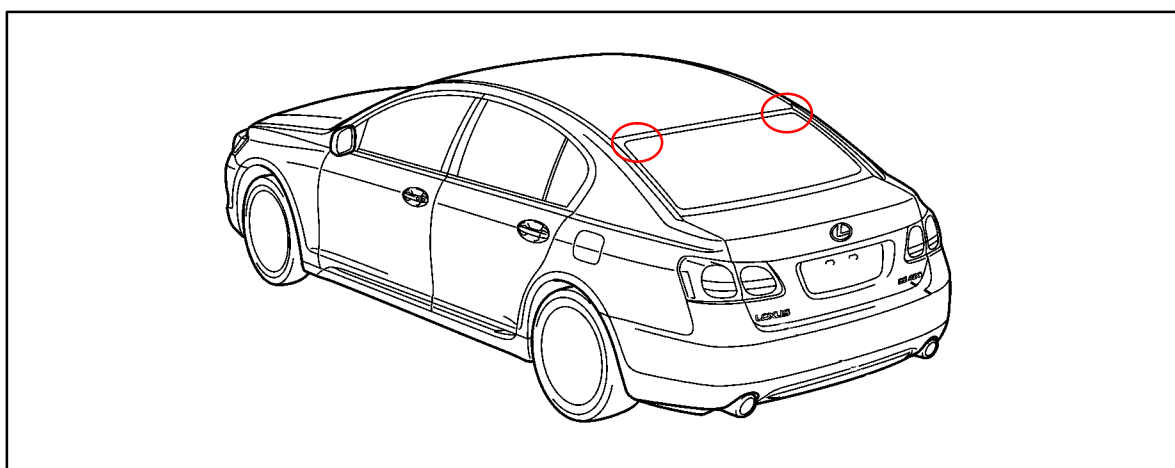
**Introduction** Some 2006 model year GS 300 and GS 430 vehicles may experience a creak noise coming from the upper portion of the back window glass. The source of this noise may be the two glass stoppers (locating pins) bonded to the top of the glass, rubbing against the body. A production countermeasure has been implemented beginning with VIN numbers listed below. Vehicles prior to the countermeasure VIN can be corrected by removal of a portion of each stopper.
