Clicking Noise From Front Wheel Area During Slow Speed Turns (F Sport 2WD)

Service Category Brake

Section Brake (front)

The information contained in this bulletin supersedes Service Bulletin No. L-SB-0100-16.

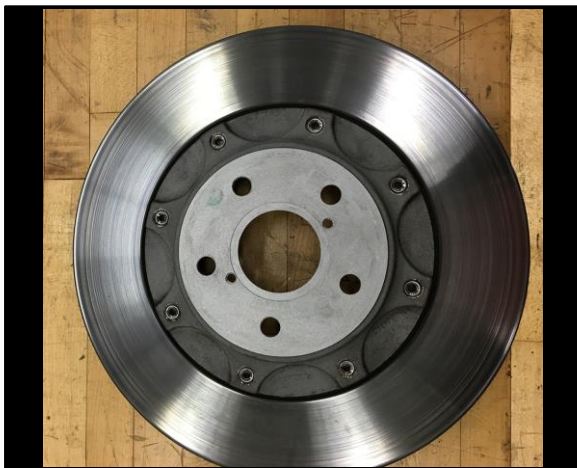
Figure 1. Before (Aluminum)

These vehicles are originally equipped with a lightweight two-piece aluminum rotor assembly. The clicking noise that can be heard during sharp turns is a normal condition. For customers that find this objectionable, an alternative steel rotor is available. Before performing this repair, it is recommended to review the visual differences of the steel rotor with the customer.

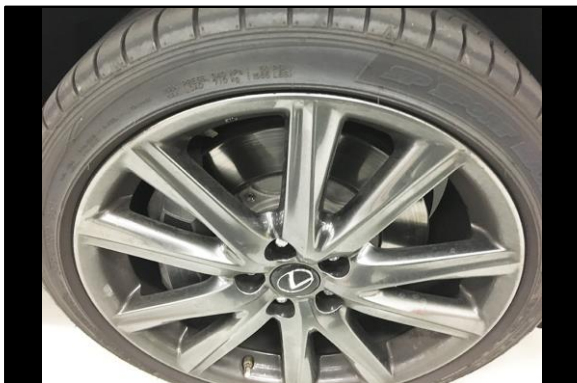
Figure 3. Before* (Aluminum)

*Example of one wheel type for the vehicle. Other wheel types may have slightly different results.

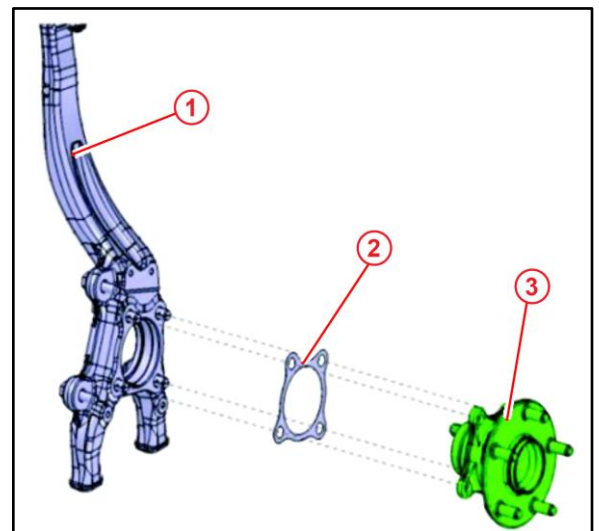
Figure 5.

1	Knuckle
2	Shim
3	Hub Bearing

- [2015](#) / [2016](#) / [2017](#) / [2018](#) RC 350:
Drivetrain – Axle and Differential – “Axle and Differential: Front Axle Hub: Removal”
 - B. Install the painted brake shim between the hub bearing and knuckle as shown.

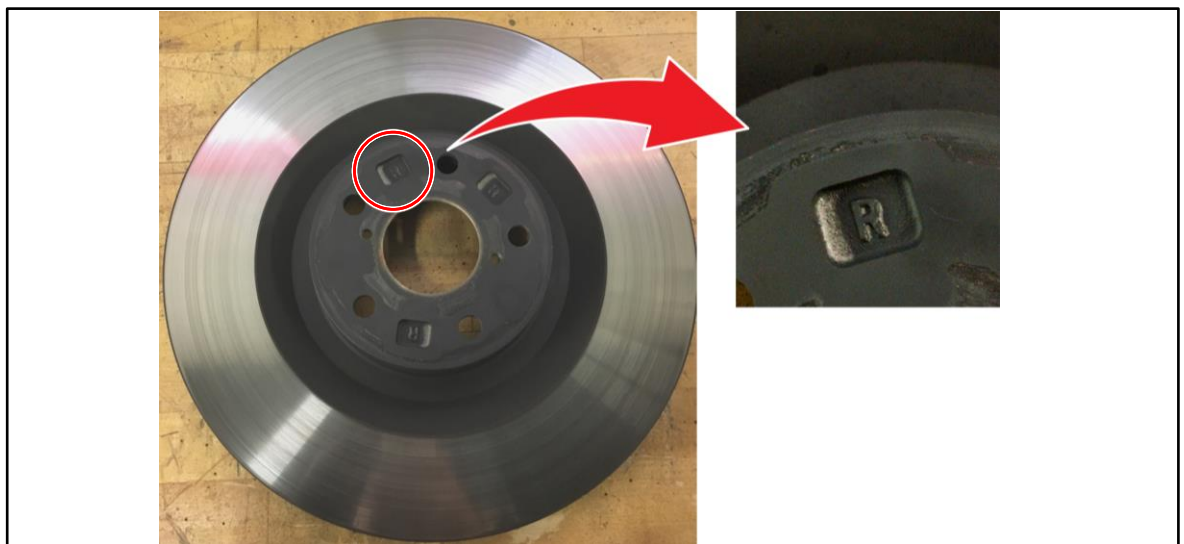
Figure 6.

NEW steel one-piece rotors do NOT have paint marks as shown in the Repair Manual. They are marked with an “L” or an “R” to show which location to install.

C. Reinstall the hub bearing, NEW rotors, and NEW brake pads.
