**Technical Service  
Information Bulletin**

Title:  
**UPPER/LOWER WINDSHIELD  
TICK NOISE**

Models:  
**'03 – '07 Lexus**

NVH  
**NV005-06**

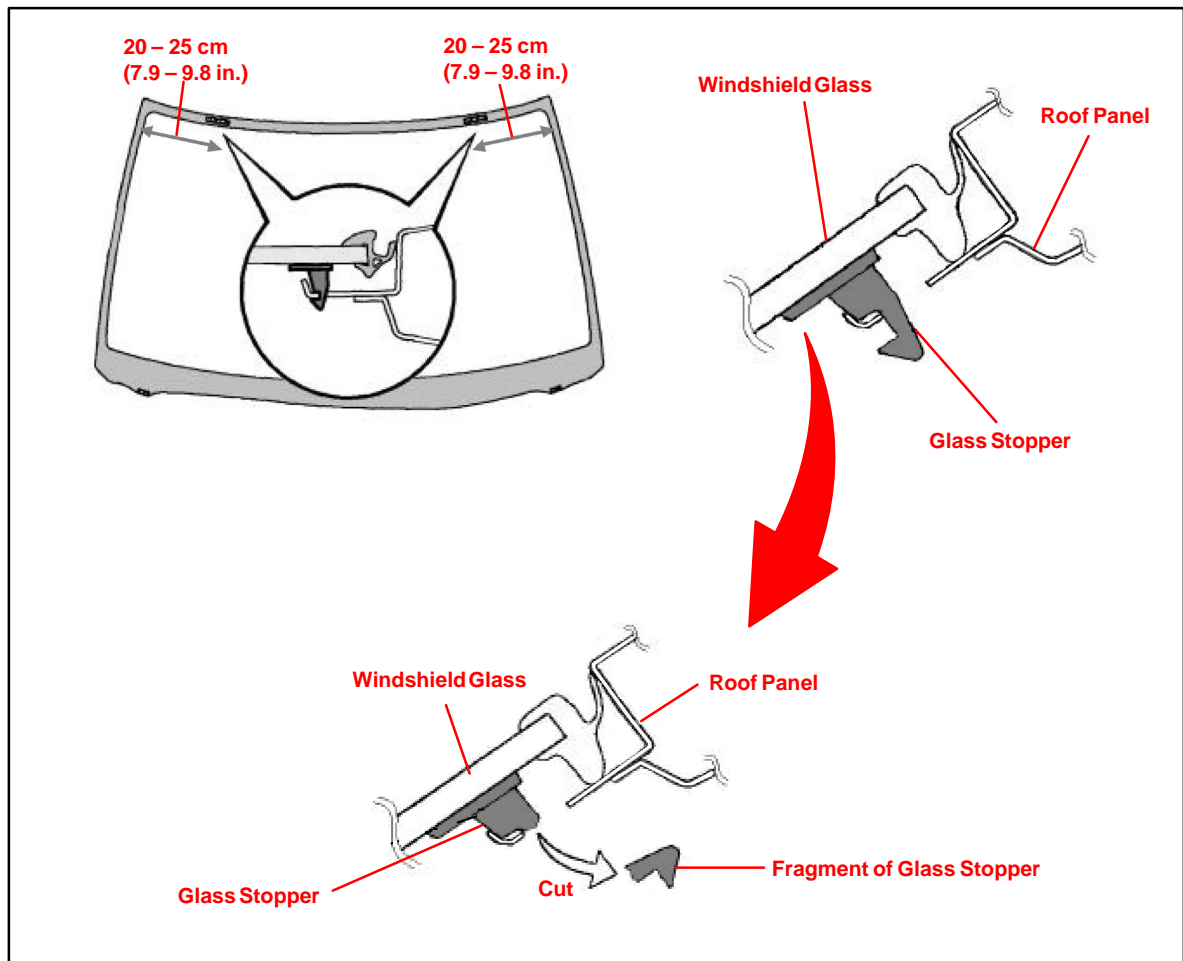
The stoppers are located on the inside of the passenger compartment behind the windshield glass blackout section (near the top front edge of the metal roof opening). The stoppers are typically located 20 – 25 cm (7.9 – 9.8 in.) inboard of the top corners of the windshield glass.

2. Cut OFF the tip of the plastic stopper as shown in the illustration.

It is sometimes necessary to bend the metal body tab down to gain access to the shaft of the stopper.

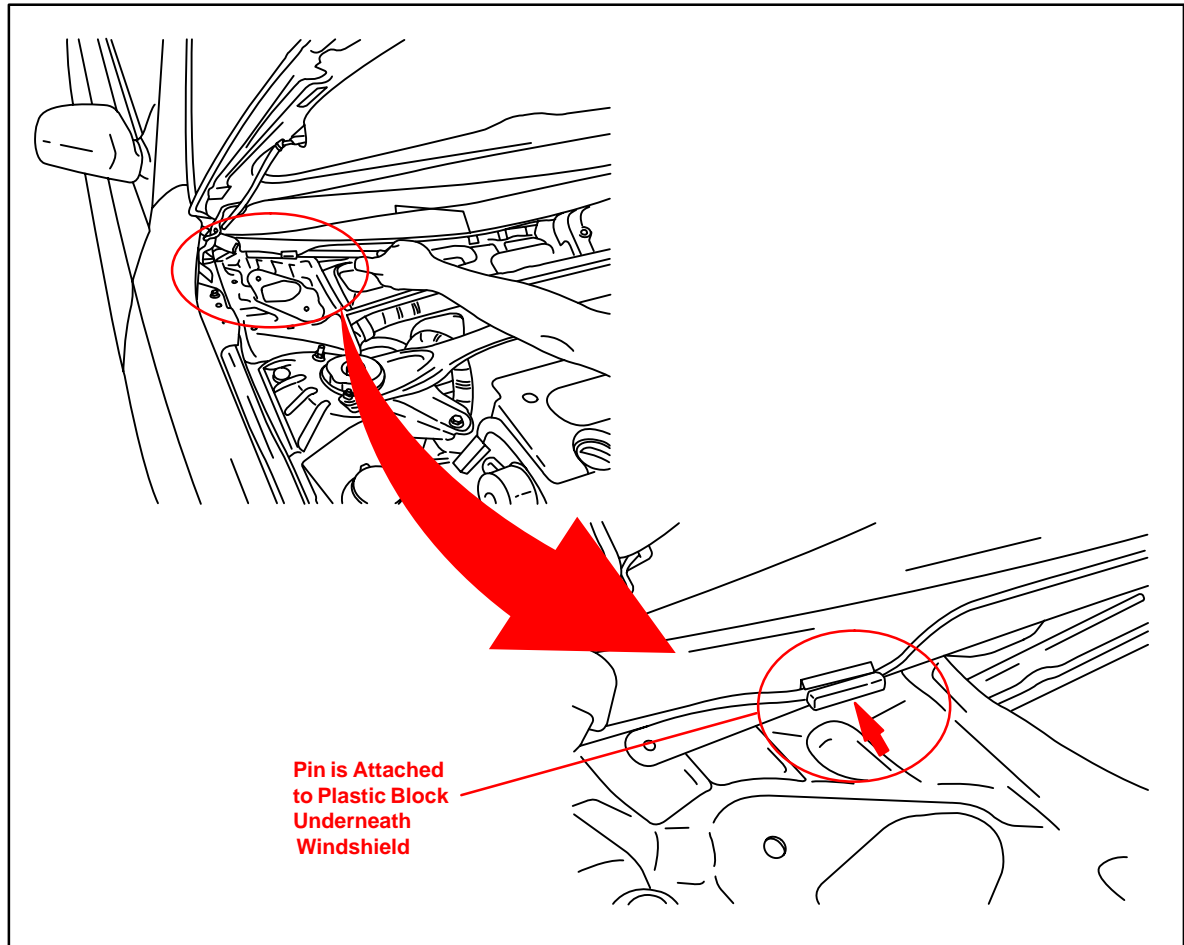
The retainers are typically located 140 – 200 mm (5.5 – 7.9 in.) inboard of the lower corners of the windshield. The flat portion of the retainer is adhered to the backside of the windshield with double-sided, foam-backed tape.

2. Locate the lower windshield retainers.
