**Technical Service
Information Bulletin**

NOISE FROM REAR A/C UNIT

'04 GX 470

HEATING & AIR CONDITIONING
AC001-05

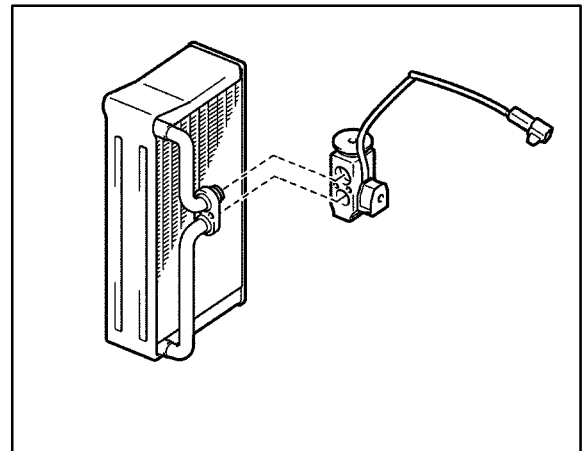
- 11. Remove the rear cooling unit expansion valve.

NOTE:
Please reconfirm that the expansion valve production date on the part is after 6F11, where 6 = month, F = year, and 11 = day (June 11, 2004).

12. Replace the expansion valve.
 - A. Sufficiently apply compressor oil to 2 new O-rings and the surface of the expansion valve.
Compressor oil: ND-OIL 8 (or equivalent)
 - B. Install the 2 O-rings to the evaporator sub-assembly.
13. Replace the air conditioner tube assembly.
 - A. Sufficiently apply compressor oil to 2 new O-rings and the surface of the tube assembly.
Compressor oil: ND-OIL 8 (or equivalent)
 - B. Install the 2 O-rings to the tube assembly.
14. Reassemble and install the cooler unit case.
15. Install the cooling (rear) unit assembly with the 3 bolts.
