Service Category	Vehicle Exterior			Lexus Supports
Section	Paint/Coatings	Market	USA	Lexus Supports ASE Certification

YEAR(S)	MODEL(S)	ADDITIONAL INFORMATION
2010 – 2011	GX460

Introduction

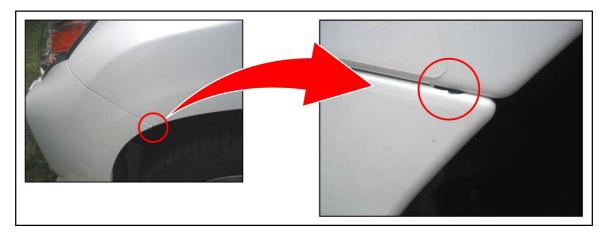
Some 2010 – 2011 model year GX 460 vehicles may exhibit a condition where paint peels or chips on the front bumper cover. The paint may peel or chip on the left side of the bumper cover at or near the rear edge where the bumper cover and front fender meet. The following procedure has been developed to address this condition and increase the gap between the bumper cover and front fender.

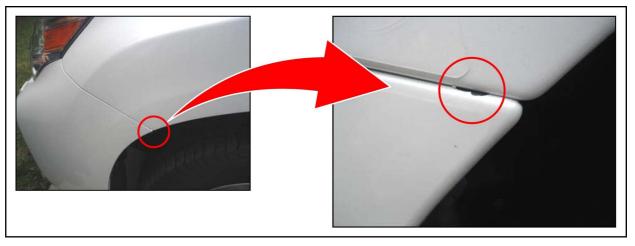
1. Confirm that the front bumper cover paint is peeling or chipping at the location indicated in Figure 1.

- If the front bumper cover paint is peeling or chipping as indicated above, proceed to step 2.
- If the front bumper cover paint is not peeling or chipping as indicated above, STOP. This TSIB does NOT apply.
- 2. Remove the 3 screws.
