Vehicle Pull, Steering Wheel Off Center, and Alignment Best Practices

Service Category Suspension

Section Alignment/Handling Diagnoses

This Service Bulletin provides best practice procedures for vehicle pulling complaint, diagnosis, and repair for 2002 – 2021 model year Lexus vehicles.

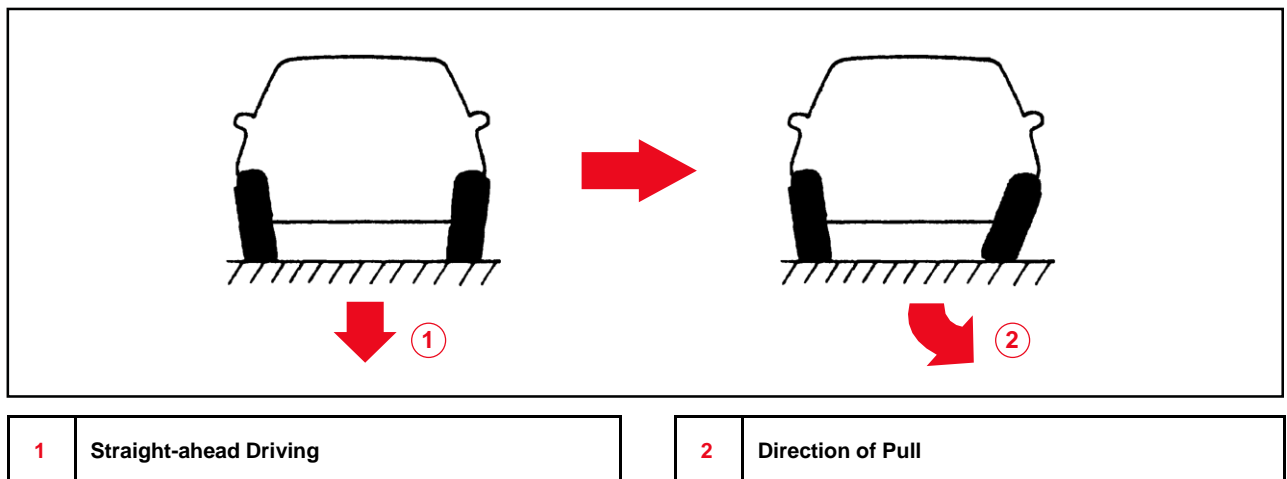
Figure 1. Camber

When the cross camber or caster of the front wheel alignment is large, it can cause vehicle pulling.

WHEEL ALIGNMENT	DIRECTION OF VEHICLE PULL
Camber	Vehicle Pulls in Direction of Wheel with Large Camber Value (See Figure 1)
Caster	Vehicle Pulls in Direction of Wheel with Small Caster Value (See Figure 2)

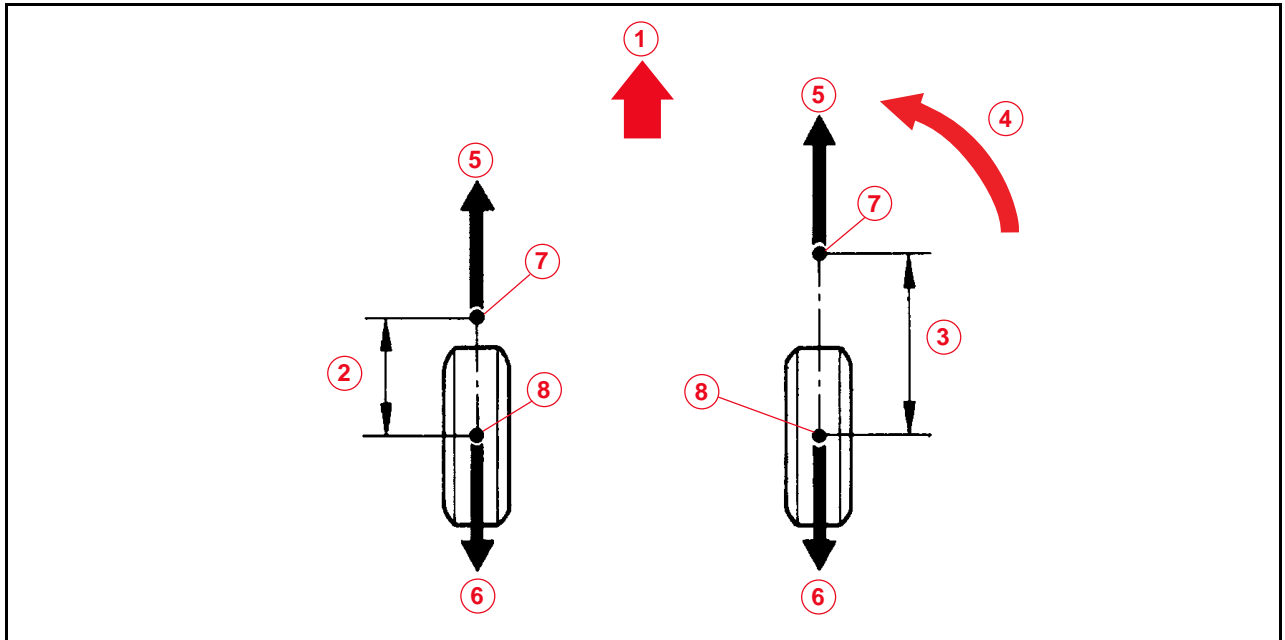
Figure 2. Caster

If the cross camber or caster is within the specified range (30' or less), noticeable vehicle pulling will not occur due to side-to-side differences in camber or caster.

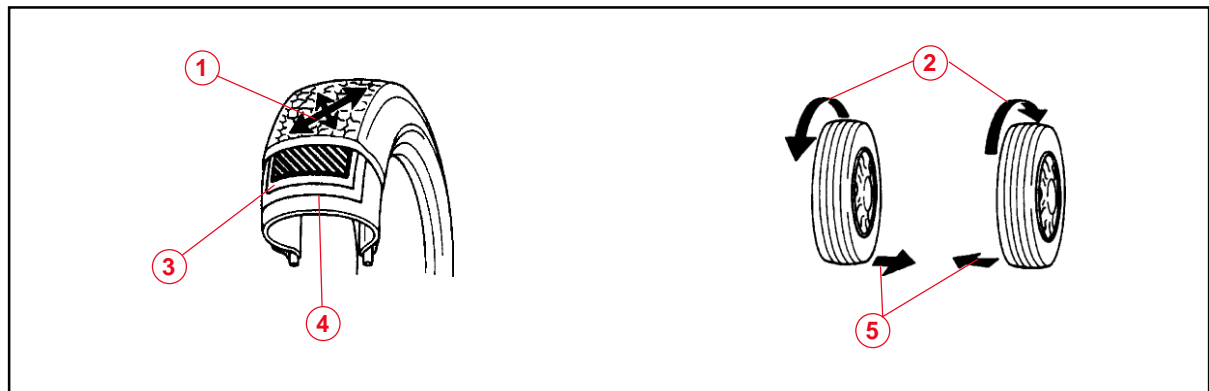
Figure 3. Ply Steer

Lateral force due to ply steer is produced by the construction of the belts inside the tire tread. With radial tires, the wire of the belt is slanted as shown in the illustration below. Thus, it is in the lateral direction that tire tread easily changes shape (stretches), and lateral force is generated between the tire and the road surface in the lateral direction.

Lateral force from ply steer prevents vehicle drift caused by road crown, so in many cases lateral force to the left is provided to compensate for road crown to the right.

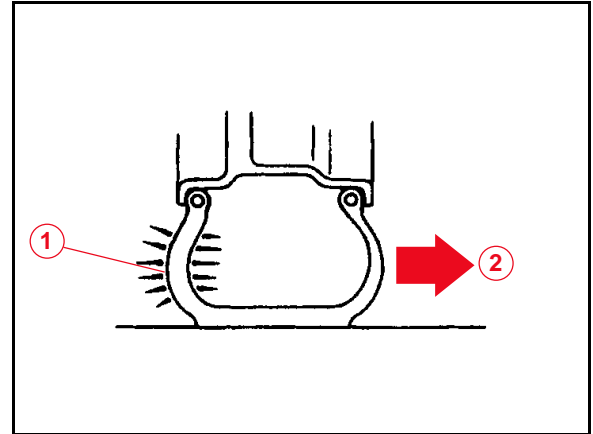
Figure 4.

Conicity is lateral force resulting from uneven formation of the left and right sides of the tire. The direction the lateral force is exerted depends on the hardness of the side walls and the difference in height between the left/right sides of the tire. The greatest effect on vehicle pulling is most often the lateral force caused by tire conicity.

When vehicle pulling is due to conicity, the amount of drift can be reduced, and the direction of drift can be changed by changing the location of the tire or reversing the tire when installing it on the wheel.

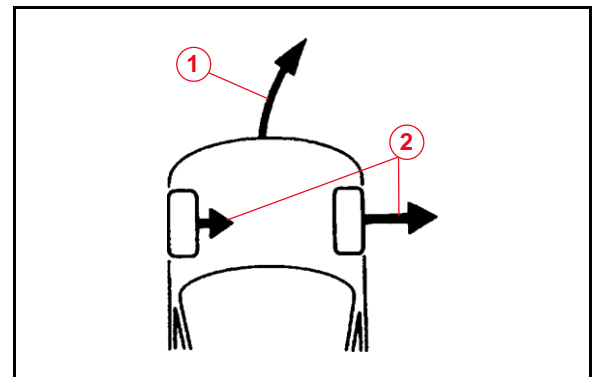
Figure 6. Original Tire Positions

3. Decide if vehicle pulling is due to wheel alignment or tires.
 - A. Switch the left and right front tires (if the tires are non-unidirectional).
 The direction of lateral force from tire conicity becomes reversed when the left and right tires are switched. Therefore, if the pulling direction changes when the tires are switched, it can be concluded that vehicle pulling is caused by tire conicity.
 - The vehicle is pulled to the right by the lateral force exerted to the right.

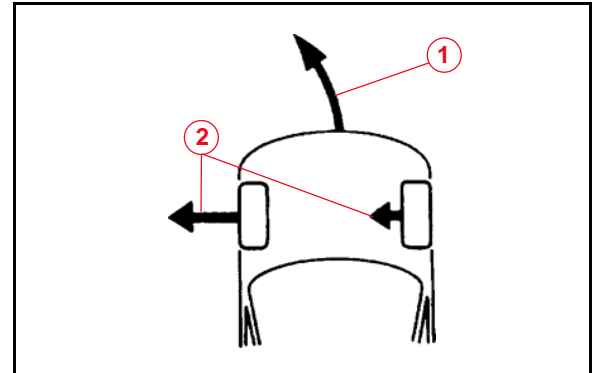
Figure 7. Tires Switched

- The direction of the tires which exerted lateral force to the right has been changed. The tires now exert lateral force to the left, and the vehicle now pulls to the left.

If the pulling direction does NOT change AFTER the front tires are switched, the cause of vehicle pulling is NOT tire conicity. In this case, the likely cause is a front wheel alignment condition.

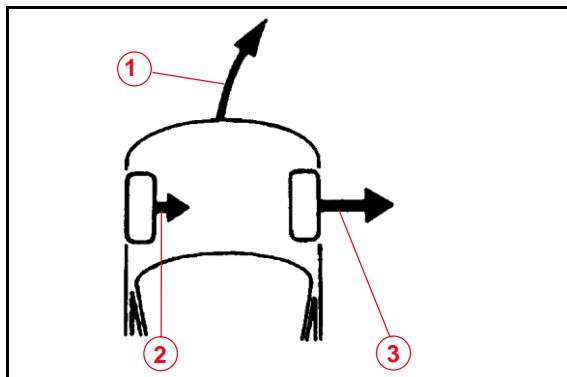
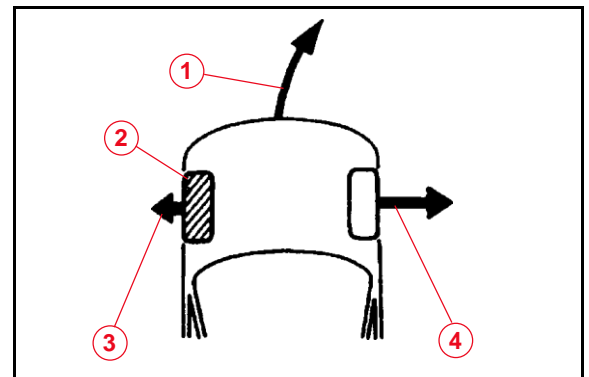
- A. If the vehicle pulls in the same direction, go to step 2.

The lateral force generated by the right front tire is greater than the left tire, so the vehicle is pulling due to the lateral force of the right tire.

1. Remove the front left tire from the wheel and reverse the tire, if the tire is not unidirectional. Then, perform a road test and check for changes in the pulling direction.

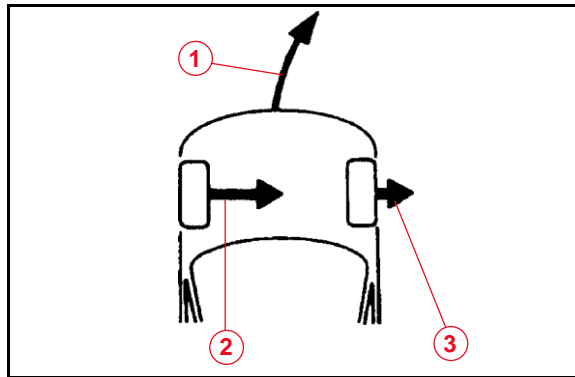
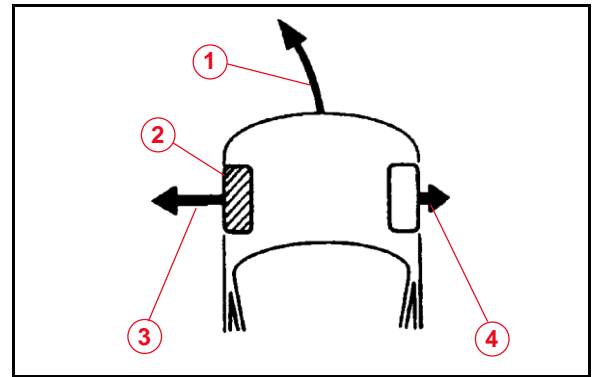
B. If the vehicle pulls in the opposite direction, go to step 2.

The lateral force generated by the left front tire is greater than the right tire, so the vehicle is pulling due to the lateral force of the left tire.

2. Rotate the LARGER lateral force front tire with the rear tire and check the change in the vehicle pulling if the front and rear wheel and tire assemblies are the same size.
