Second Row Seat Squeak

Service Category Vehicle Interior

Section Seat

YEAR(S)	MODEL(S)	ADDITIONAL INFORMATION
2010 – 2015	GX460

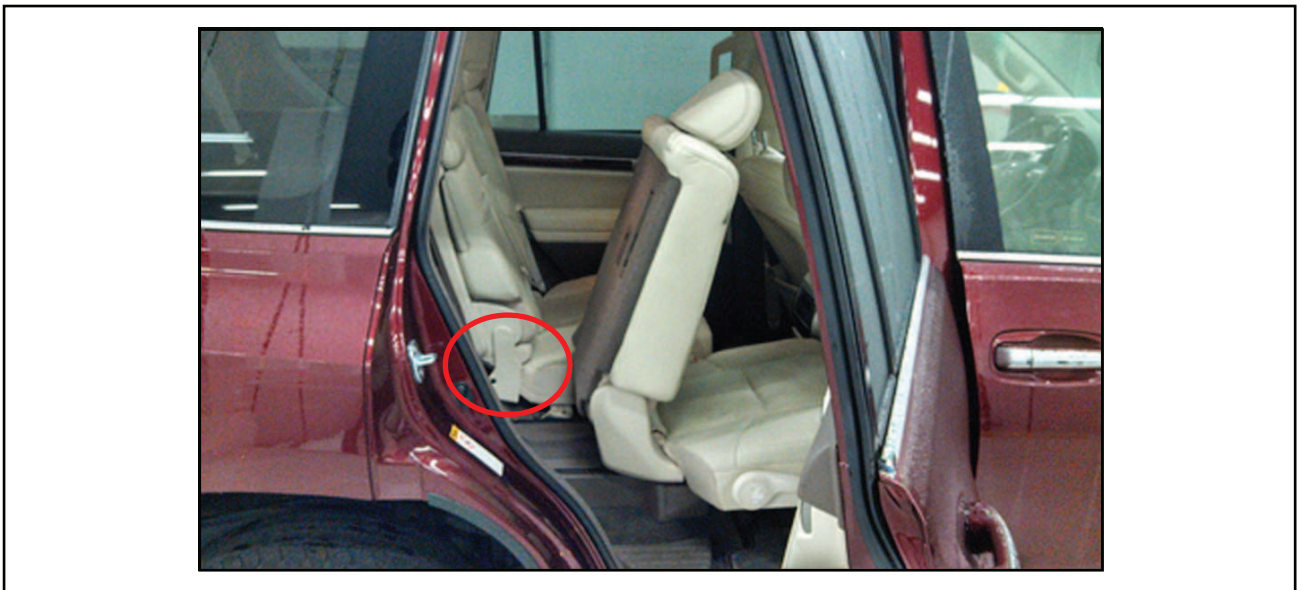
Figure 1.

Some 2010 – 2015 model year GX 460 vehicles may exhibit a squeak noise coming from the second row seats when driving over uneven terrain. The bracket for the inside hinge of the 60% second row seat may rub the seat frame. Follow the procedure outlined below to address this condition.

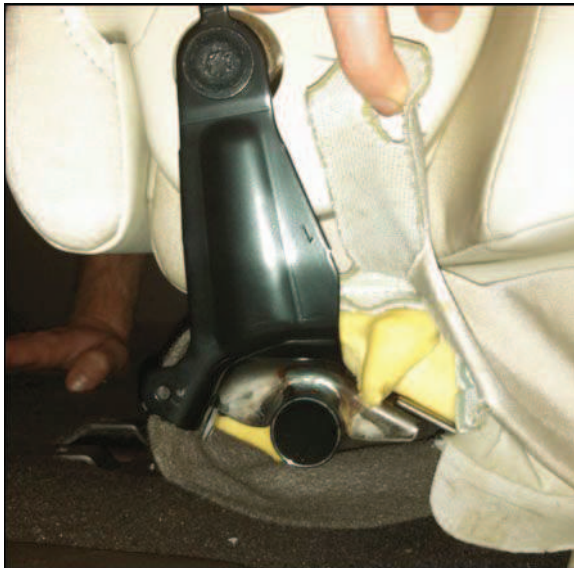
Figure 3. Approximate Vantage Point (Reposition Foam to Access View)

3. Confirm that a noise is being generated by two surfaces rubbing, as shown below.
