**Tech Tip**

**P0335 CRANKSHAFT POSITION  
SENSOR CIRCUIT MALFUNCTION**

TIP2155

ENGINE - ELECTRICAL

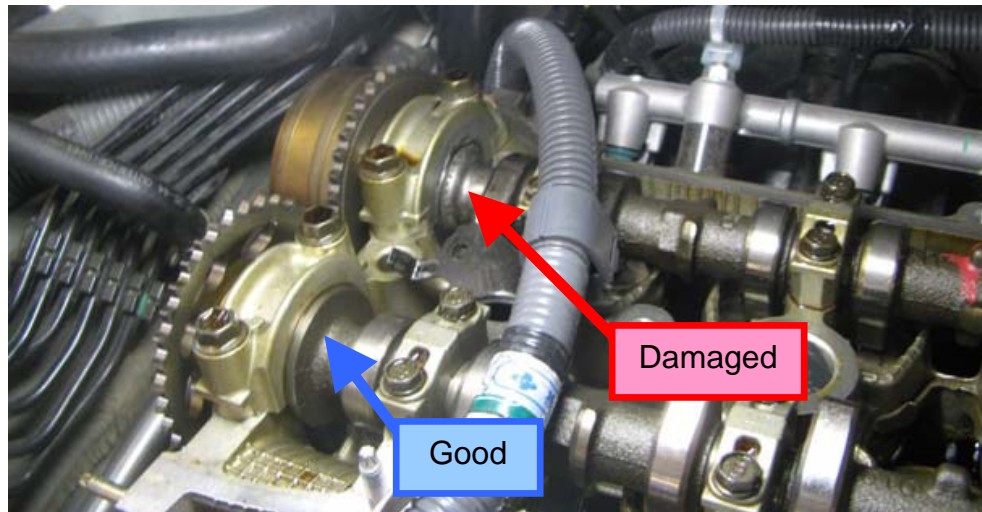
**Suggestion:** Remove the valve cover(s). Inspect the camshafts for damage. Pay close attention to the areas around the thrust washer. The camshaft (G) and crankshaft (NE) signals may be out of sync if the camshaft is able to walk back and forth.
