**Technical Service
Information Bulletin**

Title: **INSTRUMENT PANEL RATTLE**

Models: **'06 IS 250 & IS 350**

REVISED
NV003-06
NVH

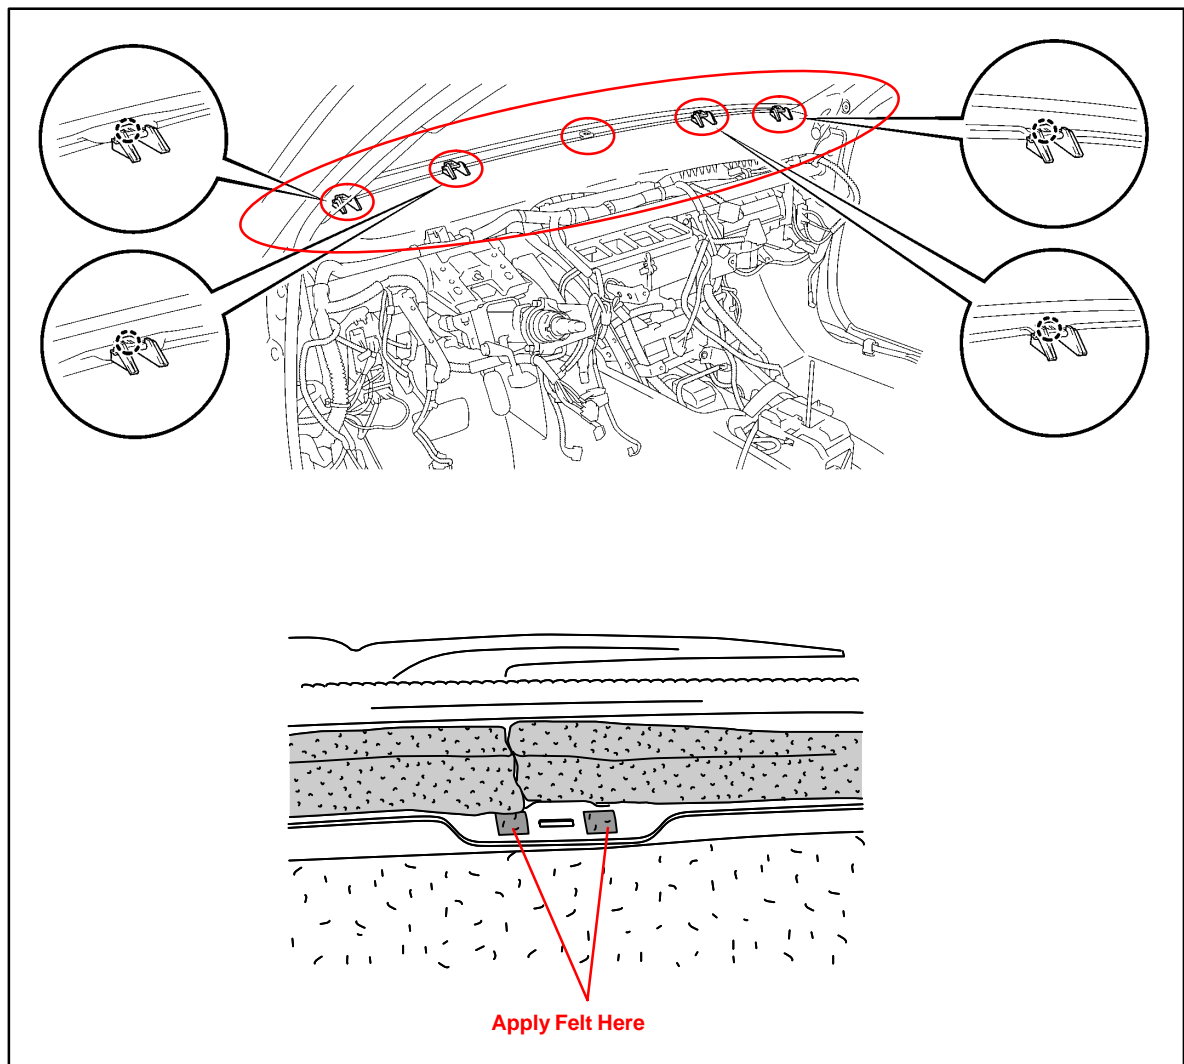
Introduction Some customers may complain of rattle noises coming from the front of the instrument panel at the base of the windshield. The following procedure has been developed to improve this condition.

1. Remove the instrument panel sub-assembly.
Refer to the Technical Information System (TIS), 2006 model year IS 250 or IS 350 Repair Manual: *Instrument Panel: Instrument Panel Safety Pad: Removal, Disassembly.*
2. Remove the instrument panel sub-assembly to expose the instrument panel attachment clips.
3. Remove the instrument panel attachment clips and apply two (2) felt squares to each of the five (5) cowl side attachment points as shown in the following illustration.

Felt Size:**Length: 10 mm (0.39 in.)****Width: 10 mm (0.39 in.)****Thickness: 0.5 mm (0.02 in.)**

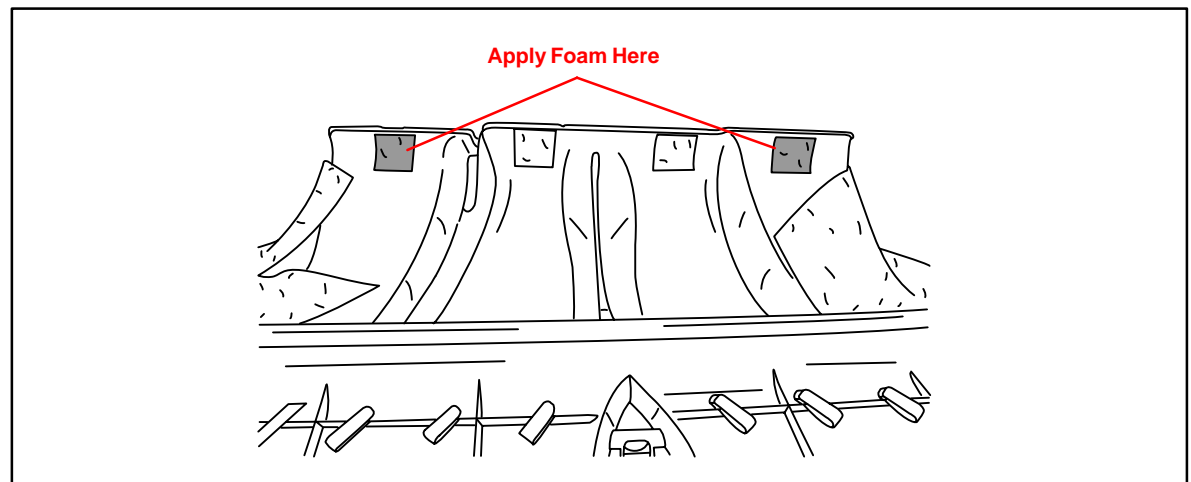
Instrument panel pad is shown upside down.

5. Apply foam to the instrument pad HVAC duct as shown in the following illustration.

Foam Size:

Length: 30 mm (1.18 in.)

Width: 30 mm (1.18 in.)

Thickness: 5 mm (0.20 in.)
