Instrument Panel Rattle

Service Category Vehicle Interior

Section Interior Panels/Trim

YEAR(S)	MODEL(S)	ADDITIONAL INFORMATION
2006 – 2007	IS250, IS350

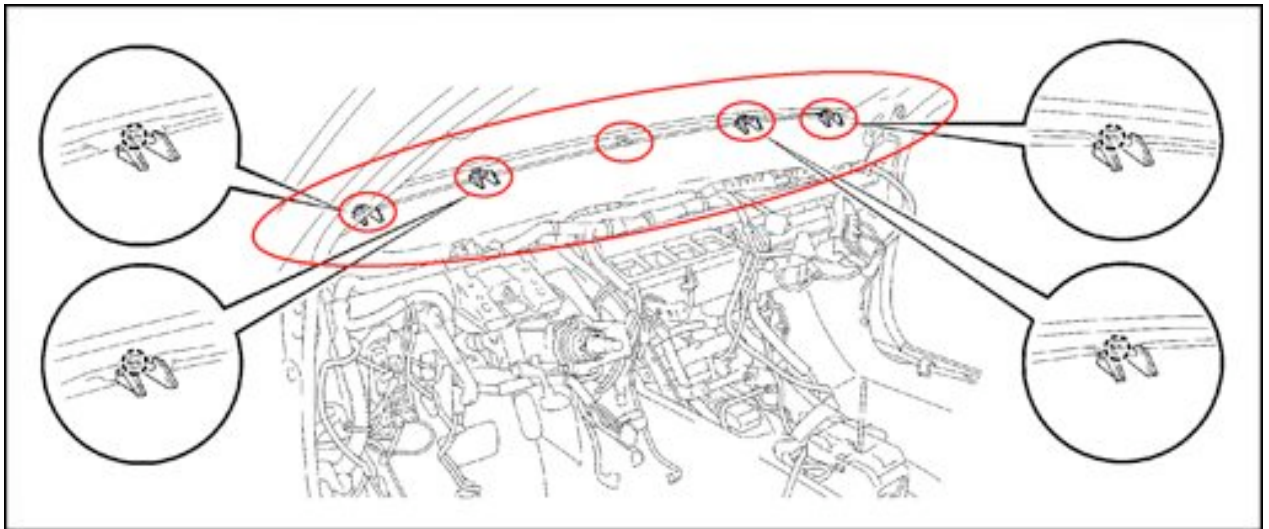
Figure 1.

Some customers may complain of rattle noises coming from the front of the instrument panel at the base of the windshield. The following procedure has been developed to improve this condition.

3. Remove the instrument panel clip (Stay No. 3) at the center of the dash and replace with the NEW clip. Repeat the same on the remaining four clips (instrument panel clip No. 1).

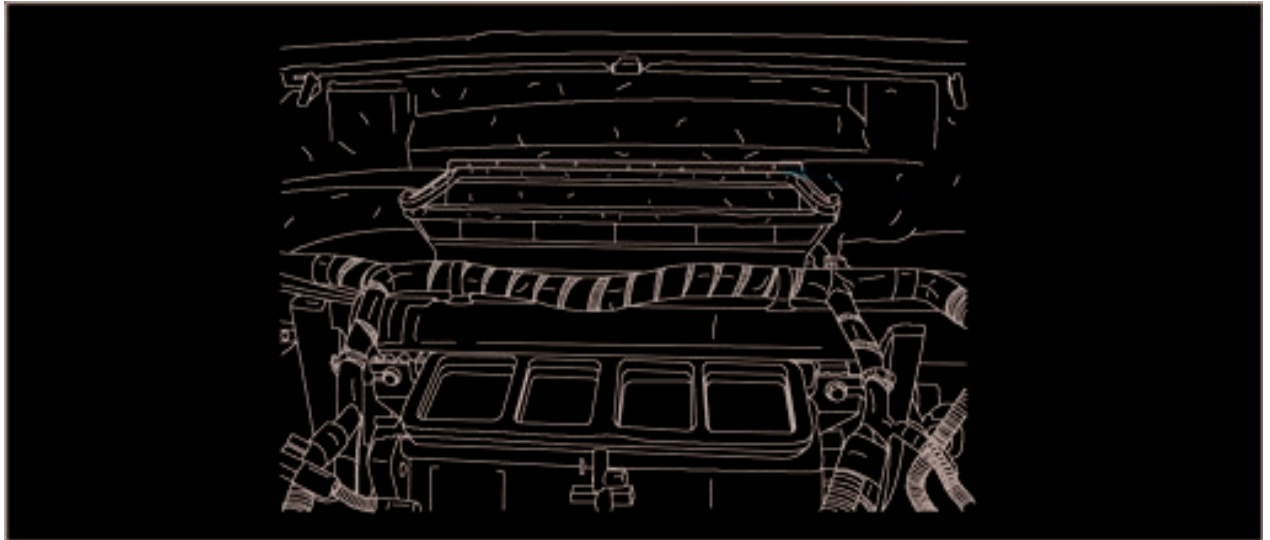
| 1 | Apply felt (as necessary) in this area if the urethane foam is worn away or if there is plastic to plastic contact between components. |

4. Apply felt along the defroster nozzle lip as shown in Figure 2.

Felt Size

Length: 29 cm (11.42 in.)

Width: 14 mm (0.55 in.)

Thickness: 0.5 mm (0.02 in.)
