# Instrument Panel Rattle

YEAR(S)	MODEL(S)	ADDITIONAL INFORMATION
2006 – 2007	IS250, IS350

Some customers may complain of rattle noises coming from the front of the instrument panel at the base of the windshield. The following procedure has been developed to improve this condition.

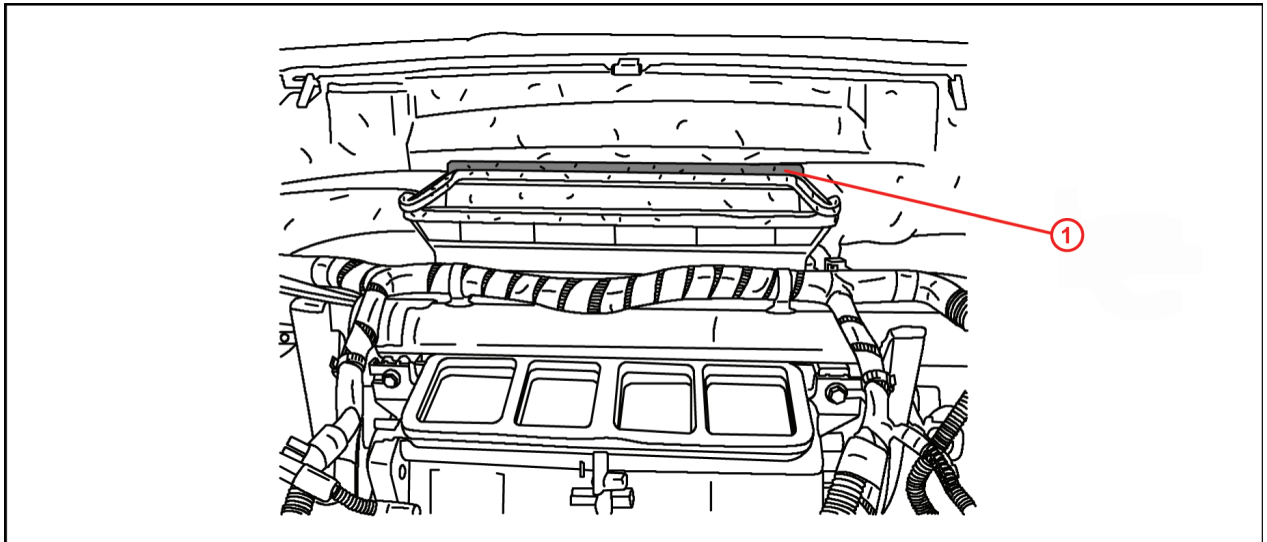
**Figure 2.**

<b>1</b>	Apply felt (as necessary) in this area if the urethane foam is worn away or if there is plastic to plastic contact between components.
----------	--

4. Apply felt along the defroster nozzle lip as shown in Figure 2.

**Length:** 29 cm (11.42 in.)

**Width:** 14 mm (0.55 in.)

**Thickness:** 0.5 mm (0.02 in.)
