**Technical Service
Information Bulletin**

Title: **PAINT STAINS UNDER RAPGARD™**
Models: **'02 – '06 All Models**

PAINT
REVISED
PA001-03

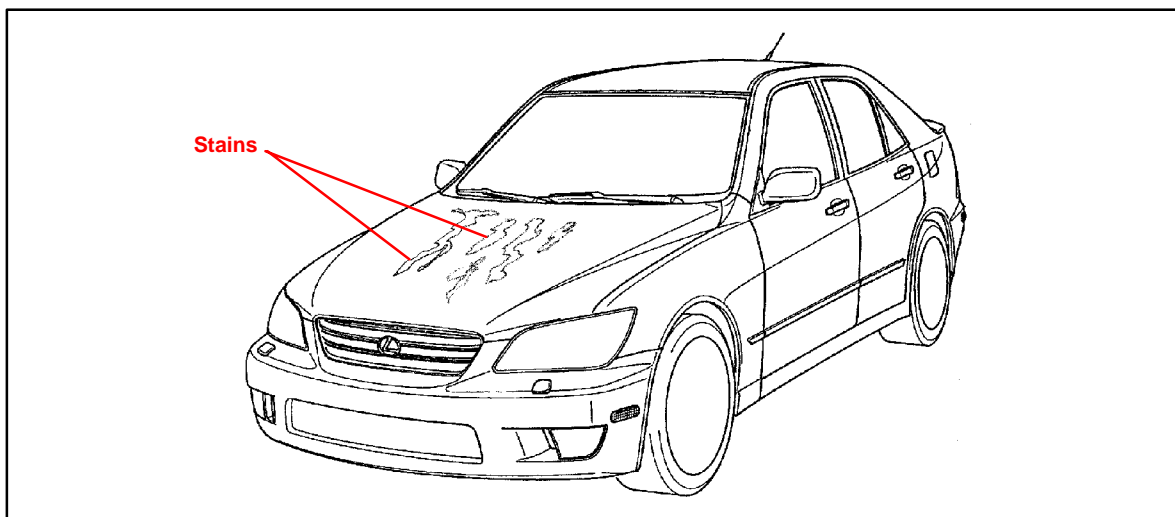
Introduction On some vehicles, when Rapgard™ is removed, the paint may have a stained appearance under the clear coat. These stains should not be considered a defect in the paint (clear coat or color coat). Wrinkles in the Rapgard™ sometimes trap water and cause the paint to stain from the trapped moisture, especially on horizontal surfaces, such as the hood, roof, and trunk. Stains can be removed by heating the stained surface to remove the trapped moisture.

1. Use the aluminum foil or damp cloth to cover plastic/rubber parts that are near the stain.
2. Apply heat to the stain using an infrared lamp or heat gun.

Apply heat for 5 – 10 minutes at 158°F – 176°F (70°C – 80°C). Do NOT allow the surface to become hotter than 176°F (80°C). Measure the temperature with a thermometer.

3. After applying heat for 5 minutes, examine the area to determine if the stain has been removed. If the stain still exists, continue to apply heat and re-examine the stain 5 minutes later.
