Intermittent Battery Discharge

Some 2013 – 2015 model year Lexus ES, GS, and IS vehicles may exhibit an intermittent discharged battery occurring with no apparent source of discharge found. One possible cause may be the Network Gateway Computer not properly going into sleep mode at key OFF. This can result in excessive parasitic draw and a discharged battery condition. Follow the procedure in this bulletin to identify and address this condition.

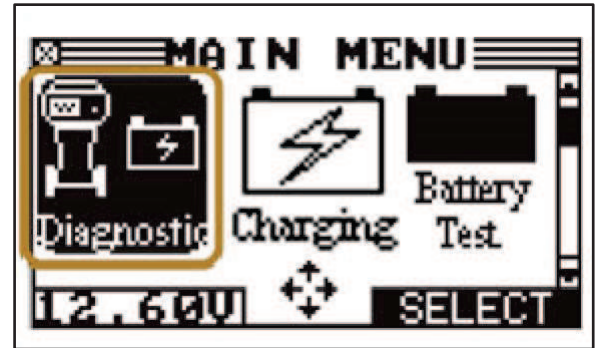
Figure 1.

1. Load test the battery with the GR8 Battery Diagnostic Station.
 - A. Select Diagnostic from the Main Menu.

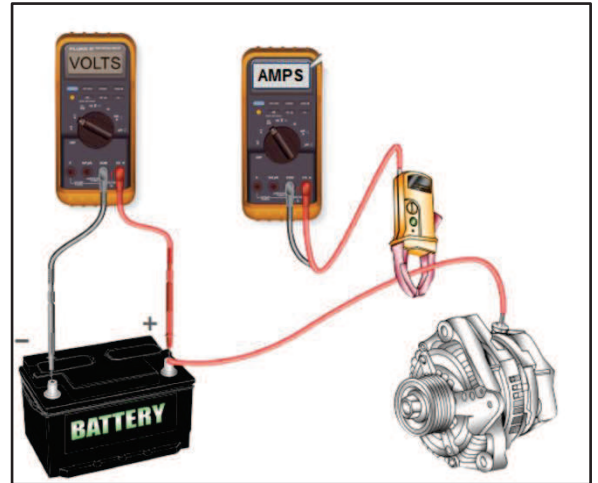
Figure 3.

- B. With the engine running at 2,000 RPM, turn the high beam headlights ON and turn the heater blower switch to the "HI" position. Verify that the voltage and amperage are within specification:

Standard amperage: 30 A or more

Standard voltage: 13.2 to 14.8 V

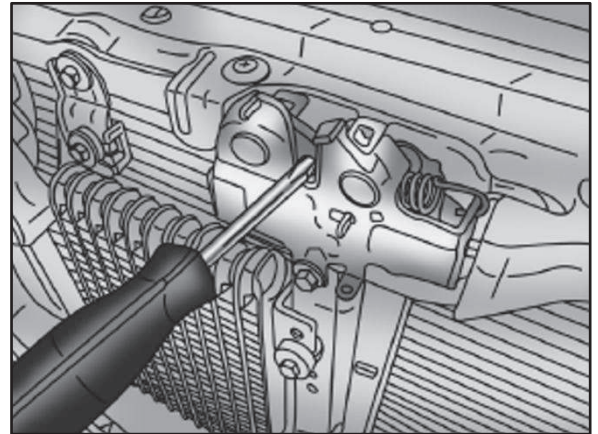
Figure 4.

3. Loosen the negative (-) battery cable so it will be easy to remove for the test.
 - A. Lock the hood latch using a screwdriver and roll the driver's window down.

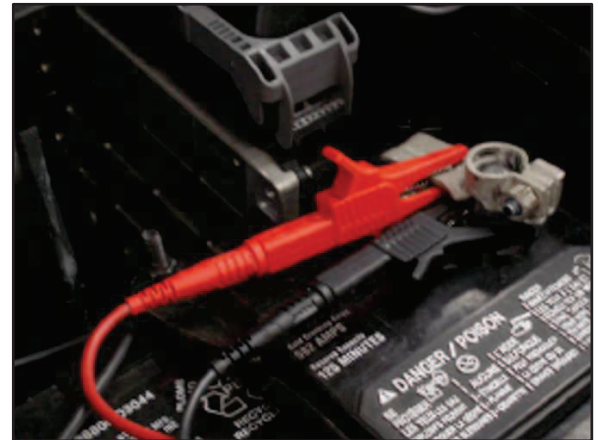
Figure 5.

- B. Turn the ignition ON and then OFF.
- C. Turn OFF all electrical loads, close and lock the doors, then wait for the ECUs to go into sleep mode. This may take anywhere from 10 minutes to 2 hours dependent upon which vehicle is being serviced and what equipment is installed in the vehicle.
- D. Attach the negative (-) lead of the ammeter to the negative (-) battery post and the positive lead of the ammeter to the negative (-) battery cable end.

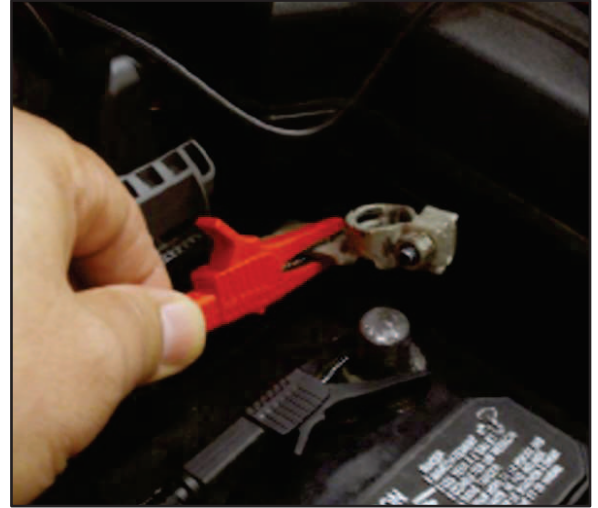
Figure 6.

- E. Remove the negative (–) battery cable without breaking the circuit between the battery and vehicle, and record the meter reading.

**Standard average parasitic draw:**

Less than 50 milliamps average (0.050 amp)
