Upper/Lower Windshield Tick Noise

Service Category Vehicle Exterior

Section Window/Glass

The information contained in this bulletin supersedes SB No. NV005-06.

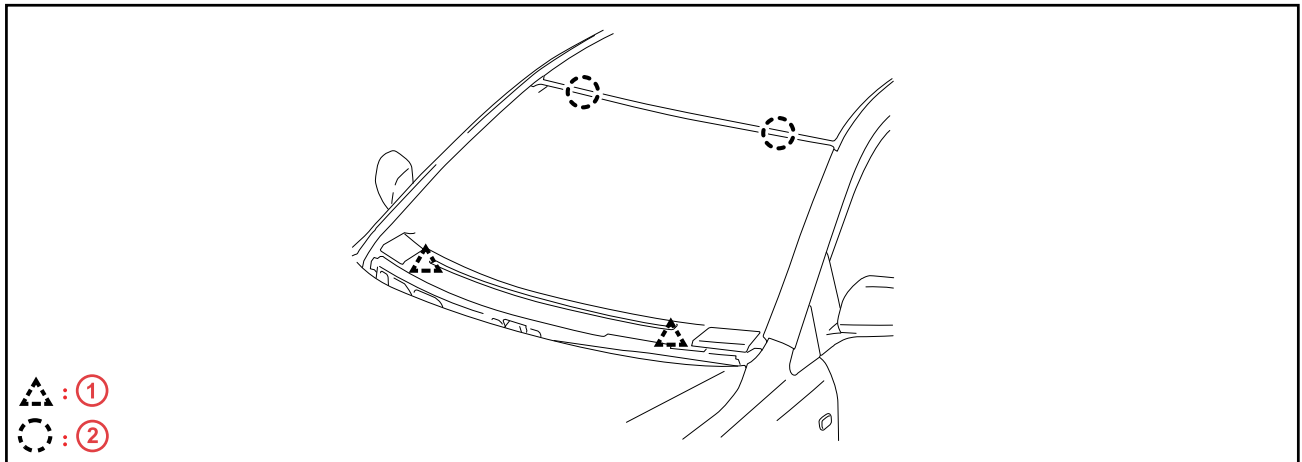
Figure 1.

If a creak, tick, or rattle noise is heard at the top or bottom of the windshield, the source of the noise may be the two windshield stoppers bonded to the top of the windshield or the windshield retainers bonded to the lower edge of the windshield. This bulletin provides the recommended repair procedure to eliminate these types of noises from the windshield area.

1 Retainer

2 Stopper

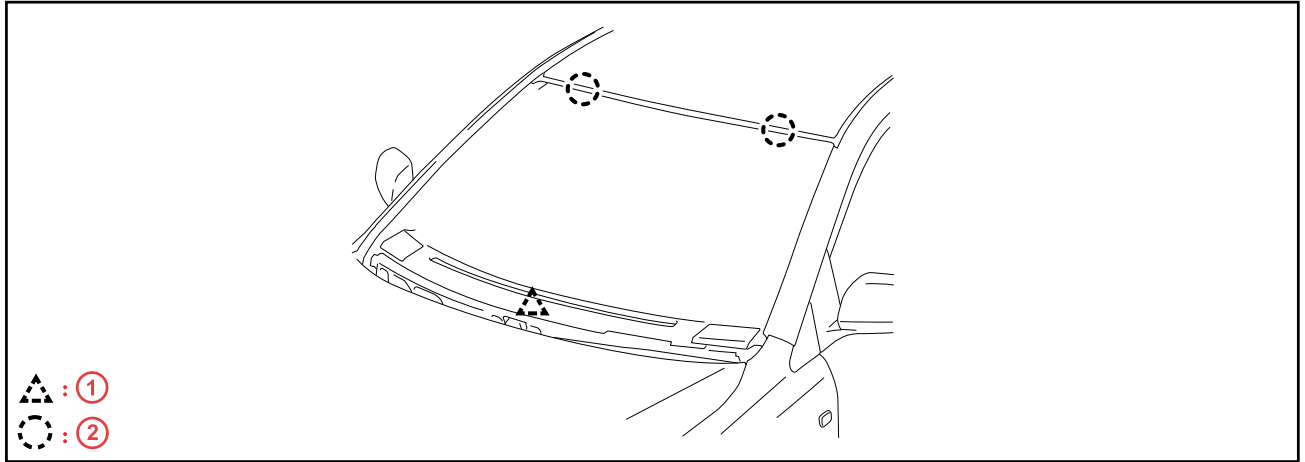
Figure 2. 2003 – 2009 RX models ONLY

* One retainer at the bottom of the windshield ONLY applies to 2003 – 2009 RX models.

1	Retainer
---	----------

2	Stopper
---	---------

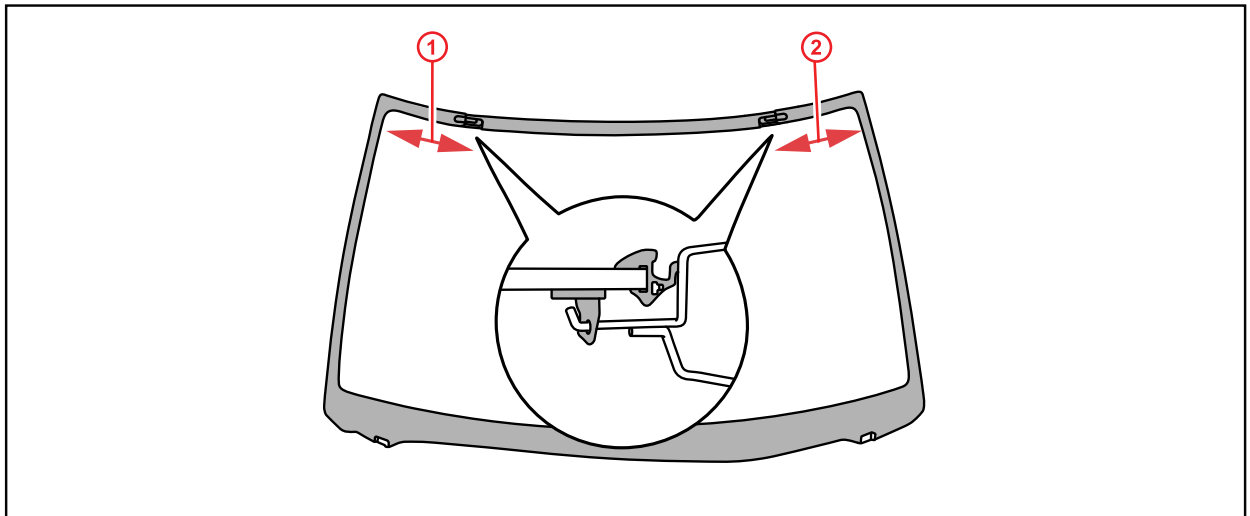
Figure 5.

The stoppers are located on the inside of the passenger compartment behind the windshield glass blackout section (near the top front edge of the metal roof opening). The stoppers are typically located 200 – 250 mm (7.9 – 9.8 in.) inboard of the top corners of the windshield glass.

1. Remove both sun visors and both A-pillar garnishes, and then carefully lower the front of the headliner to gain access to the windshield stoppers (refer to the appropriate model year Repair Manual for the proper procedure).

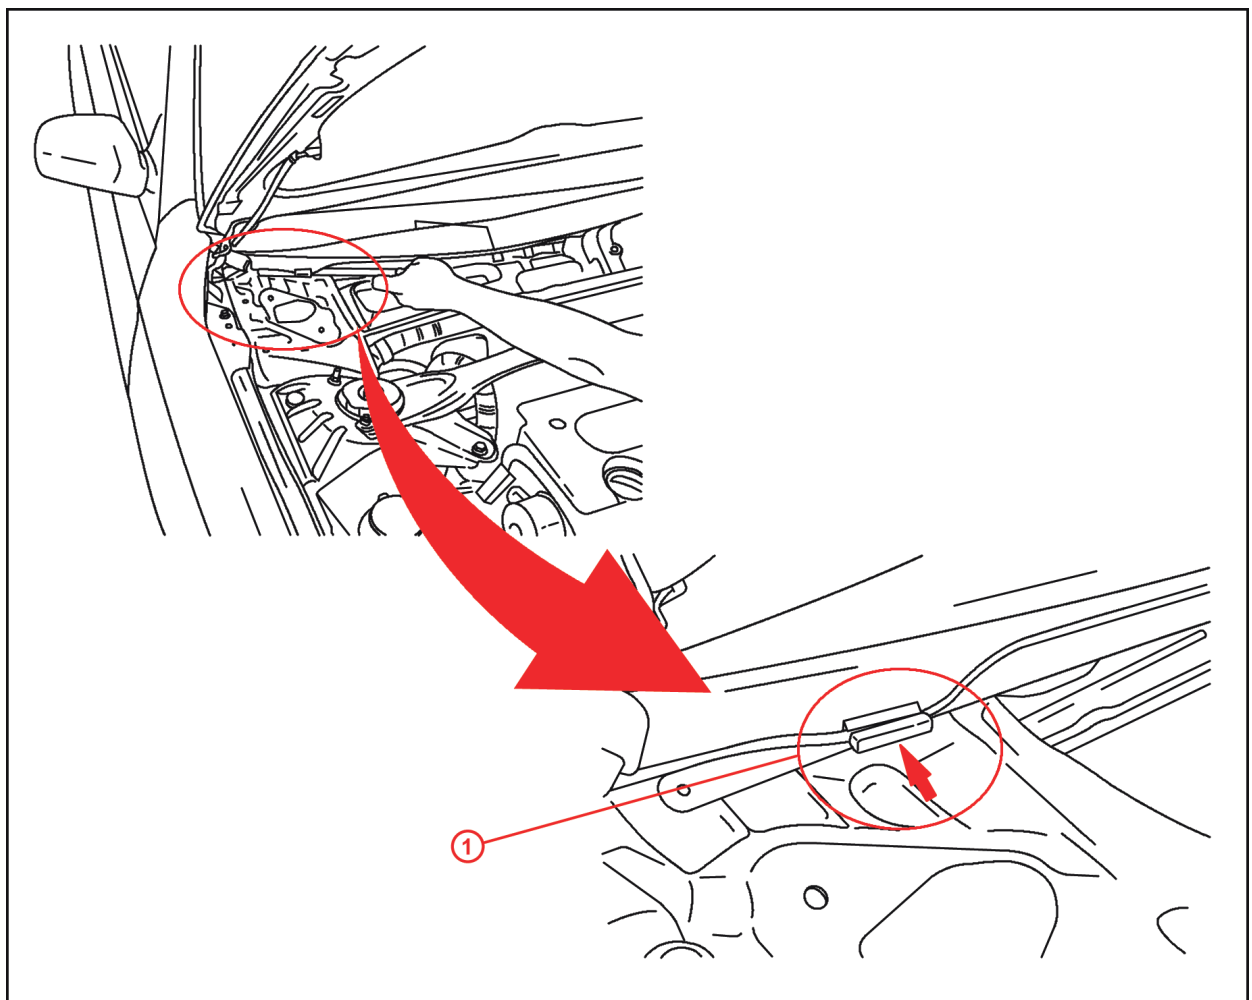
Figure 9.

The retainers are typically located 140 – 200 mm (5.5 – 7.9 in.) inboard of the lower corners of the windshield. The flat portion of the retainer is adhered to the backside of the windshield with double-sided, foam-backed tape.

1 Pin Attached to Plastic Block Underneath Windshield

2. Locate the windshield retainers at the lower edge of the windshield.

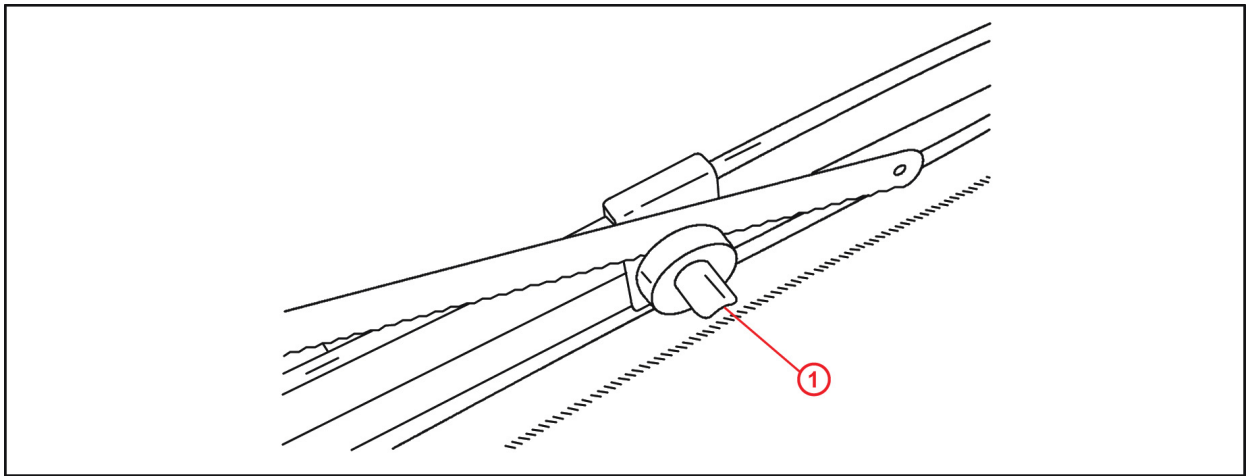
Figure 10. View from Underneath Windshield

1	Plastic Pin
---	-------------

3. Use a "Mini" Hacksaw with a fine tooth 10-inch blade to cut OFF the pin portion of the glass retainer flush with the flat portion of the windshield retainer (see Figures 9 and 10 for pin location).

4. Test drive the vehicle to confirm the elimination of the noise.
5. Reinstall the plastic cowl top ventilator louver(s).
