**Technical Service
Information Bulletin**

**WIND NOISE FROM FRONT SIDE
WINDOW AREA AT HIGHWAY SPEEDS**

'07 – '08 LS 460 (Standard Wheelbase)

REVISED
NV009-07
NVH

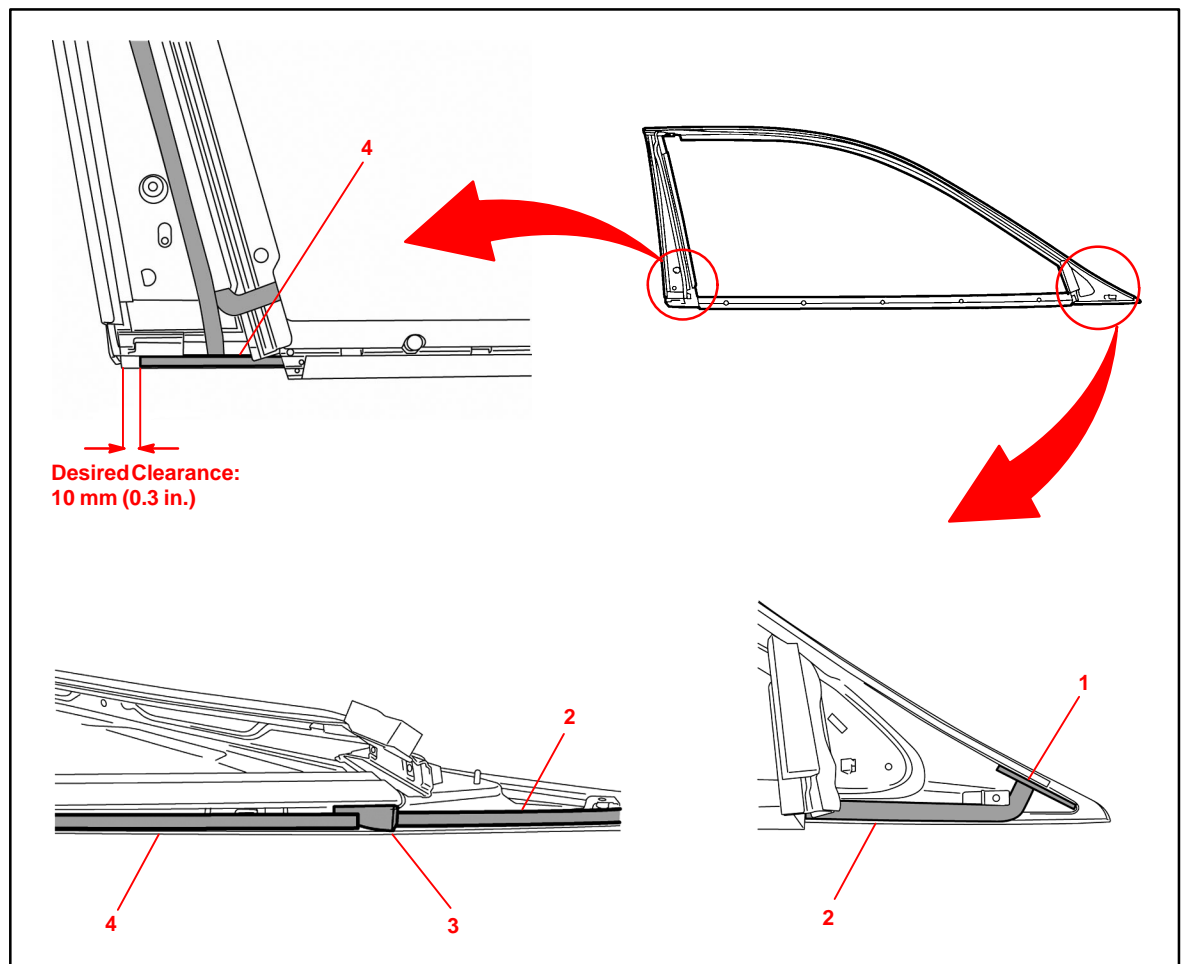
Part 1, Step A:

1. Add EPT foam behind the chrome belt molding.
Dimensions: 5 x 5 x 925 mm (0.20 x 0.20 x 36.40 in.)
2. Attach the NEW EPT foam on the front door belt molding (refer to 4 in the following illustration).
3. Replace existing foam (refer to 2 in the following illustration).

- A. Remove the original EPT foam (refer to 2 in the illustration above) and replace with NEW EPT foam (from the repair kit) as shown above.

NEW EPT Foam Dimensions: 5 x 10 x 142 mm (0.20 x 0.40 x 5.6 in.).

Make sure there is NO gap between the NEW foam (refer to 2 in the illustration above) and existing foam (refer to 1 & 3 in the illustration above).

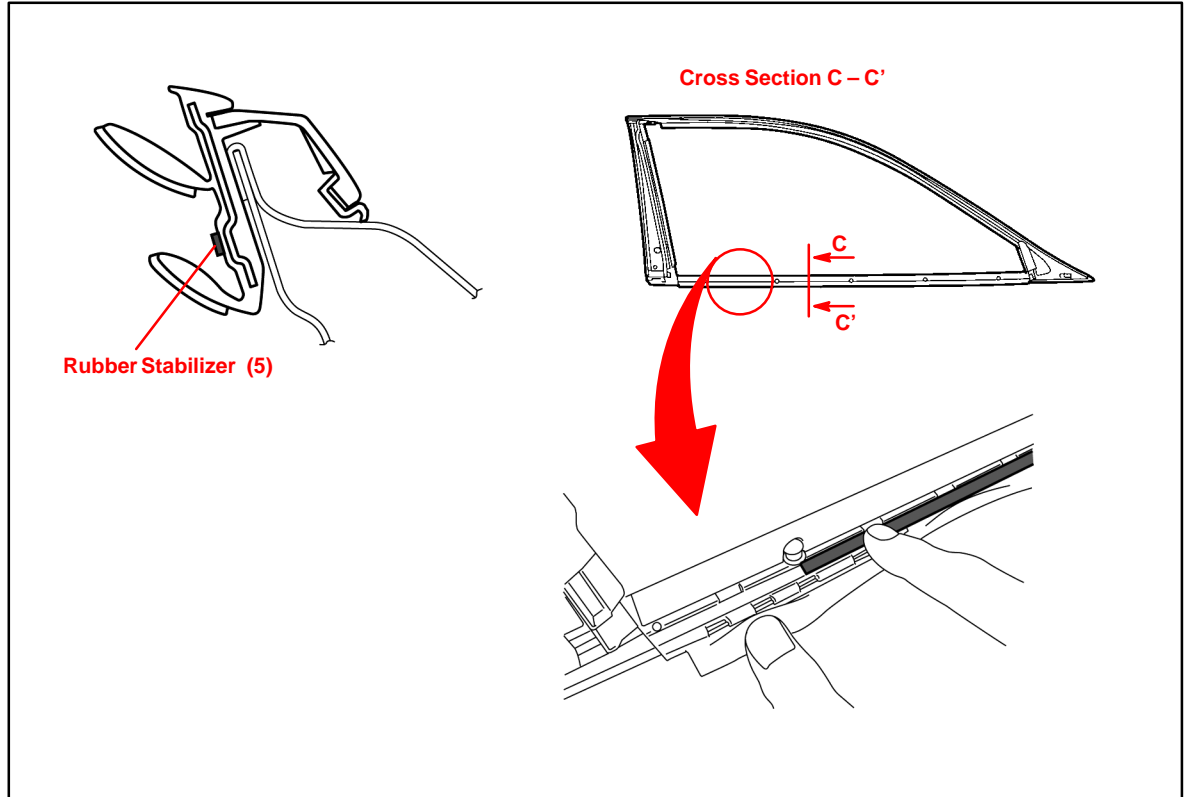
Part 1, Step B:

Add rubber stabilizer to outer door glass seal lip.

Attach the rubber stabilizer (refer to 5 in the following illustration) in the front door glass outer weatherstrip.

1. Clean the area of the molding where the rubber stabilizer will be installed. Make sure that the area is dry before installing the rubber stabilizer.
2. Attach the rubber stabilizer (refer to 5 in the illustration above) using instant “super” glue.
3. Start from the rear (near the B-pillar end of the belt molding).
4. Align the end of the rubber stabilizer to the last screw hole in the front door glass outer weatherstrip.

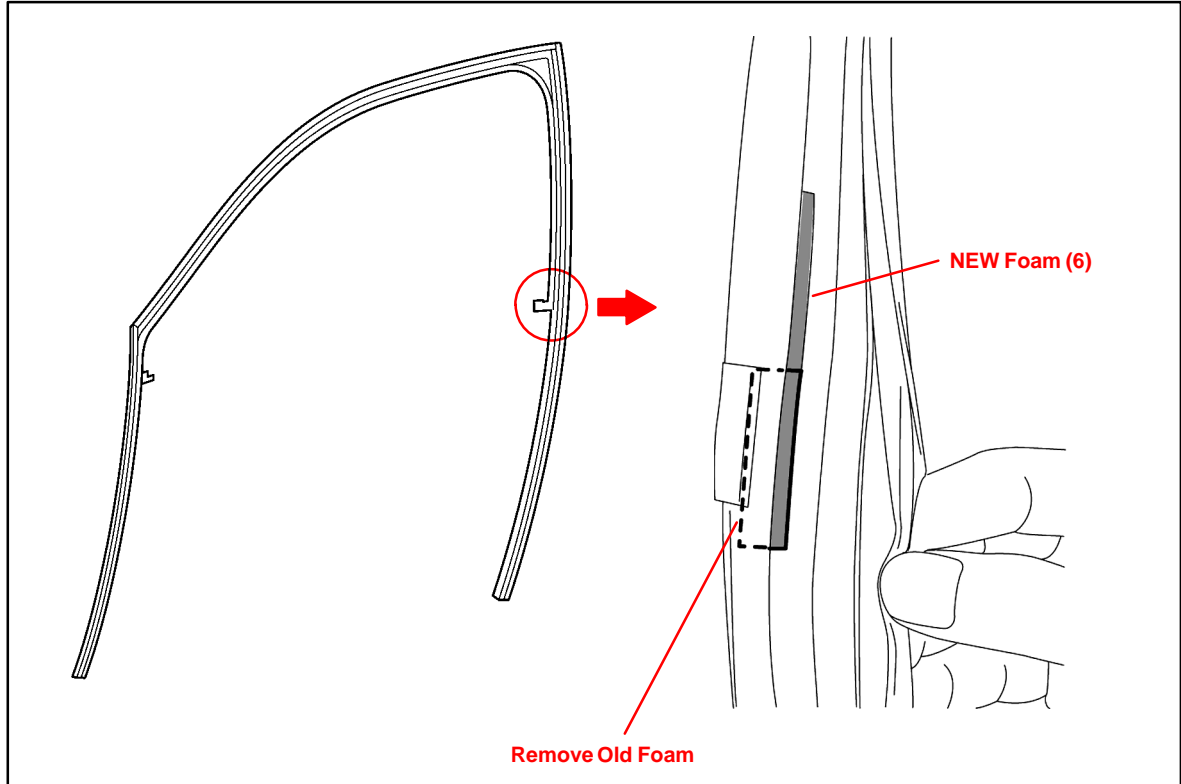
Part 1, Step C:

1. Add EPT foam to glass run rubber.

2. Add EPT foam (refer to 6 in the following illustration) in front door glass run at the rear lower corner of the window opening.

3. Remove the existing piece of foam behind the glass run at the location shown in the picture above. Attach the new longer piece of foam (refer to 6 in the illustration above).

Position the NEW piece of foam (refer to 6 in the following illustration) starting at the lower end of the previous piece of foam.

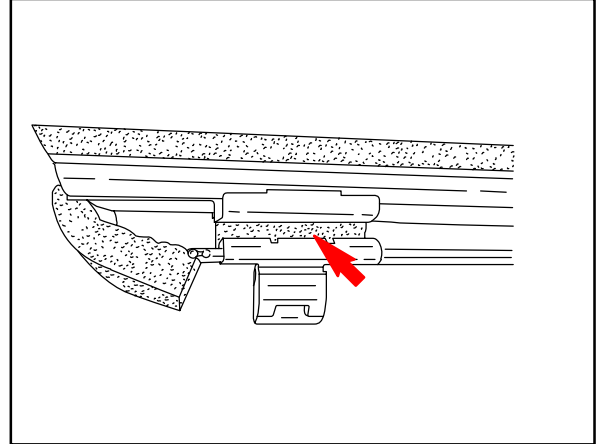
At the top of the rear 3 of the 4 clips, a piece of foam is inserted to prevent noise from the metal to metal contact.

These foam pieces are NOT glued in place so the foam pieces can fall out when the door inner trim panel is removed.

When reassembling the door inner belt seal assembly to the door panel, check that the foam pieces are in place. If NOT, insert NEW pieces.

**Foam Dimensions:
5 x 5 x 25 mm (0.20 x 0.20 x 0.98 in.)**

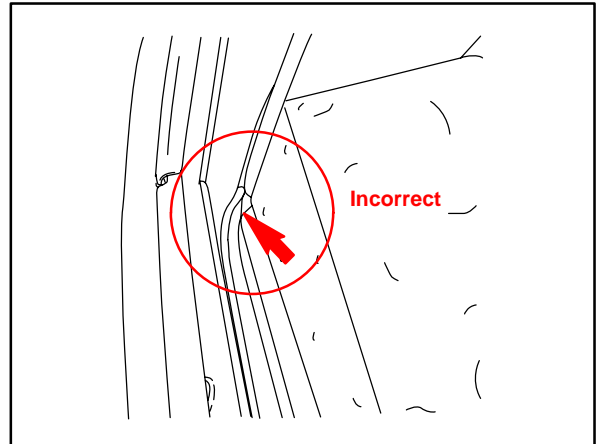
The door belt inner glass seal can be installed incorrectly causing a gap at the front end of the door glass run at the belt (near A-pillar).

NOTE:
The illustration shows the glass seal installed incorrectly.

Make sure that the inner glass seal is sitting on the outside of the door glass run.
