**Technical Service
Information Bulletin**

WIND NOISE FROM MIRROR BASE

'07 LS 460/460L

NVH
NV003-07

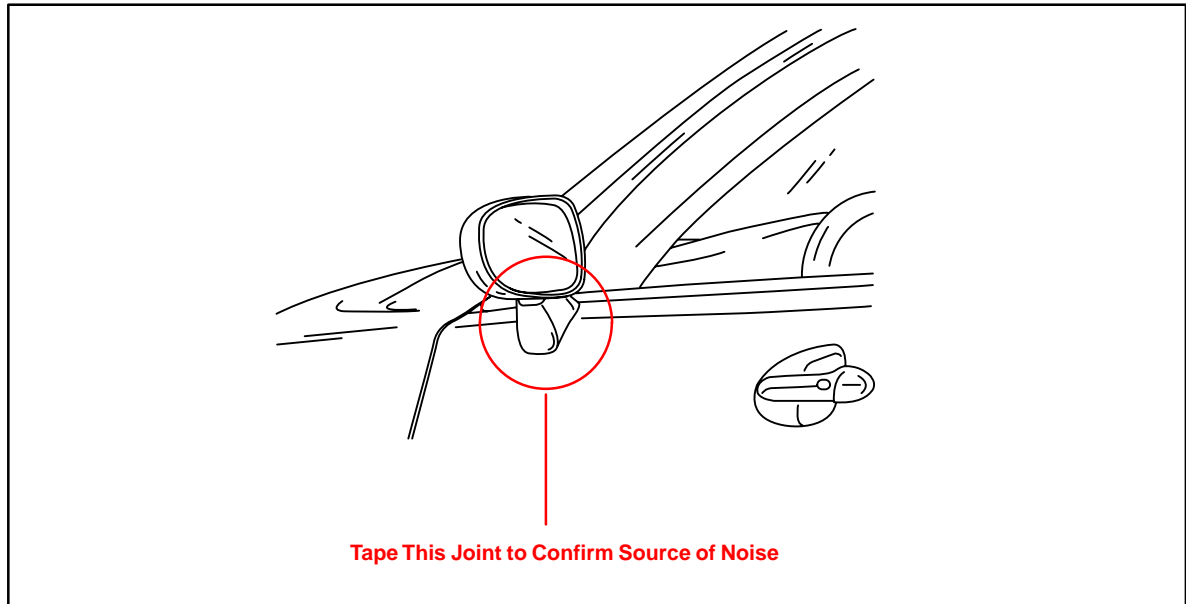
1. Confirm that the noise is coming from the base of the mirror.

2. Apply tape to the joint between the mirror base and the door outer panel.
3. Test drive the vehicle. If the noise goes away, then follow the steps below to correct this condition.
