Vehicle Pulling to One Side

Service Category Suspension

Section Alignment/Handling Diagnoses

YEAR(S)	MODEL(S)	ADDITIONAL INFORMATION
2007 – 2010	LS460	
2008 – 2010	LS600H

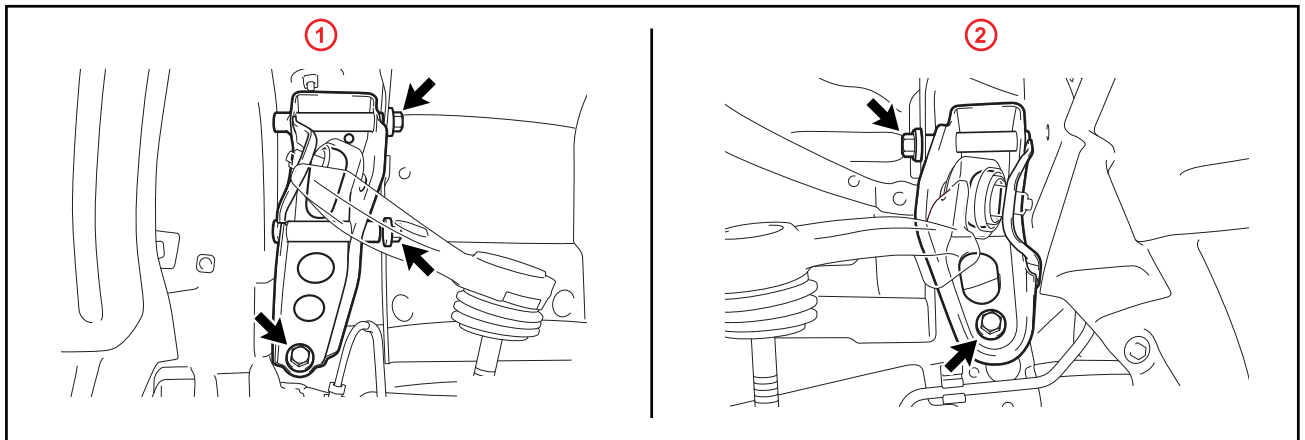
Figure 1.

1 No. 1 Arm Attachment Plate Inner (LH Shown)

2 No. 2 Arm Attachment Plate Inner (LH Shown)

- No. 1 arm has 3 attachment bolts and is the upper control arm towards the FRONT of the vehicle.
- No. 2 arm has 2 attachment bolts and is the upper control arm towards the REAR of the vehicle.

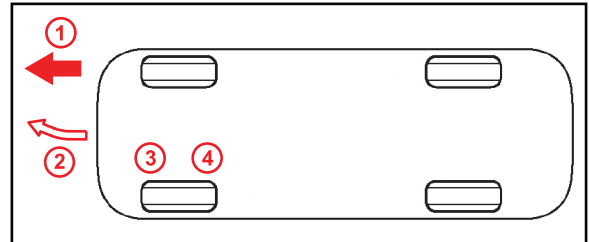
Figure 4.

1	Front of Vehicle
2	Pulls Right
3	No. 1 Arm Attachment Inner Plate
4	No. 2 Arm Attachment Inner Plate

- If the vehicle is still pulling to the **RIGHT**, replace the No. 1 and No. 2 arm attachment inner plates on the **LEFT** side. This adjusts camber.

Complete the alignment by adjusting front and rear toe to Repair Manual specifications. Test drive the vehicle to ensure the pull condition no longer exists.

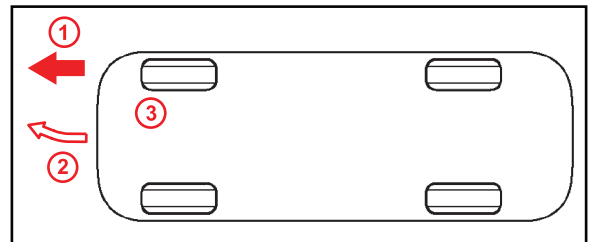
Figure 5.

1	Front of Vehicle
2	Pulls Right
3	No. 1 Arm Attachment Inner Plate

- If the vehicle is still pulling to the **RIGHT**, replace the No. 1 arm attachment inner plate on the **RIGHT** side. This adjusts caster.

Complete the alignment by adjusting front and rear toe to Repair Manual specifications. Test drive the vehicle to ensure the pull condition no longer exists.

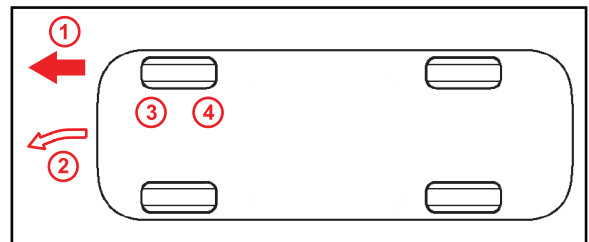
Figure 6.

1	Front of Vehicle
2	Pulls Left
3	No. 1 Arm Attachment Inner Plate
4	No. 2 Arm Attachment Inner Plate

- If the vehicle is still pulling to the **LEFT**, replace the No. 1 and No. 2 arm attachment inner plates on the **RIGHT** side. This adjusts camber.

Complete the alignment by adjusting front and rear toe to Repair Manual specifications. Test drive the vehicle to ensure the pull condition no longer exists.
