Hesitation on Acceleration

Service Category Engine/Hybrid System

Section Engine Control

Market USA

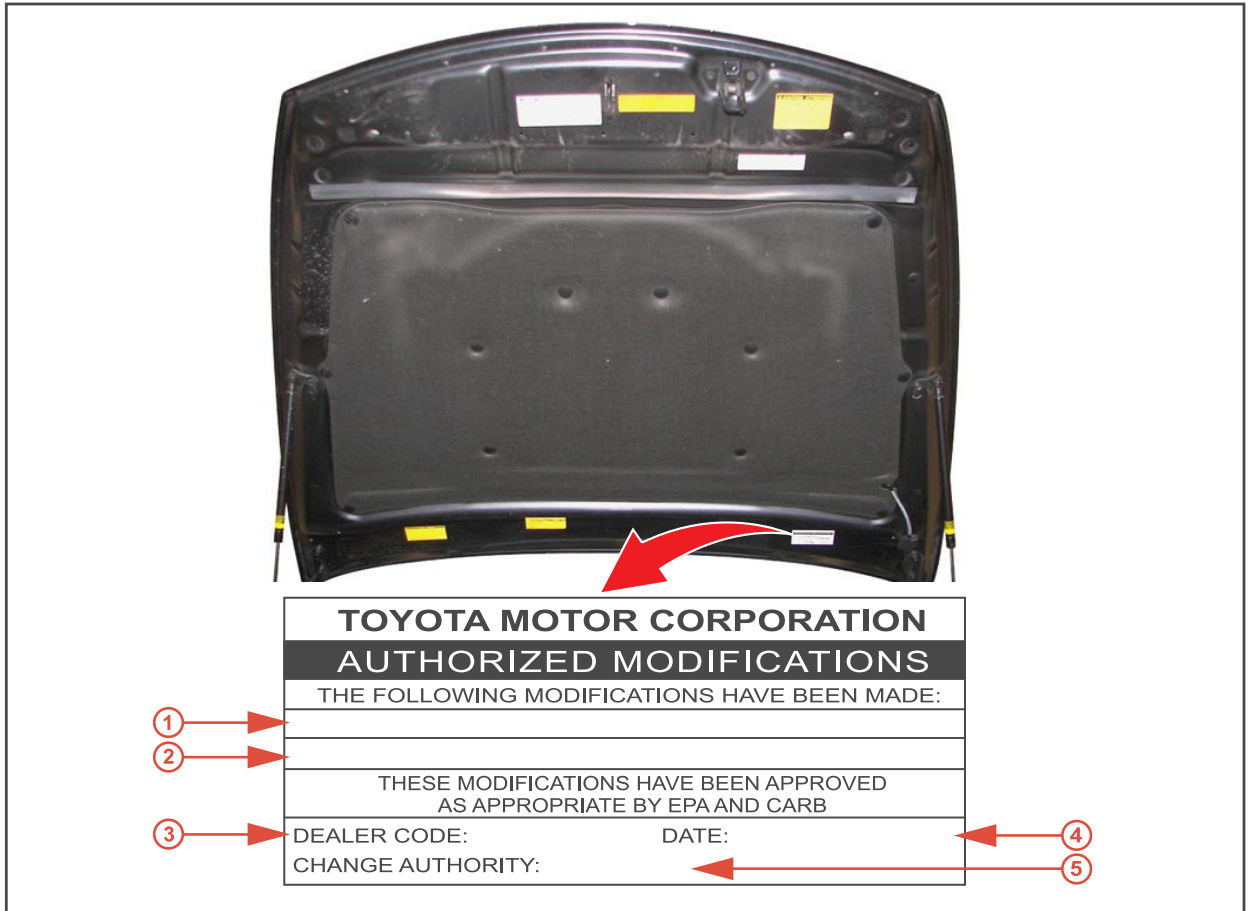
Figure 1. Location of Authorized Modifications Label on 2007 – 2008 LS 460

1. Check for the Authorized Modifications Label affixed to the vehicle in the location shown in Figure 1. Confirm if the ECM (PCM) calibration has been updated.
 - If the calibration ID listed is NOT the latest ECM (PCM) calibration — go to step 2.
 - If the vehicle has the latest calibration — go to step 4.

3. Install the Authorized Modifications Label.
 - A. Using a permanent marker, enter the following information on the label:
 - ECM part number [Refer to the **Parts Information** section for the **CURRENT PART NUMBER**]
 - Calibration ID(s) [Refer to the **Calibration Identification Chart** for the **NEW CALIBRATION ID**]
 - Dealer Code
 - Repair Date
 - Change Authority [**This SB number**]
 - B. Affix the Authorized Modifications Label to the vehicle at the location shown in Figure 1. The Authorized Modifications Label is available through the MDC, P/N 00451-00001-LBL.
4. Replace both valve cover assemblies, both cylinder heads, all intake and exhaust valves for the left and right cylinder banks.
