**Technical Service  
Information Bulletin**

**REPAIR MANUAL SUPPLEMENT:  
VEHICLE PULLING TO ONE SIDE**

'08 Lexus

SUSPENSION  
SU001-08

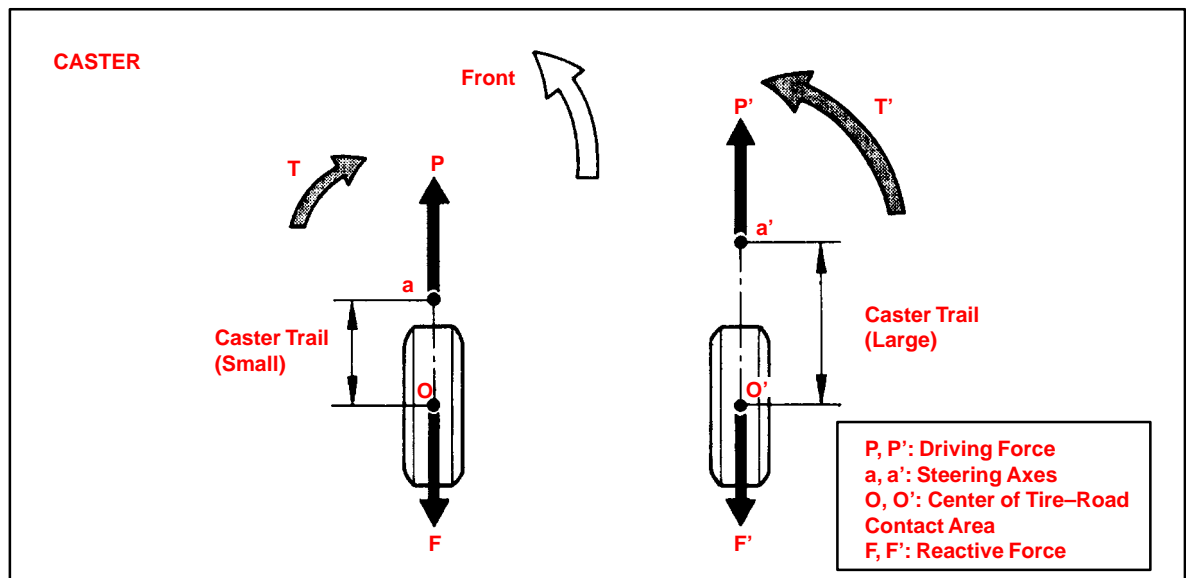
**1. Relationship Between Wheel Alignment and Vehicle Pulling**

When the cross camber or caster of the front wheel alignment is large, it can cause vehicle pulling.

WHEEL ALIGNMENT	DIRECTION OF VEHICLE PULLING
Camber	Vehicle pulls in direction of wheel with large camber value
Caster	Vehicle pulls in direction of wheel with small caster value

If the cross camber or caster is within the specified range (30' or less), noticeable vehicle pulling will not occur due to side-to-side differences in camber or caster.

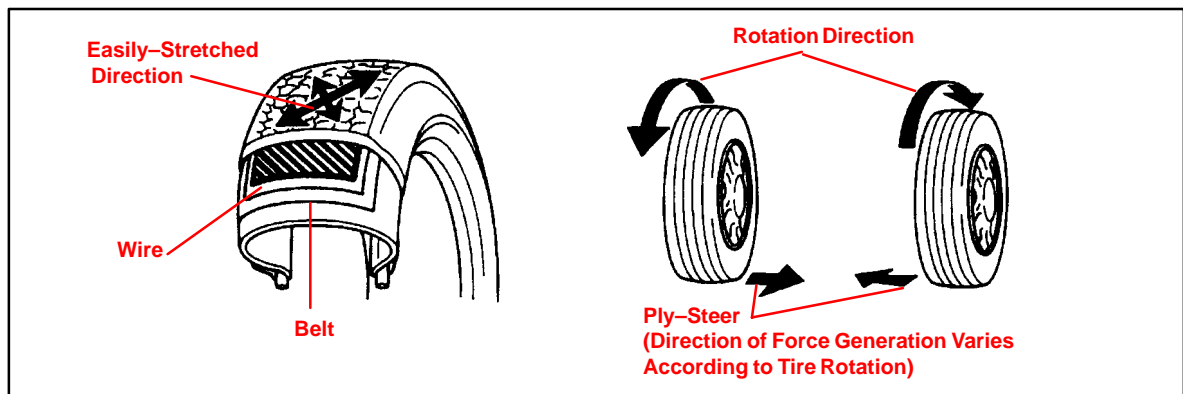
### A. Ply-Steer

Lateral force due to ply-steer is produced by the construction of the belts inside the tire tread. With radial tires, the wire of the belt is slanted as shown in the illustration below. Thus, it is in this direction that tire tread easily changes shape (stretches), and lateral force is generated between the tire and the road surface.

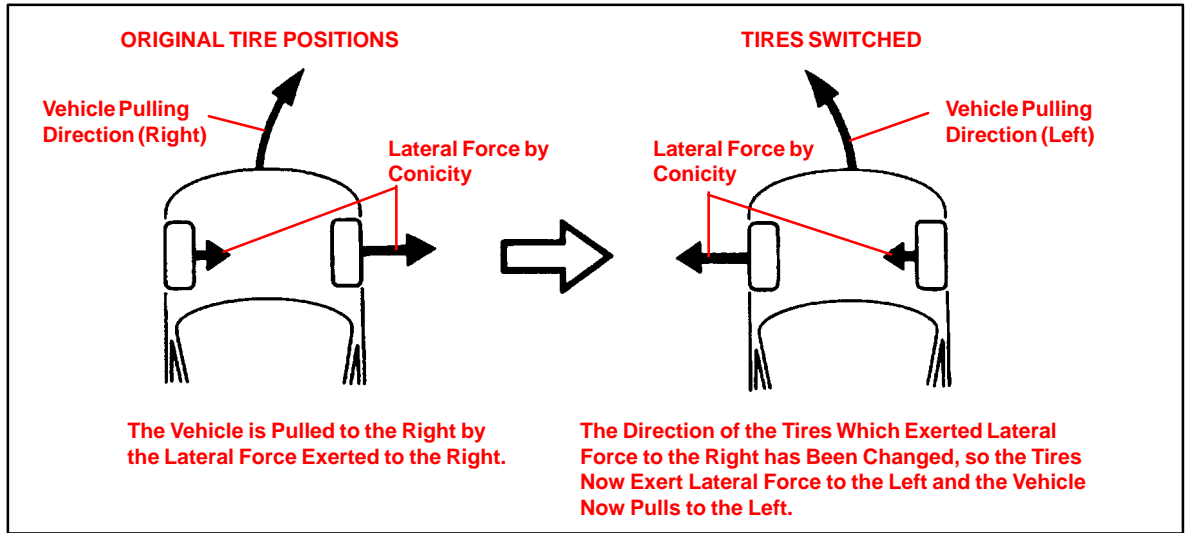
- The direction of lateral force from tire conicity becomes reversed when the left and right tires are switched. Therefore, if the pulling direction changes when the tires are switched, it can be concluded that vehicle pulling is caused by tire conicity.

- If the pulling direction does not change after the front tires are switched, the cause of vehicle pulling is not tire conicity. In this case, the likely cause is a front wheel alignment condition.

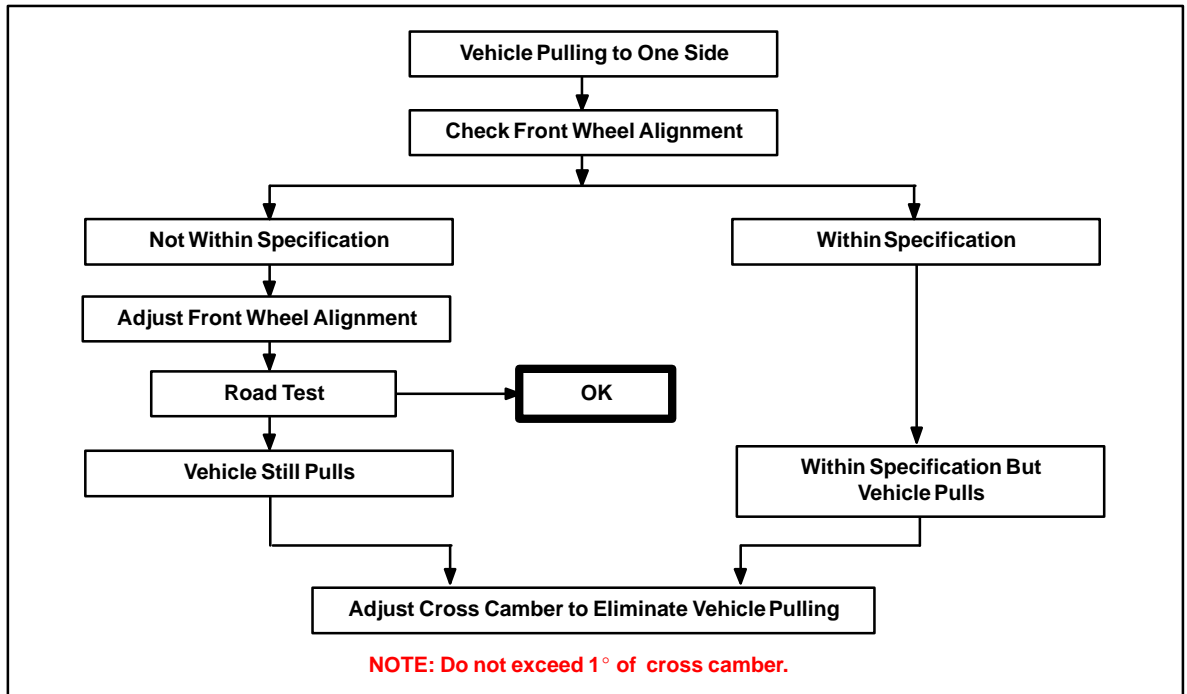
**3. Vehicle Pulling Caused by Wheel Alignment**

When it is determined by troubleshooting that the vehicle pulling is caused by wheel alignment, perform repairs according to the following procedure.

WHEN VEHICLE PULLS TO LEFT	WHEN VEHICLE PULLS TO RIGHT
Increase right front camber and decrease left front camber until vehicle pulling is eliminated	Increase left front camber and decrease right front camber until vehicle pulling is eliminated

- Keep the cross camber within 1° or less.
- Keep the camber of each wheel within specifications (+/-45' of center value).
- If adjustment exceeds the specifications, uneven tire wear will result.

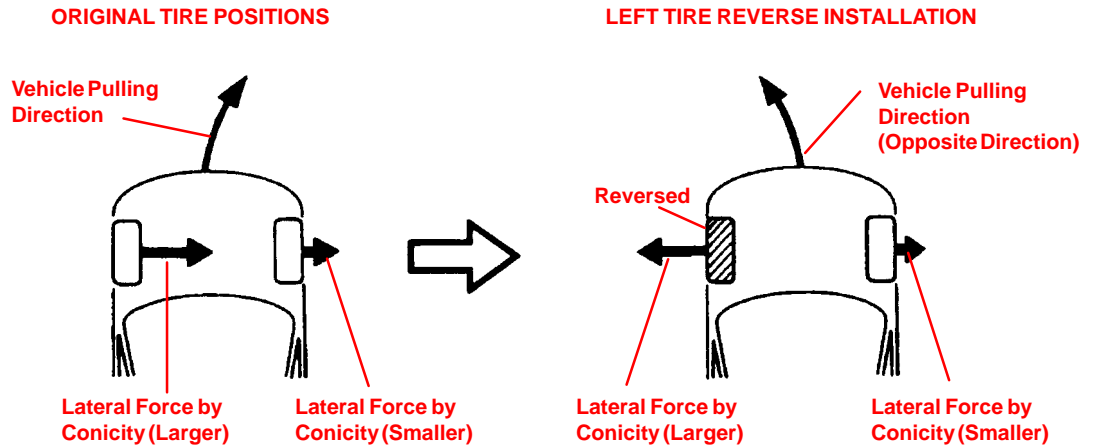
**If Vehicle Pulls in the Opposite Direction: Go to STEP 2.**

The lateral force generated by the left front tire is greater than the right tire, so the vehicle is pulling due to the lateral force of the left tire.

Rotate the **larger** lateral force front tire with the rear tire and check the change in the vehicle pulling.
