# Multimedia System Enhancements Phase 3 (Panasonic)

**Service Category** Audio/Visual/Telematics

**Section** Navigation/Multi Info Display

Lexus navigation is now available with additional features such as Apple CarPlay® and Amazon Alexa™ for applicable 2018 – 2019 model year Lexus vehicles. Follow the Software Update Procedure in this bulletin to install these new features.

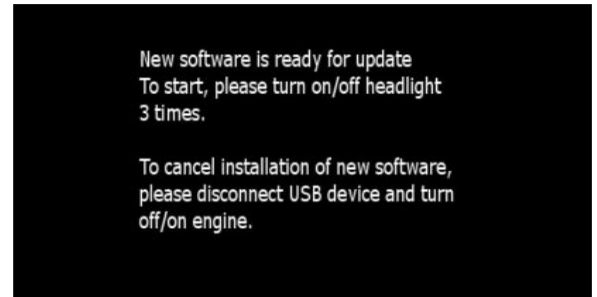
**Figure 1.**

10. When the “New software is ready for update” screen appears, cycle the headlights ON/OFF three times within 3 seconds.

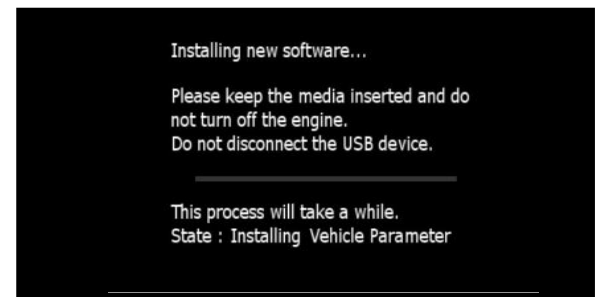
**Figure 2.**

11. Once the “Installing new software...” screen appears, do NOT turn the vehicle off or remove the USB flash drive. This will cause damage to the head unit.

**If a red or green screen appears, cycle “IG-OFF” and “IG-ON.” If the head unit does NOT boot up after “IG-OFF” and “IG-ON,” replace the head unit.**

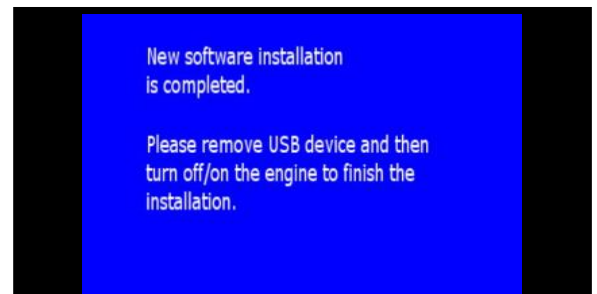
**Figure 3.**

12. Once the blue “New software installation is completed” screen appears, remove the USB flash drive.

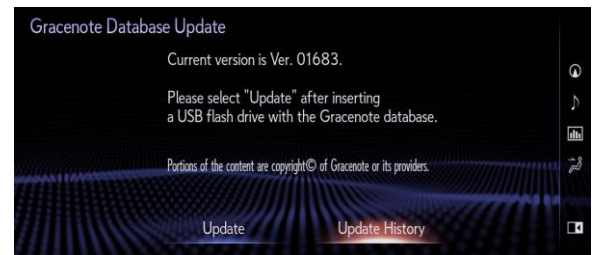
**Figure 4.**

16. Select Setup, scroll down, and select Gracenote Database Update.  
Verify the Gracenote Database version is 01683.  
If the version does NOT match, replace both the head unit and MEU.
