ACURA ServiceNews

BSN 23890 (0206)

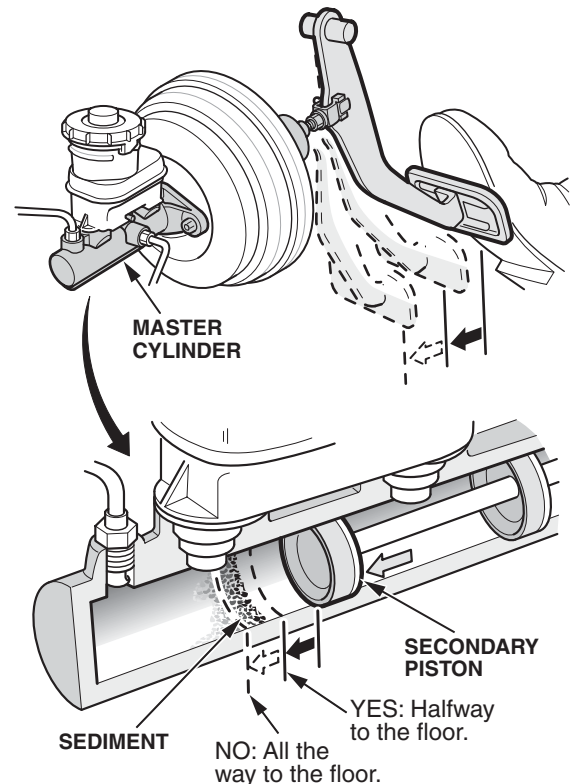
On all Acura models, if you're manually bleeding the brakes, make sure whoever's pumping the brake pedal pushes it only halfway to the floor. If the pedal is pushed all the way to the floor, you might push the master cylinder secondary piston into any sediment or deposits that have collected on the piston cylinder walls. If this happens, the seals can be permanently damaged and cause an internal leak.

To completely avoid this potential problem, use any of the brake pressure bleeder equipment available through the Acura Tool and Equipment Program (call 888-424-6857). The equipment makes brake bleeding much quicker and easier.

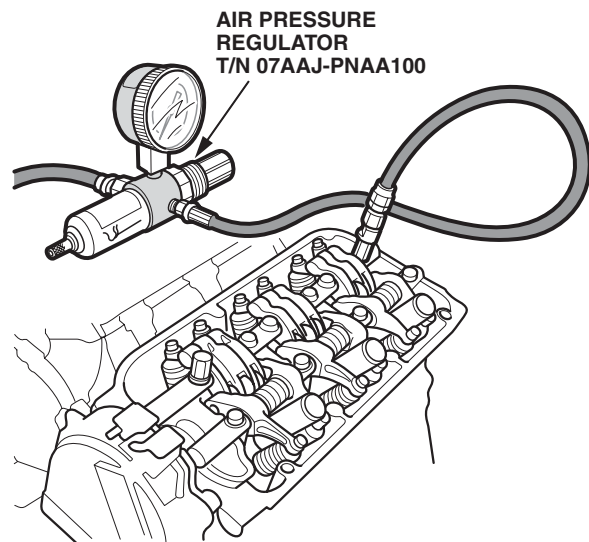
As mentioned in the November '01 ServiceNews article, if you are having problems engaging the rocker arm synchronizing pistons during the VTEC rocker arm test, you might not have enough air volume.

Acura now has an air pressure regulator (T/N 07AAJ-PNAA100) specifically made for the VTEC rocker arm test in the S/M. It's rated at 150 psi, so it's capable of supplying more than enough air to move the rocker arm synchronizing pistons.
