**Technical Service  
Information Bulletin**

**REPAIR MANUAL SUPPLEMENT:  
VEHICLE PULLING TO ONE SIDE**

**All '02 - '07 Model**

REVISÉD  
ST004-01  
STEERING

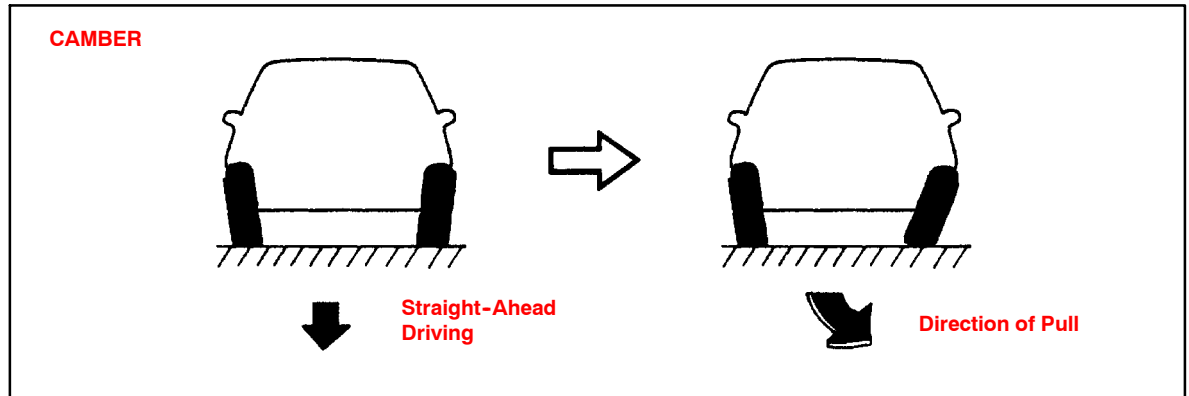
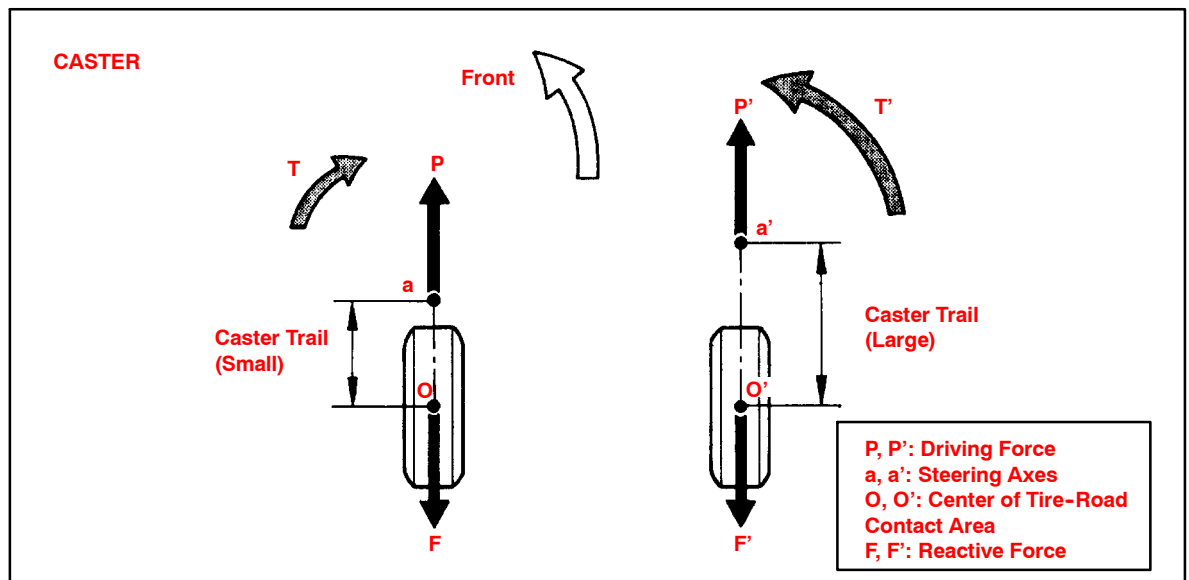
When the cross camber or caster of the front wheel alignment is large, it can cause vehicle pulling.

WHEEL ALIGNMENT	DIRECTION OF VEHICLE PULLING
Camber	Vehicle pulls in direction of wheel with large camber value
Caster	Vehicle pulls in direction of wheel with small caster value

If the cross camber or caster is within the specified range (30' or less), noticeable vehicle pulling will not occur due to side-to-side differences in camber or caster.

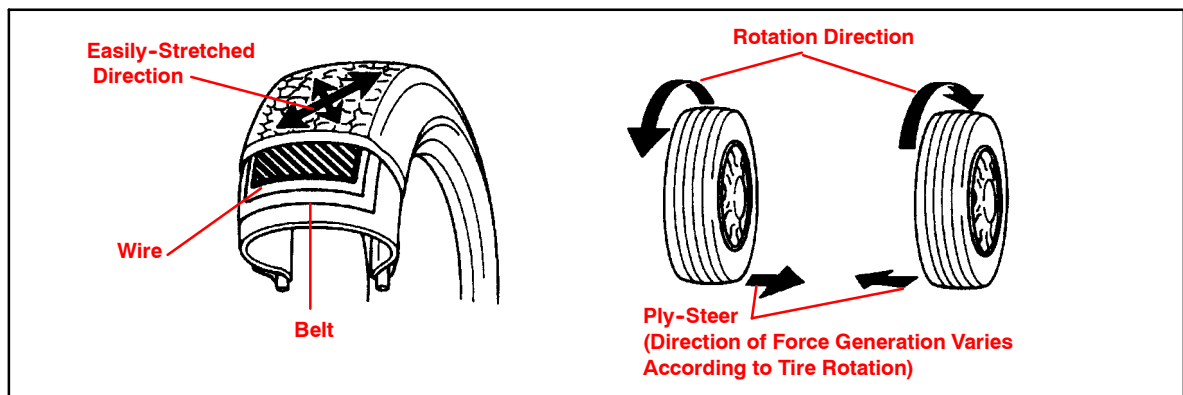
Lateral force due to ply-steer is produced by the construction of the belts inside the tire tread. With radial tires, the wire of the belt is slanted as shown in the illustration below. Thus, it is in the lateral direction that tire tread easily changes shape (stretches), and lateral force is generated between the tire and the road surface in the lateral direction.

Lateral force from ply-steer prevents vehicle drift caused by road slant, so in many cases lateral force to the right is provided for left-handed steering vehicles.

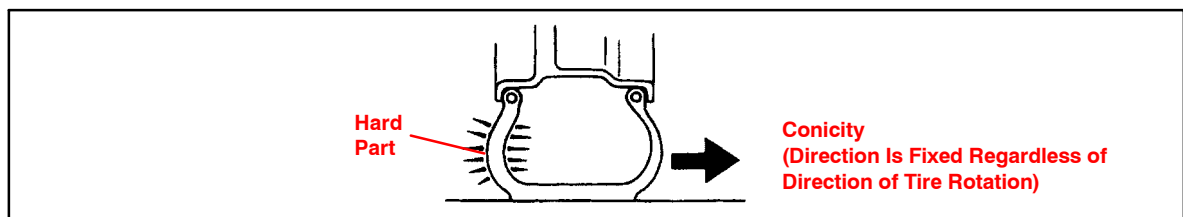
Conicity is lateral force resulting from uneven formation of the left and right sides of the tire. The direction the lateral force is exerted depends on the hardness of the side walls and the difference in height between the left/right sides of the tire.

- In the case of vehicle pulling caused by tires, the lateral force which is exerted as a result of conicity has the greatest effect. On a flat road, if the steering wheel is held without exerting steering effort for 100 m (109 yards) when travelling at 100 km/h (62 mph), the vehicle may drift as much as 1.5 m (5 ft).
- When vehicle pulling is due to conicity, the amount of drift can be reduced and the direction of drift can be changed by changing the location of the tire or reversing the tire when installing it on the wheel.

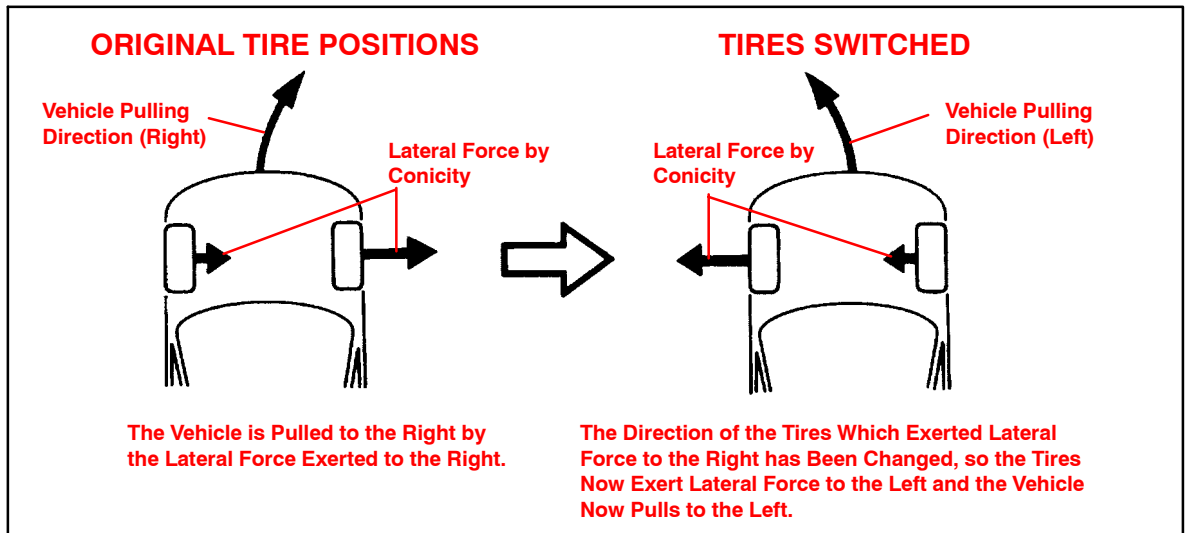
- The direction of lateral force from tire conicity becomes reversed when the left and right tires are switched. Therefore, if the pulling direction changes when the tires are switched, it can be concluded that vehicle pulling is caused by tire conicity.

- If the pulling direction does not change after the front tires are switched, the cause of vehicle pulling is not tire conicity. In this case, the likely cause is a front wheel alignment condition.

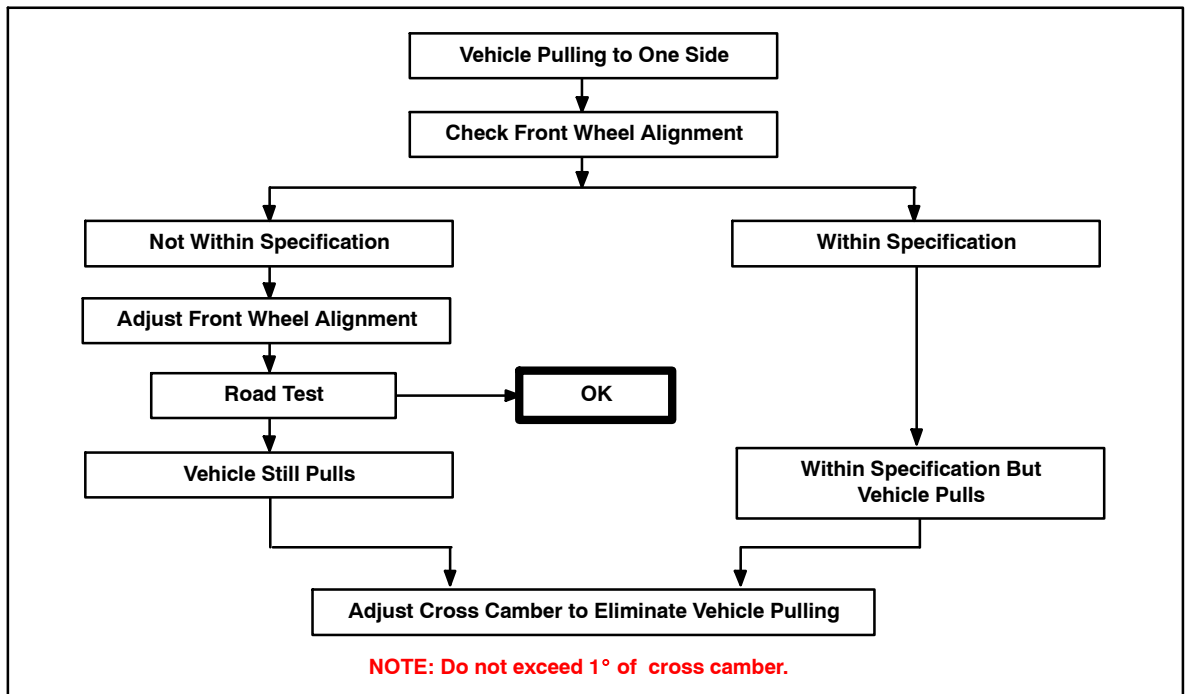
When it is determined by troubleshooting that the vehicle pulling to one side is caused by wheel alignment, perform repairs according to the following procedure.

WHEN VEHICLE PULLS TO LEFT	WHEN VEHICLE PULLS TO RIGHT
Increase right front camber and decrease left front camber until vehicle pulling is eliminated	Increase left front camber and decrease right front camber until vehicle pulling is eliminated

- Keep the cross camber within 1° or less.
- Keep the camber of each wheel within specifications (+/-45' of center value).
- If adjustment exceeds the specifications, uneven tire wear will result.

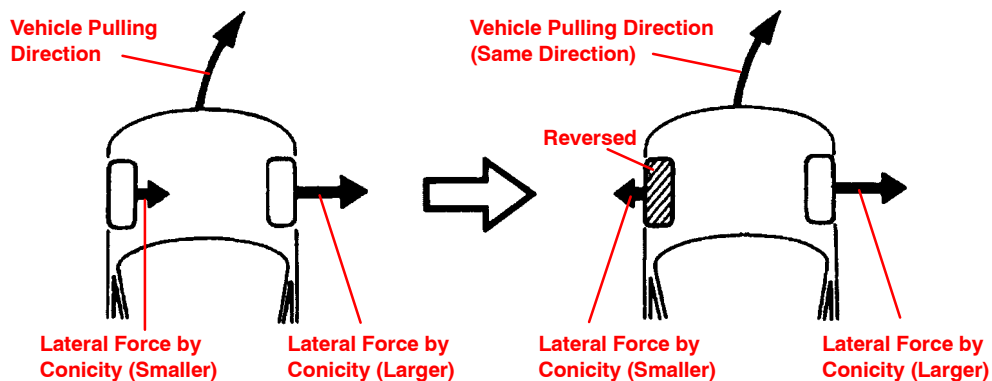
**If Vehicle Pulls in the Same Direction: Go to STEP 2.**

The lateral force generated by the right front tire is greater than the left tire, so the vehicle is pulling due to the lateral force of the right tire.

Remove the front left tire from the wheel and reverse the tire. Then perform a road test and check for change in the pulling direction.

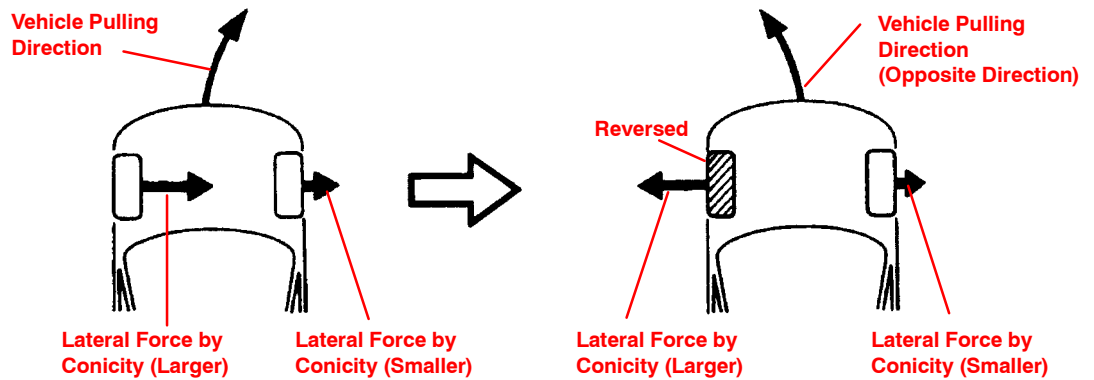
**If Vehicle Pulls in the Opposite Direction: Go to STEP 2.**

The lateral force generated by the left front tire is greater than the right tire, so the vehicle is pulling due to the lateral force of the left tire.
