Vehicle Bucking on 1 - 2 and/or 2 - 3 Upshifts and Surge Between 0 - 46 mph

Service Category Engine/Hybrid System

Section Engine Control

YEAR(S)	MODEL(S)	ADDITIONAL INFORMATION
2016 - 2019	RX350

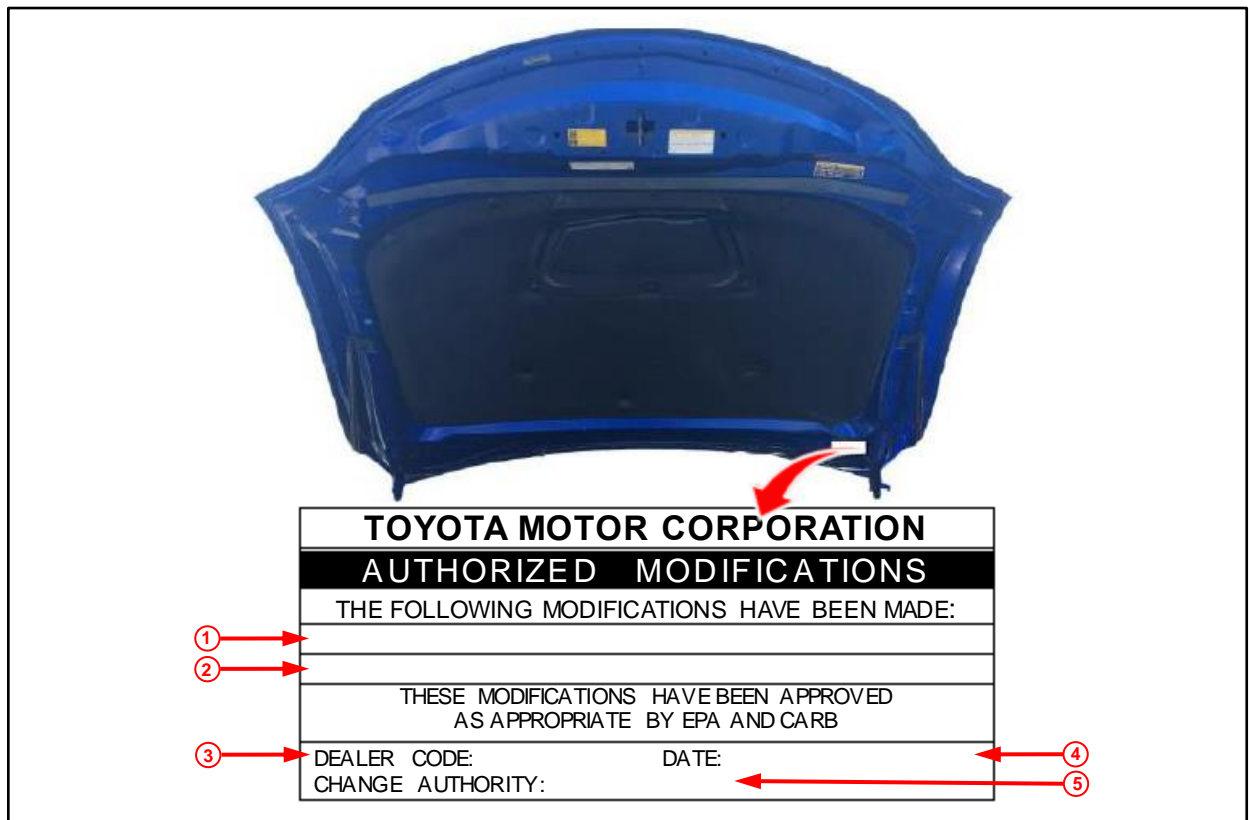
Figure 1. Location of Authorized Modifications Label on 2016 – 2019 RX350

- Use Techstream to confirm if the ECM (PCM) calibration has been updated and check for the Authorized Modifications Label affixed to the vehicle in the location shown below.

B. Install the Authorized Modifications Label onto the vehicle at the location shown in Figure 1. The Authorized Modifications Label is available through the MDC, P/N 00451-00001-LBL.
