Knocking Noise From Fuel Tank Area

Service Category Engine/Hybrid System

Section Fuel System

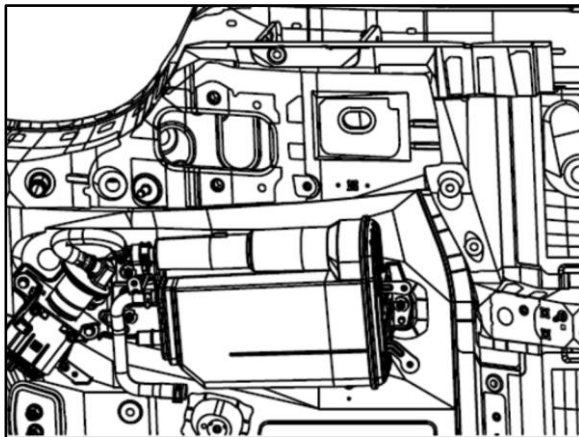
Figure 1. Without Pulsation Damper Valve Assembly Installed

The NEW part can be identified by the addition of a bracket and valve assembly attached to the charcoal canister.
