# Vehicle Bucking on 1 - 2 and/or 2 - 3 Upshifts and Surge Between 0 - 46 mph

**Service Category** Engine/Hybrid System

**Section** Engine Control

YEAR(S)	MODEL(S)	ADDITIONAL INFORMATION
2016 - 2019	RX350

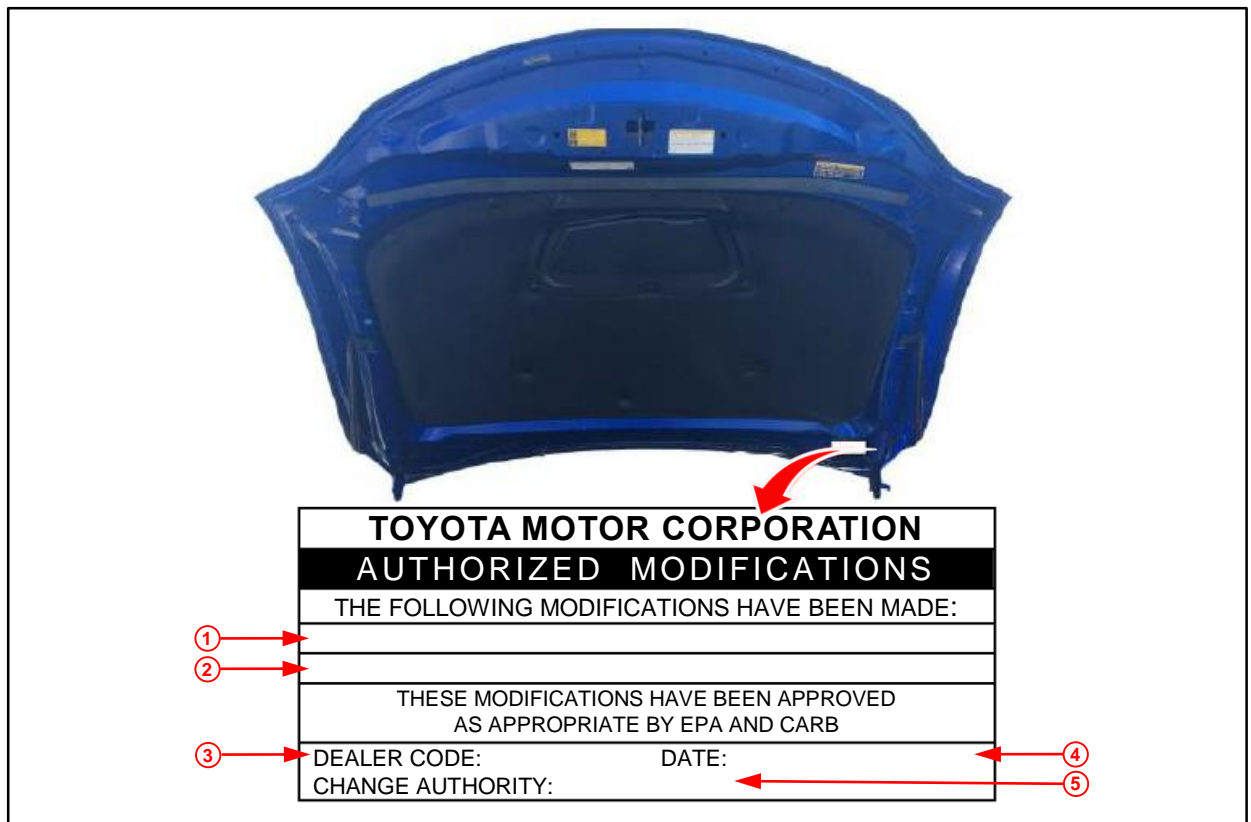
**Figure 1. Location of Authorized Modifications Label on 2016 – 2019 RX350 and RX350L**

<b>1</b>	Replacement ECM (PCM) Part Number (e.g., 89661-0E765)
<b>2</b>	New Calibration ID (e.g., 896630E36600)
<b>3</b>	Dealer Code

<b>4</b>	Date Completed
<b>5</b>	This SB Number

B. Install the Authorized Modifications Label onto the vehicle at the location shown in Figure 1. The Authorized Modifications Label is available through the MDC, P/N 00451-00001-LBL.
