**Technical Service  
Information Bulletin**

Title:  
**NAVIGATION SYSTEM  
DOOR REPLACEMENT**

Models:  
**'02 – '05 SC 430**

**BODY**  
**BO011-04**

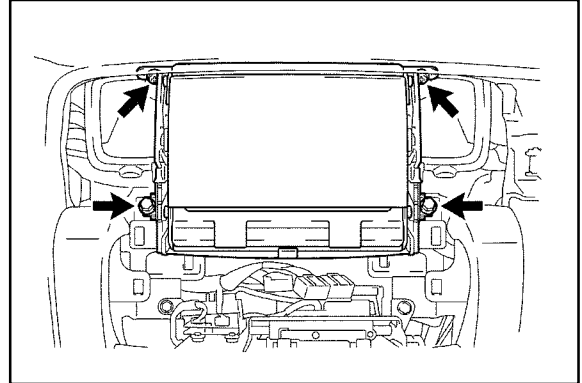
1. Remove Air Conditioner Control Assembly.
2. Remove Instrument Panel Safety Pad Garnish Sub-assembly.
3. Remove Instrument Panel Garnish Sub-assembly No. 2.
4. Remove Instrument Cluster Finish Panel Sub-assembly Center.
  - A. Remove the 2 bolts and 2 screws.
  - B. Disconnect the connector, then remove the multi-display (Center Display) display and instrument cluster finish panel sub-assembly center and clip.
