Lexus Supports

MIL "ON" DTC P0172, P0175, P2196, P2198, P0138, P0158, P0037, or P0057

YEAR(S)	MODEL(S)	ADDITIONAL INFORMATION	
2006	GS300	Drive Type(s): 2WD, 4WD Engine(s): 3GR Transmission(s): 6AT VDS(s): BH96S, CH96S

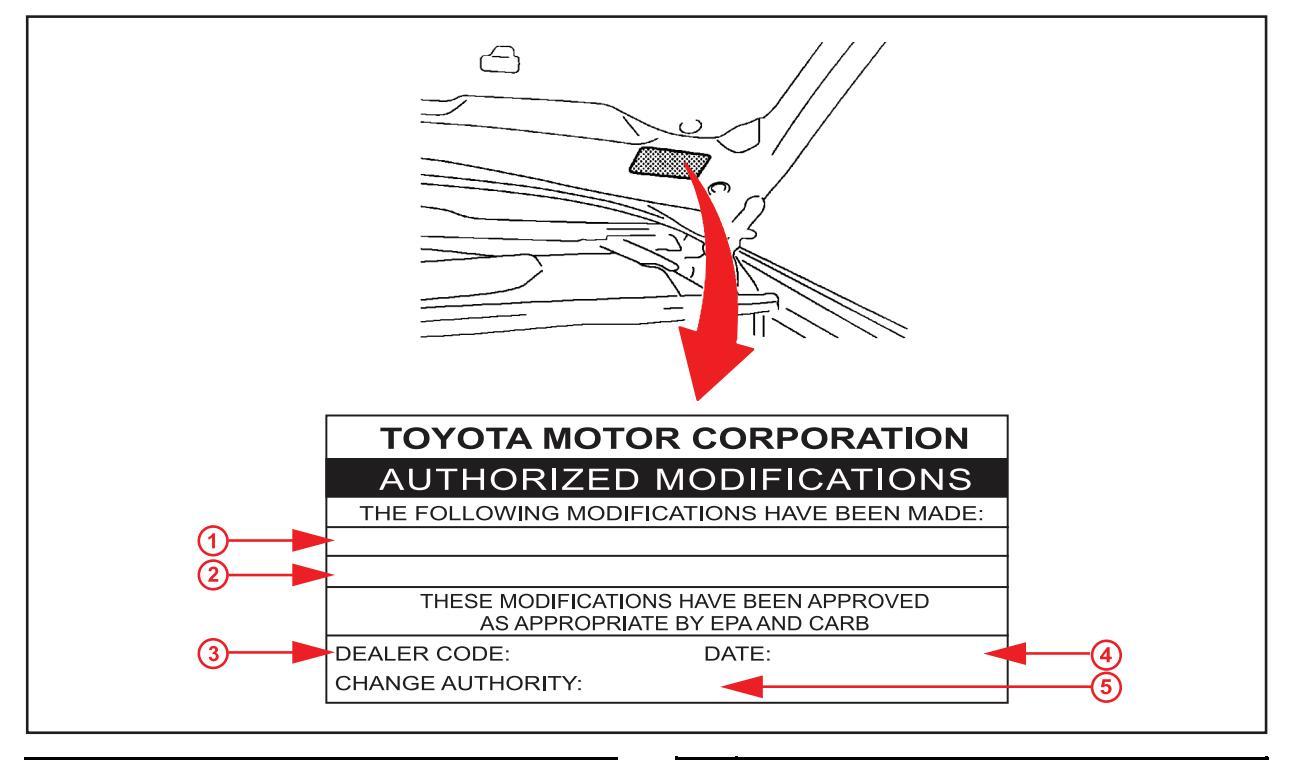
Figure 1. Location of Authorized Modifications Label on 2006 GS 300

1	Replacement ECM (PCM) Part Number (i.e., 89666-30354)
2	New Calibration ID(s) (i.e., 33065400)
3	Dealer Code

4	Date Completed
5	This TSIB Number

- 1. Confirm the calibration ID is applicable based on the Calibration Identification Chart in this bulletin.
- Check for the Authorized Modifications Label affixed to the vehicle in the location shown in Figure 1. Confirm if the ECM (PCM) calibration has been updated. If the calibration ID listed is NOT the latest ECM (PCM) calibration — go to step 3.

- 4. Install the Authorized Modifications Label.
 - A. Using a permanent marker, enter the following information on the label:
 - ECM part number [Refer to the **Parts Information** section for the **CURRENT PART NUMBER**]
 - Calibration ID(s) [Refer to the Calibration Identification Chart for the NEW CALIBRATION ID]
 - Dealer Code
 - Repair Date
 - Change Authority [This TSIB number]
 - B. Affix the Authorized Modifications Label to the vehicle at the location shown in Figure 1. The Authorized Modifications Label is available through the MDC, P/N 00451-00001-LBL.
- 5. Change the engine oil and oil filter.
