Last Modified: 7-13-2007		1.6 A
Service Category: Audio/Visual/Telematics	Section: Park Assist/Monitoring	
Model Year: 2008	Model: ES350	Doc ID: RM000001PYN00EX
Title: PARK ASSIST / MONITORING: CLEARANCE WARNING BUZZER: REMOVAL (2008 ES350)

REMOVAL

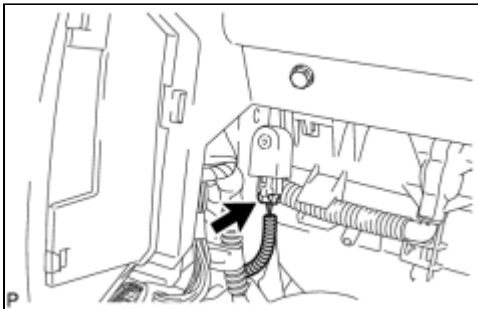
(a) Disconnect the connector.

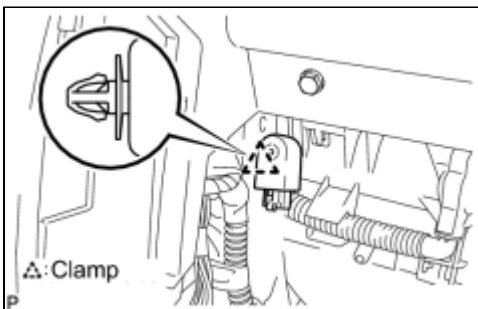
(b) Disengage the clamp and remove the clearance warning buzzer.
