Last Modified: 7-13-2007		1.6 A	
Service Category: Audio/Visual/Telematics	Section: Audio/V	Section: Audio/Video	
Model Year: 2008	Model: ES350	Doc ID: RM000001PZJ008X	
Title: AUDIO / VISUAL: RADIO RECEIVER: REMOVAL (2008 ES350)

### **REMOVAL**

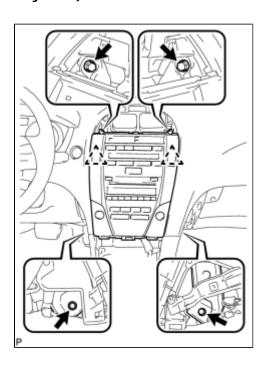
- 1. REMOVE SHIFT LEVER KNOB SUB-ASSEMBLY
- 2. REMOVE UPPER CONSOLE PANEL ASSEMBLY WITH FRONT ASH RECEPTACLE
- 3. REMOVE INSTRUMENT PANEL FINISH PANEL END LH
- 4. REMOVE INSTRUMENT PANEL FINISH PANEL END RH
- 5. REMOVE NO. 2 INSTRUMENT PANEL REGISTER ASSEMBLY
- 6. REMOVE INTEGRATION CONTROL PANEL WITH RADIO RECEIVER ASSEMBLY (w/o Navigation System)

(a) Remove the 4 bolts.

- (b) Pull the integration control panel with radio receiver assembly toward the rear of the vehicle and disengage the 2 clips.
- (c) Disconnect each connector and remove the integration control panel with radio receiver assembly.
- 7. REMOVE NO. 1 RADIO BRACKET (w/o Navigation System)

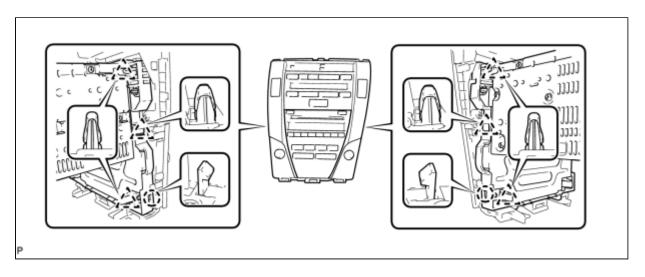
#### 9. REMOVE RADIO RECEIVER ASSEMBLY (w/o Navigation System)

(a) Disengage the 2 claws and 6 clips.

(b) Remove the radio receiver assembly.

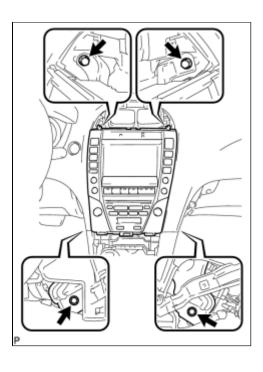
# 10. REMOVE MULTI-DISPLAY WITH RADIO RECEIVER ASSEMBLY (w/ Navigation System)

(a) Remove the 4 bolts.

- (b) Pull the multi-display with radio receiver assembly toward the rear of the vehicle and disengage the 2 clips.
- (c) Disconnect each connector and remove the multi-display with radio receiver assembly.

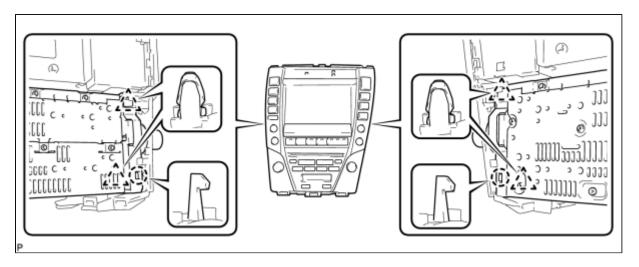
## 13. REMOVE RADIO RECEIVER ASSEMBLY (w/ Navigation System)

(a) Disengage the 2 claws and 4 clips.

(b) Remove the radio receiver assembly.
