Last Modified: 7-13-2007		1.7 A
Service Category: Vehicle Interior	Section: Heating/Air Conditioning	
Model Year: 2008	Model: ES350	Doc ID: RM0000026PU00GX
Title: AIR CONDITIONING: AIR CONDITIONING AMPLIFIER: REMOVAL (2008 ES350)

REMOVAL

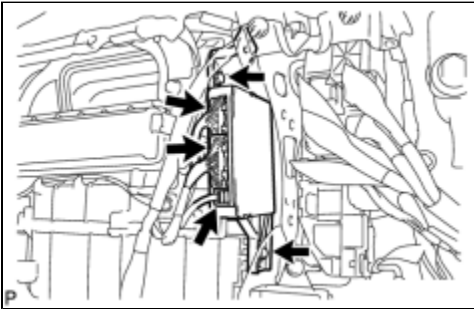
8. REMOVE AIR CONDITIONING AMPLIFIER ASSEMBLY

(a) Disconnect the 3 connectors.

(b) Remove the 2 bolts and air conditioning amplifier assembly.
