Last Modified: 7-13-2007		1.6 A
Service Category: Vehicle Exterior	Section: Mirror (ext)	
Model Year: 2008	Model: ES350	Doc ID: RM000001XT7009X
Title: MIRROR: OUTER MIRROR CONTROL ECU: REMOVAL (2008 ES350)

REMOVAL

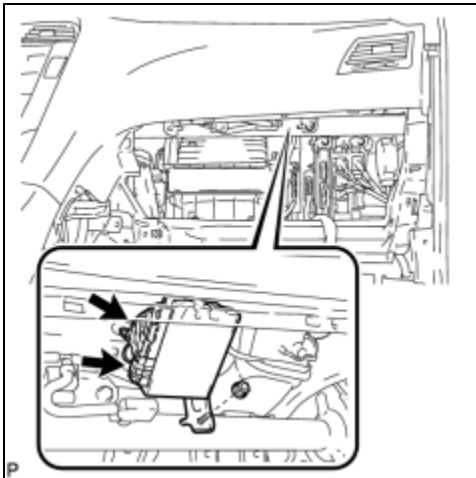
9. REMOVE OUTER MIRROR CONTROL ECU ASSEMBLY

(a) Disconnect the 2 connectors.

(b) Remove the nut and the outer mirror control ECU assembly.
