Last Modified: 06-07-2019	6.8:8.0.48	Doc ID: RM100000000QAY6
Model Year Start: 2016	Model: ES300H	Prod Date Range: [07/2015 -]
Title: MIRROR (EXT): OUTER REAR VIEW MIRROR GLASS: REMOVAL; 2016 - 2018 MY ES300H [07/2015 -]

REMOVAL

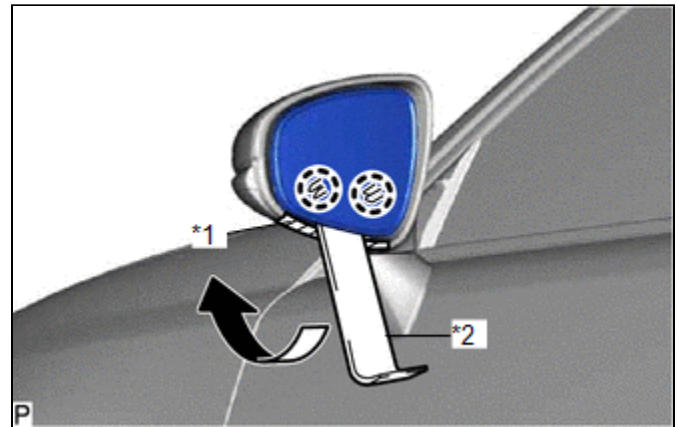
(a) Push the upper part of the mirror surface and tilt it.

(b) Apply protective tape to the areas shown in the illustration.

*1	Protective Tape
*2	Moulding Remover

(c) Using a moulding remover, disengage the 2 claws at the lower part of the outer rear view mirror.

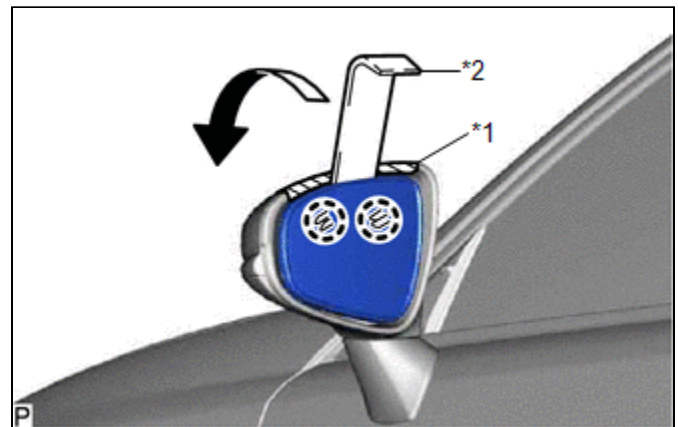
(d) Push the lower part of the mirror surface and tilt it.

(e) Apply protective tape to the areas shown in the illustration.

*1	Protective Tape
*2	Moulding Remover

(f) Using a moulding remover, disengage the 2 claws at the upper part of the outer rear view mirror.

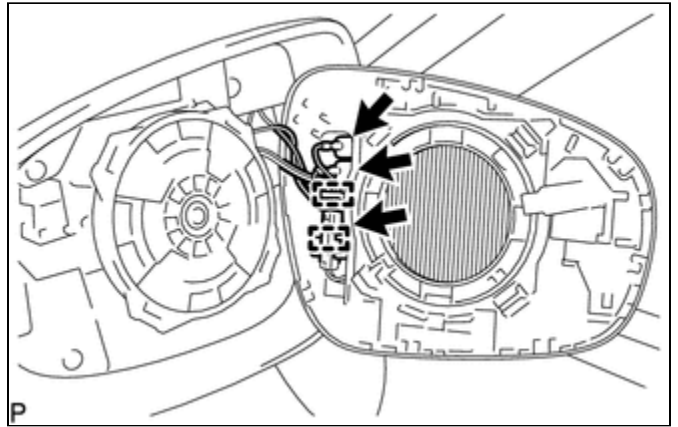
(g) w/o Blind Spot Monitor System:

(1) Disengage the 2 clamps.

(2) Disconnect the 3 connectors and remove the outer mirror.

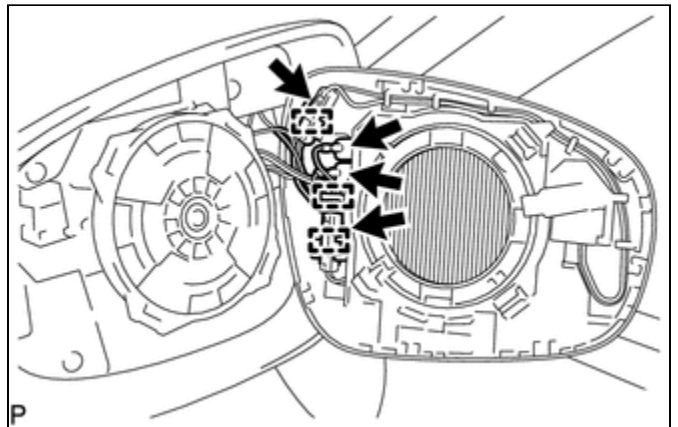
(h) w/ Blind Spot Monitor System:

(1) Disengage the 3 clamps.

(2) Disconnect the 3 connectors and remove the outer mirror.

(3) Release the tabs of the blind spot monitor indicator connector to disconnect the connector and remove the outer mirror.

- Do not bend the tabs excessively to prevent them from being damaged.
- If the tabs are damaged, replace the outer mirror with a new one.
