## **Engine mounts Replacement.** 12361-50151 & Transmission Mount 12371-50200

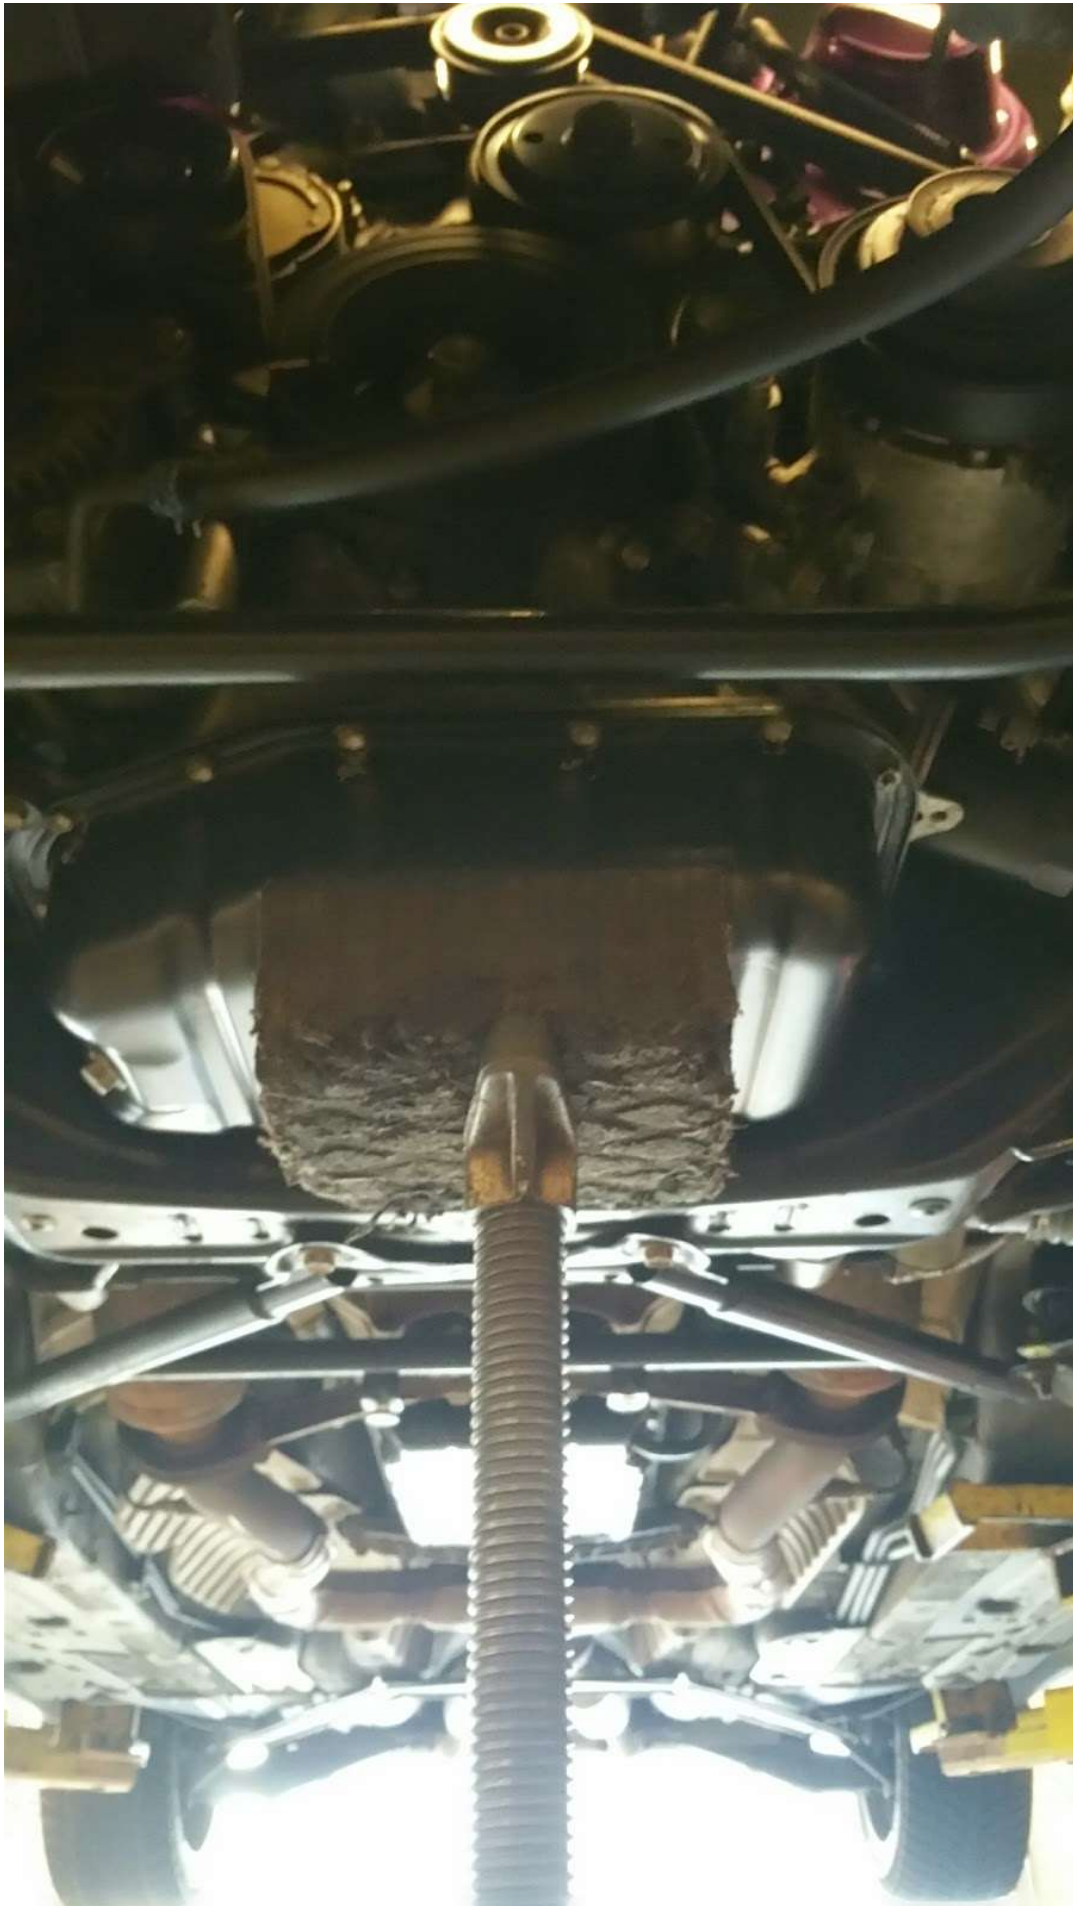
With the car on the lift, a transmission jack was used at the edge of the oil pan to support the engine.

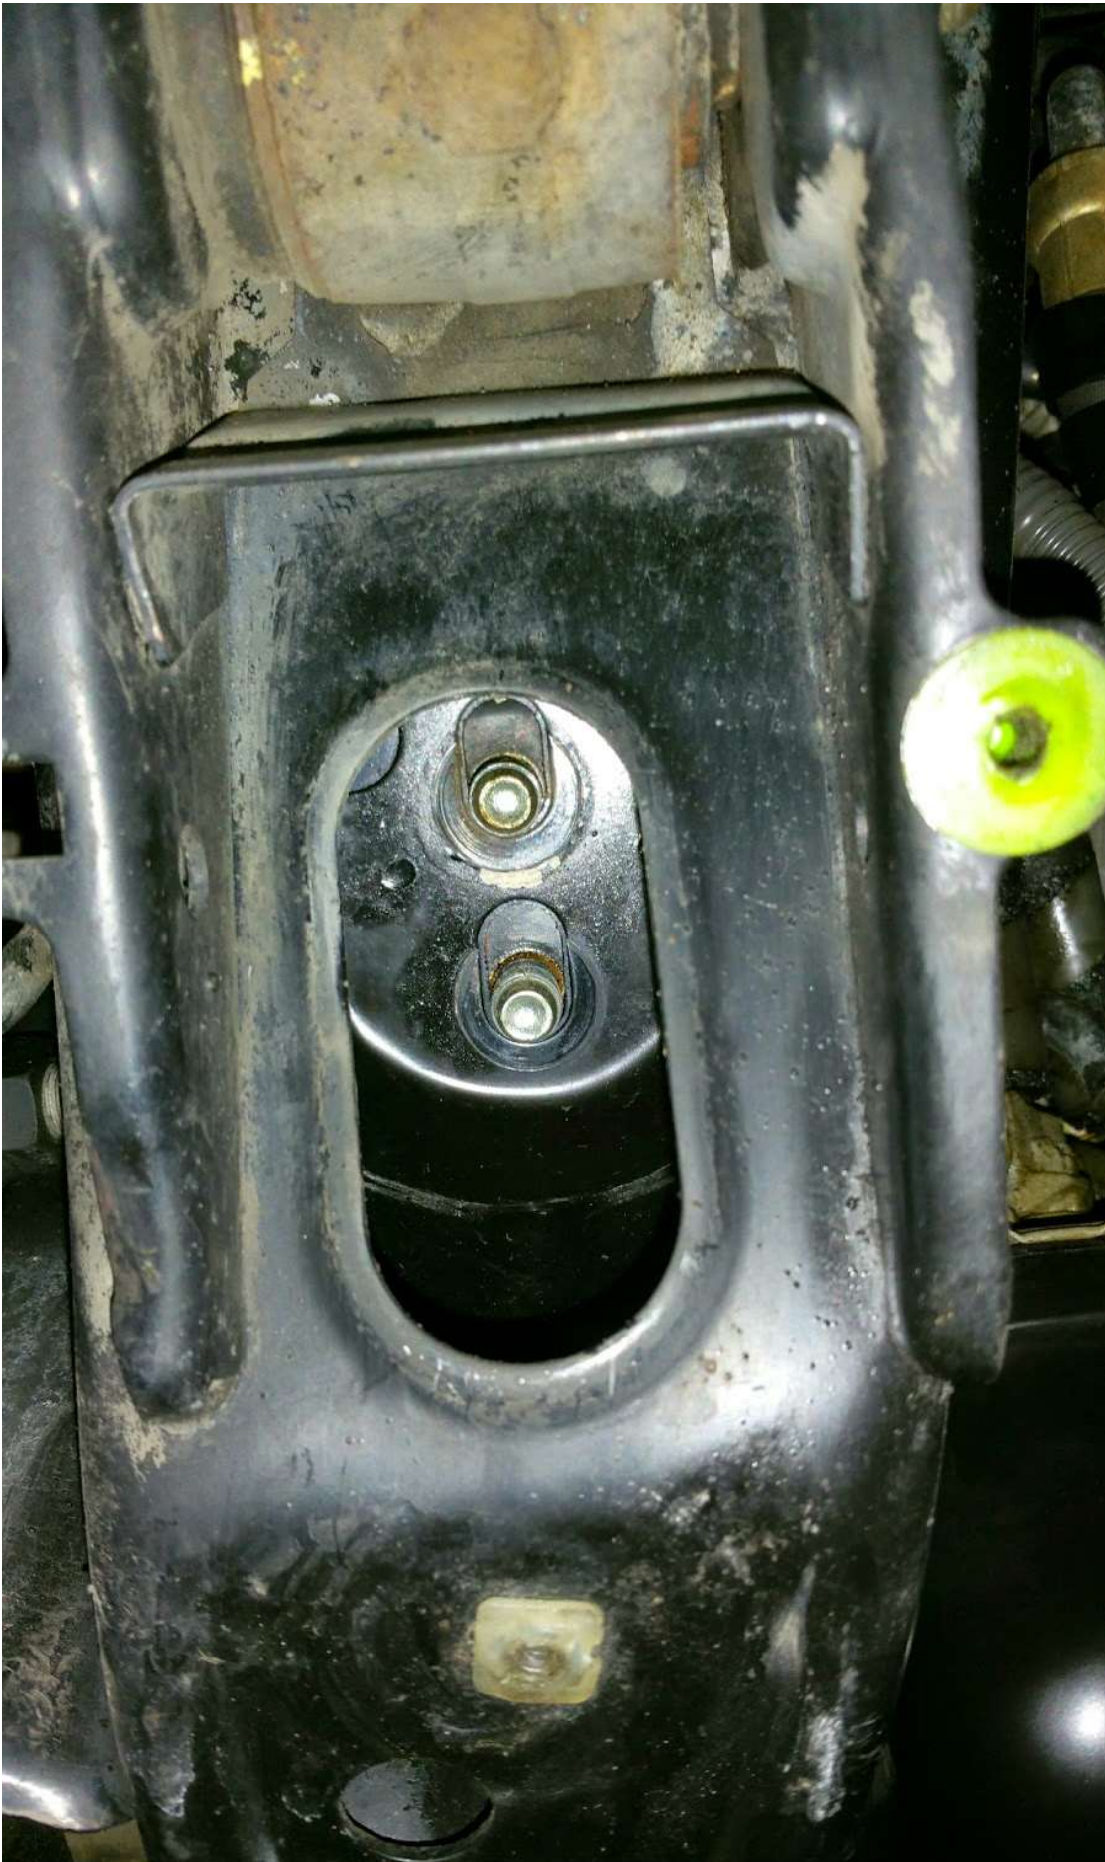
Undo the two bolts holding the motor mount onto the sub-frame and the four bolts that hold the complete mount to the engine block. It was easier to remove the complete mount as opposed to trying to loosen the one bolt up top for the engine mount itself. Once loose, you will have to use the transmission jack to lift the motor about an inch and a half so that the mounts can slide out.

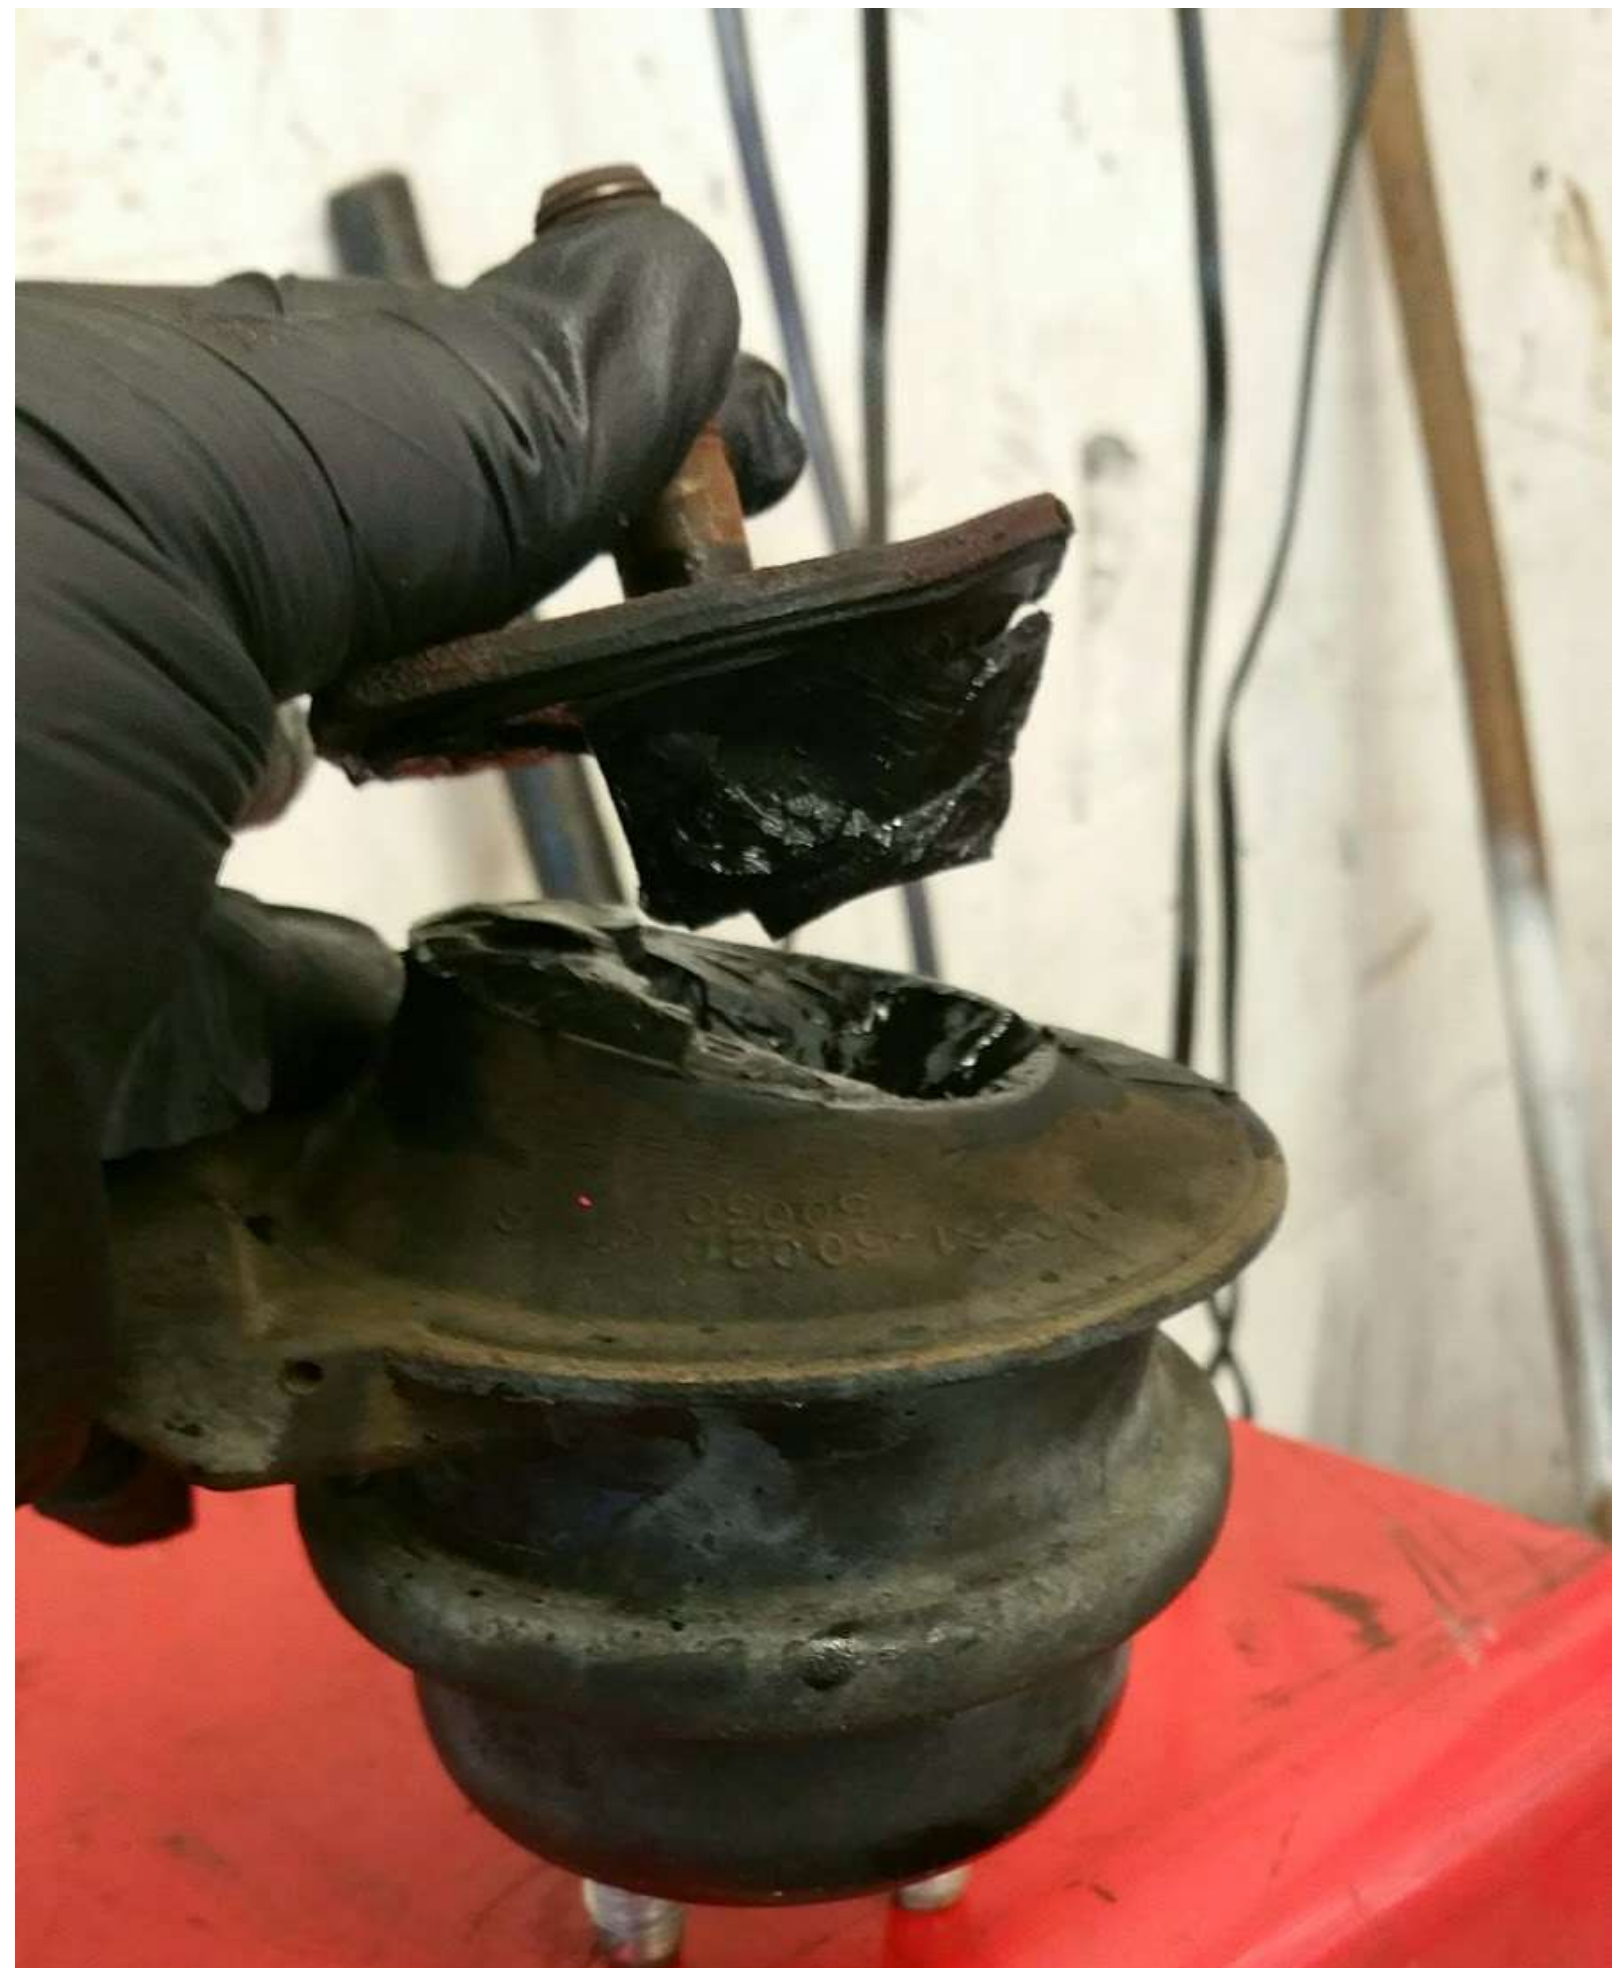
The driver side mount was completely shot, as you can tell by the picture.

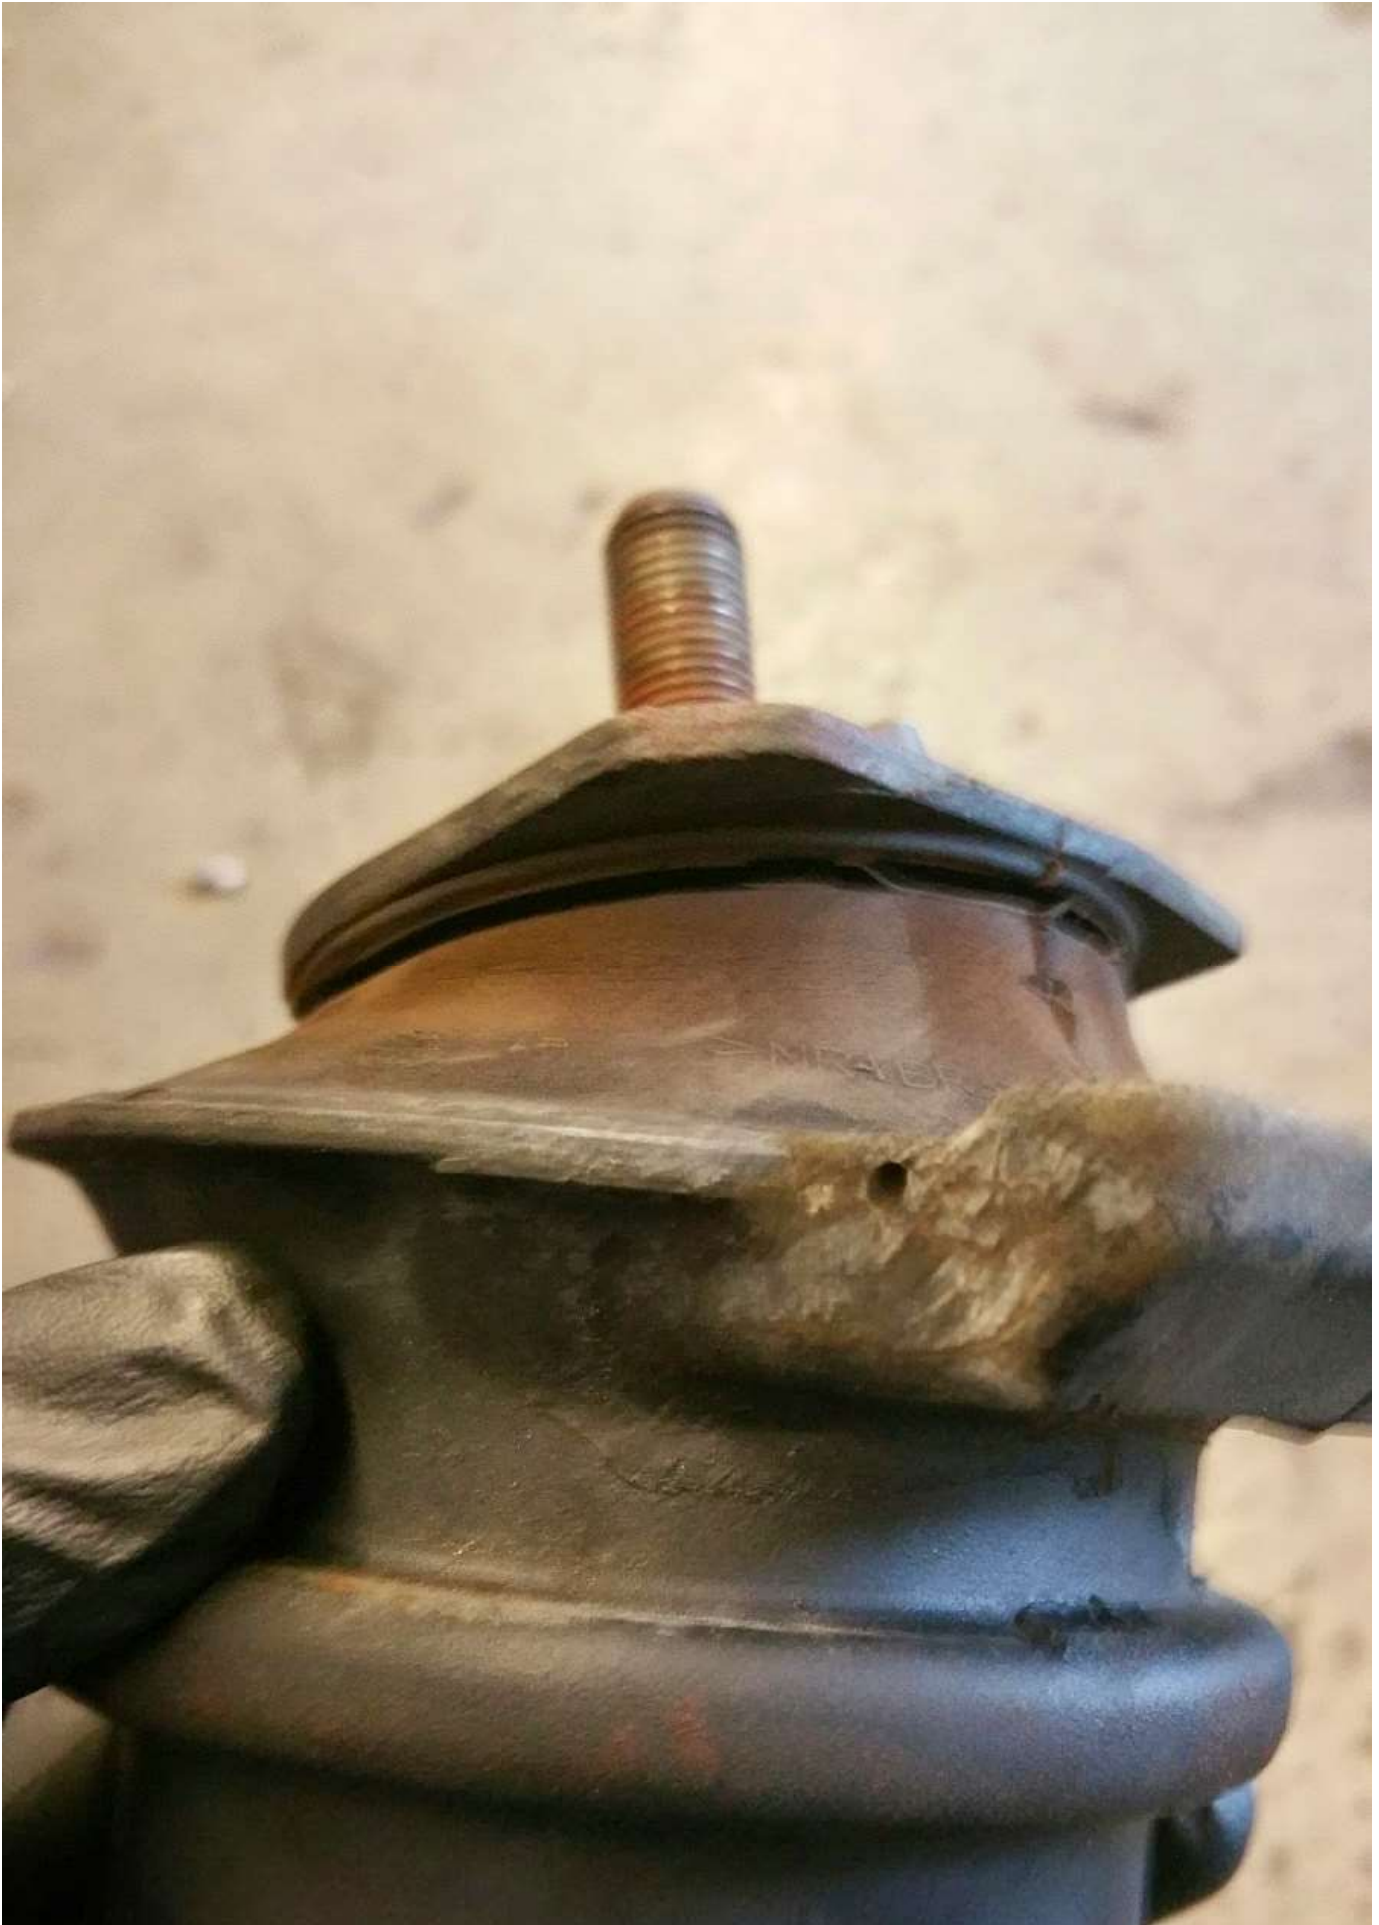
The passenger side mount was on its way out, might not be visible in the picture but the top had a rip in it and was starting to separate.

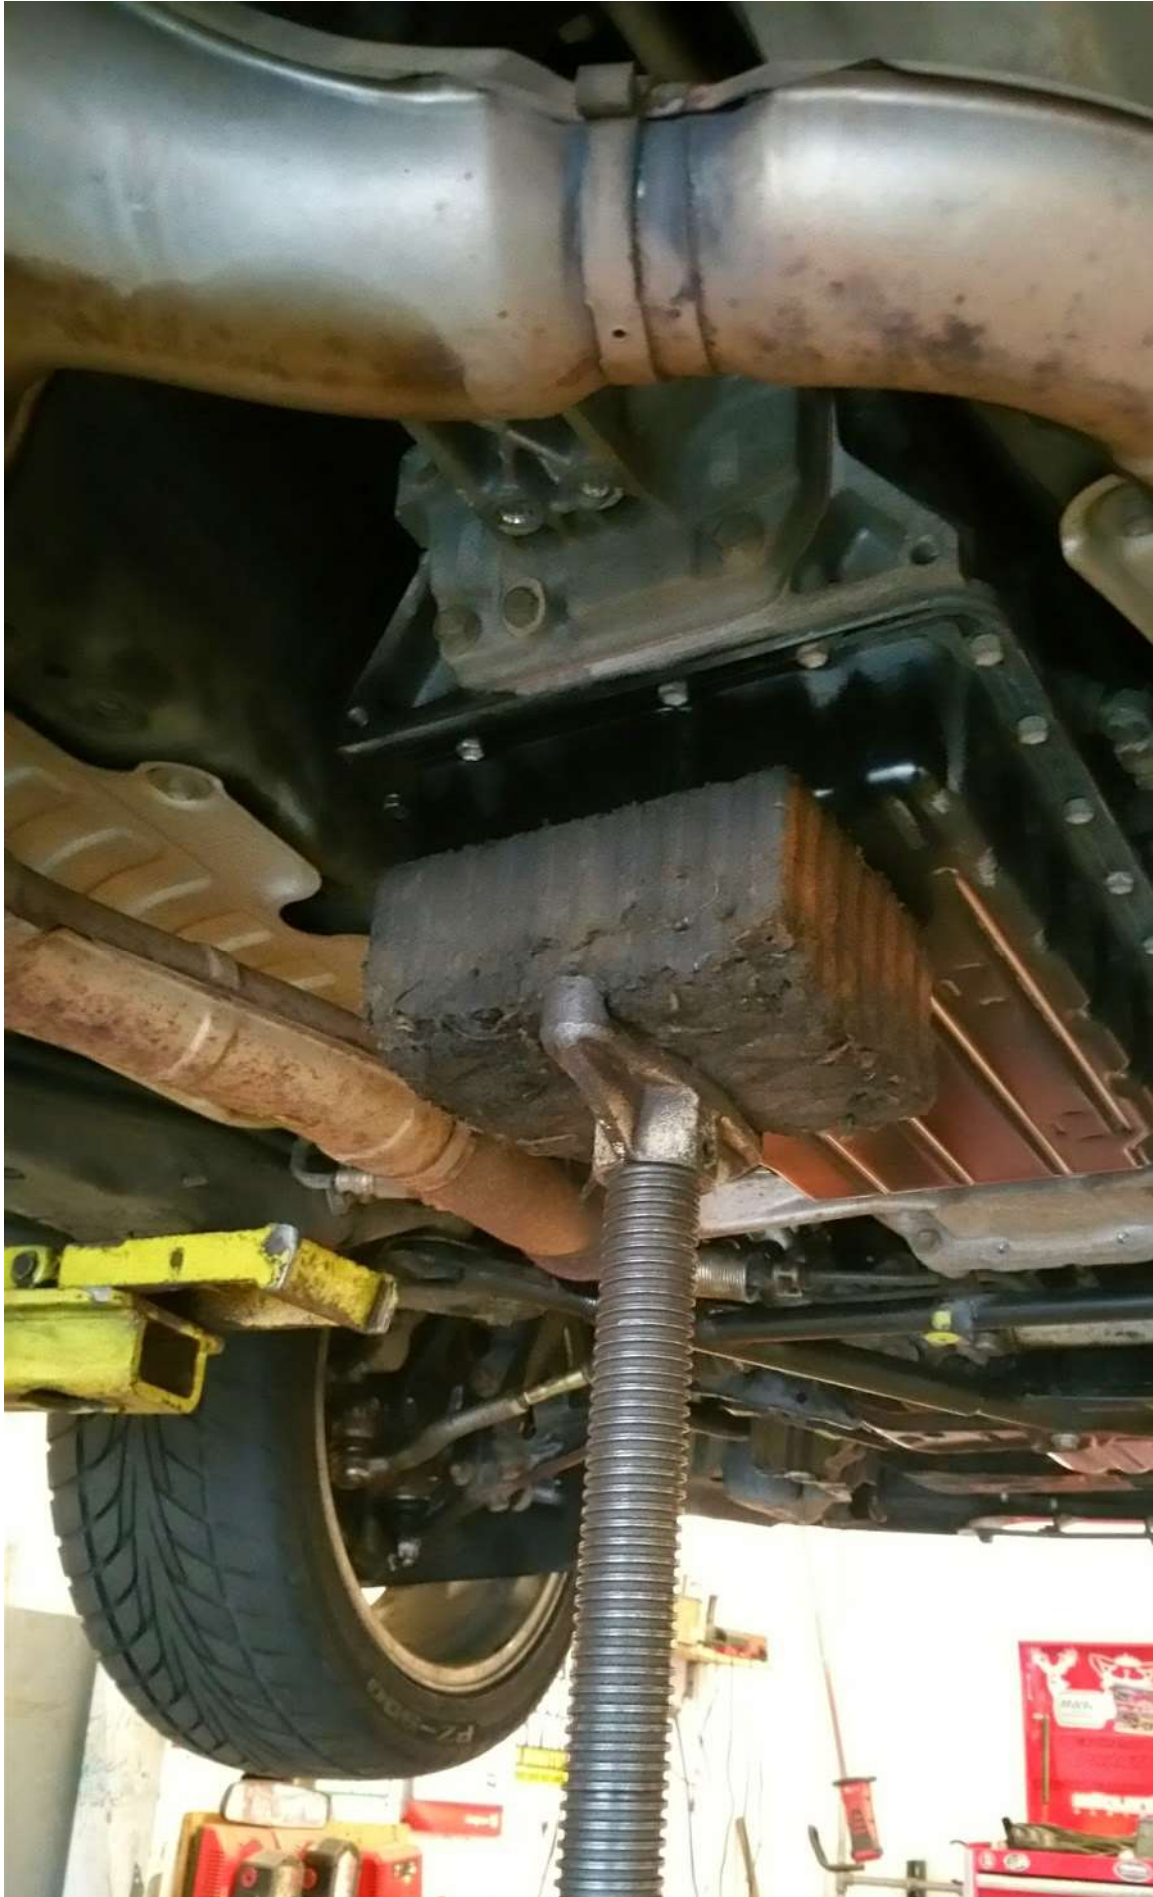
Replaced the engine mounts and did the same for the transmission mount. Used the transmission jack to support the transmission. Undid the 4 bolts and removed the transmission bracket and the 4 bolts that hold the mount to the transmission.

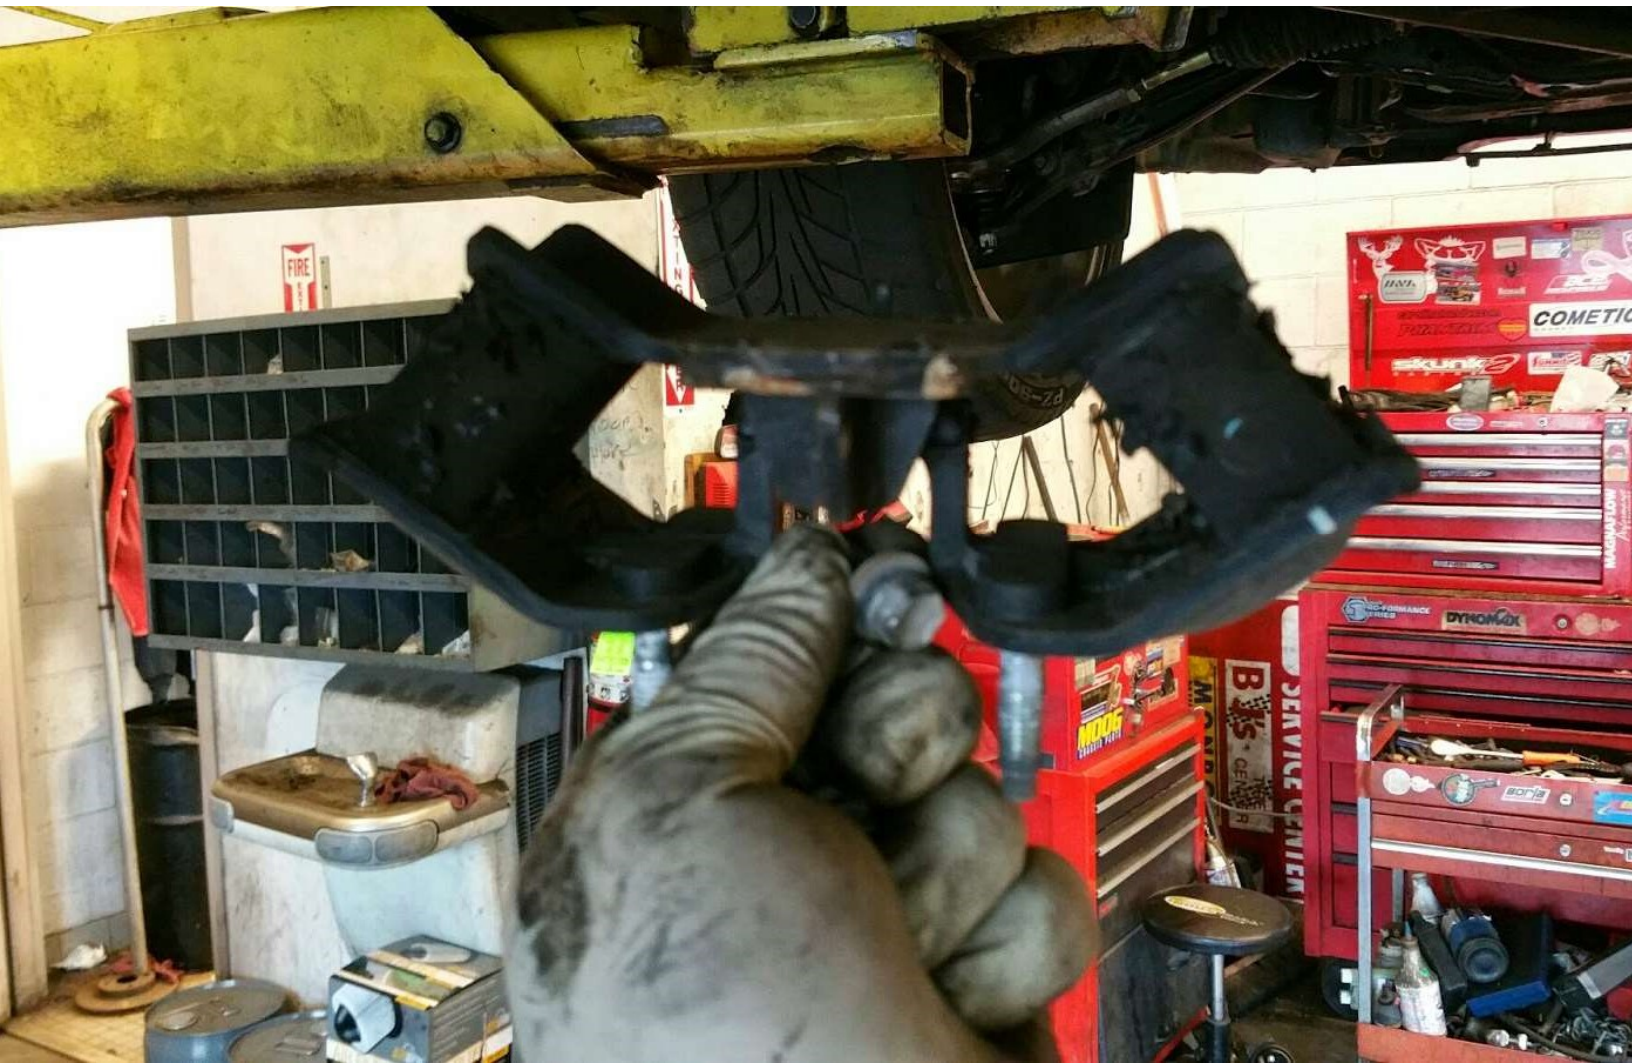
The transmission mount didn't look bad on a visual inspection. There was some sort of coating that was flaking as you can see in the pic but didn't look torn, or see any stress cracks etc.

Replaced the transmission mount and then onto the transmission flush.

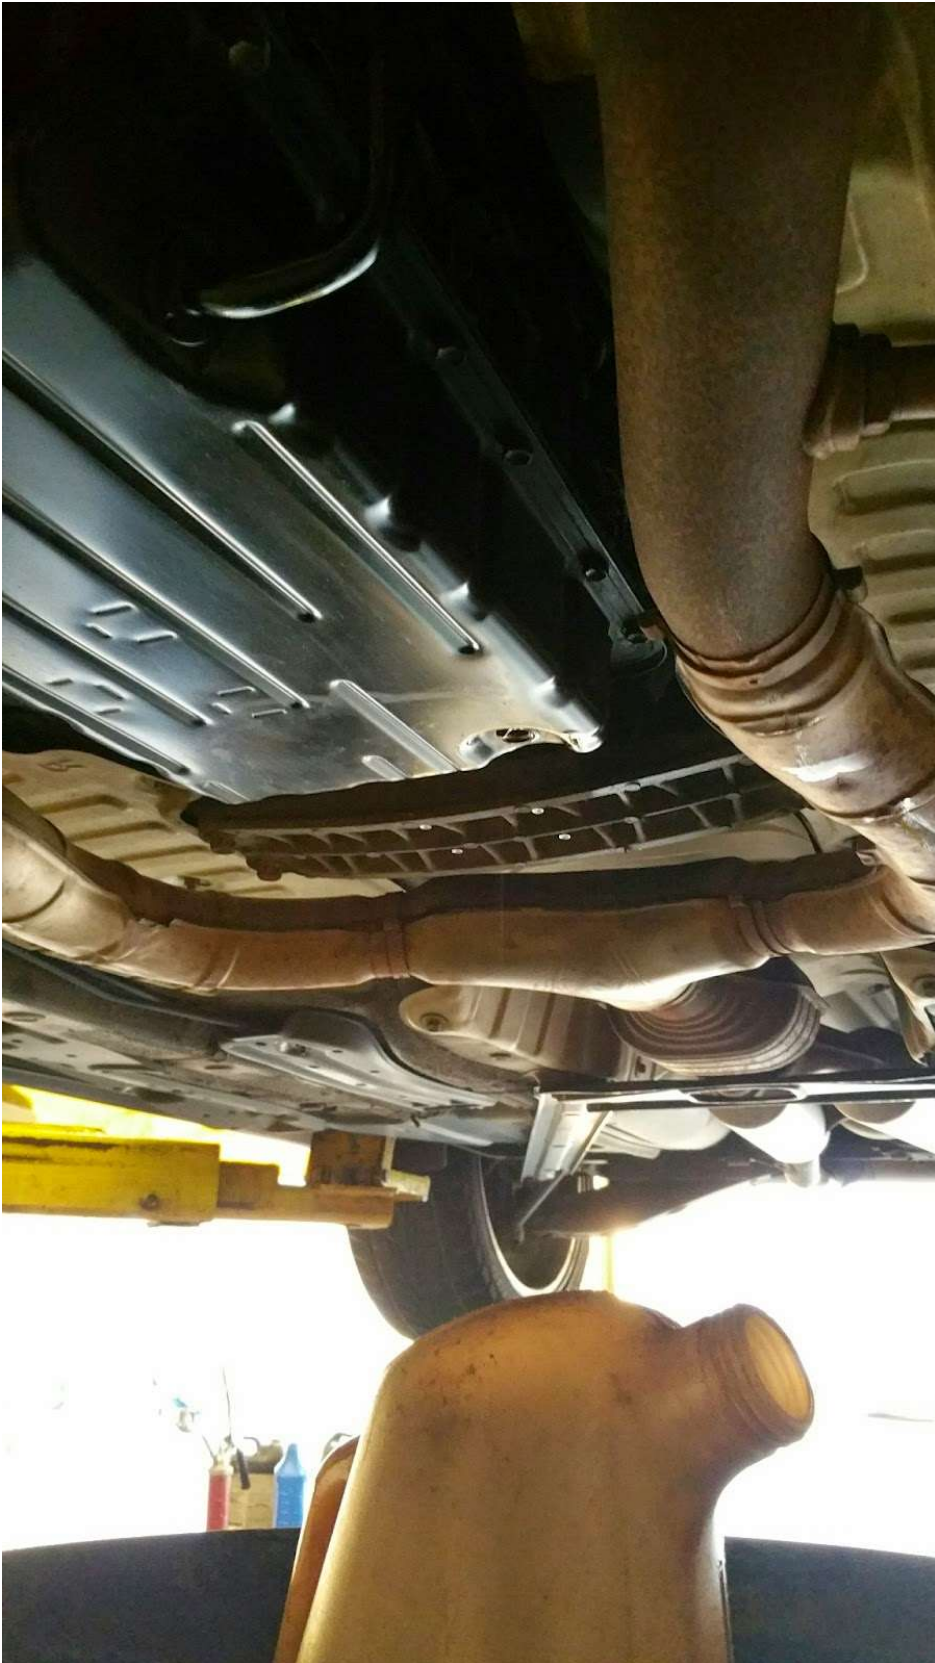
Put the drain plug back in because there is still oil in the drain pan. I learnt from the last time a flush was done on my other car. With the pan off poured the oil in the pan into the measuring jar as well, there was about 1.5 quarts of oil in the pan.

The oil was a dark brown and not the red it is supposed to be. Also two days prior to this I had put in 0.5 pints of Seafoam trans tune to help break down any build up etc in the transmission.

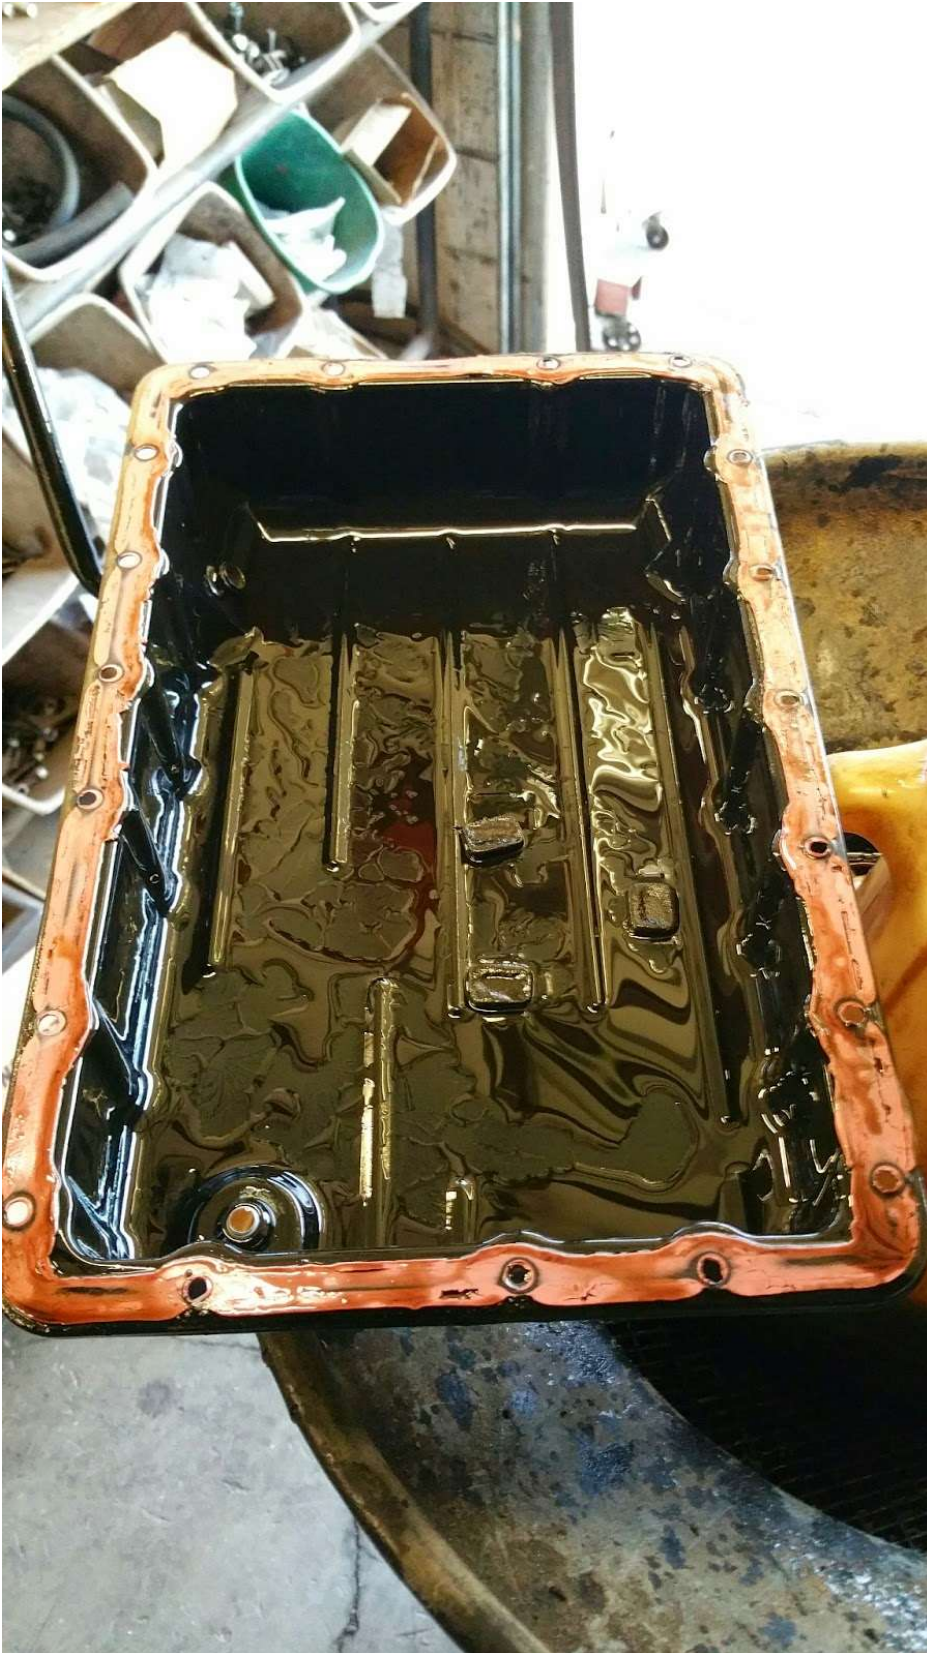
The transmission pan is held in place by Toyota Fipg so it'll take a little yanking to get the pan off. Cleaned up all the fipg off including the 3 magnets in the pan along with the pan itself. I didn't use fipg to put the pan back, instead Felpro makes a transmission pan gasket for it and that's what I used. I've used this method before and have had no issues. Just make sure you don't go ham on the bolts, snug it up there to about 15-18ft/lb where you see the gasket just starting to squeeze away from the pan a little.

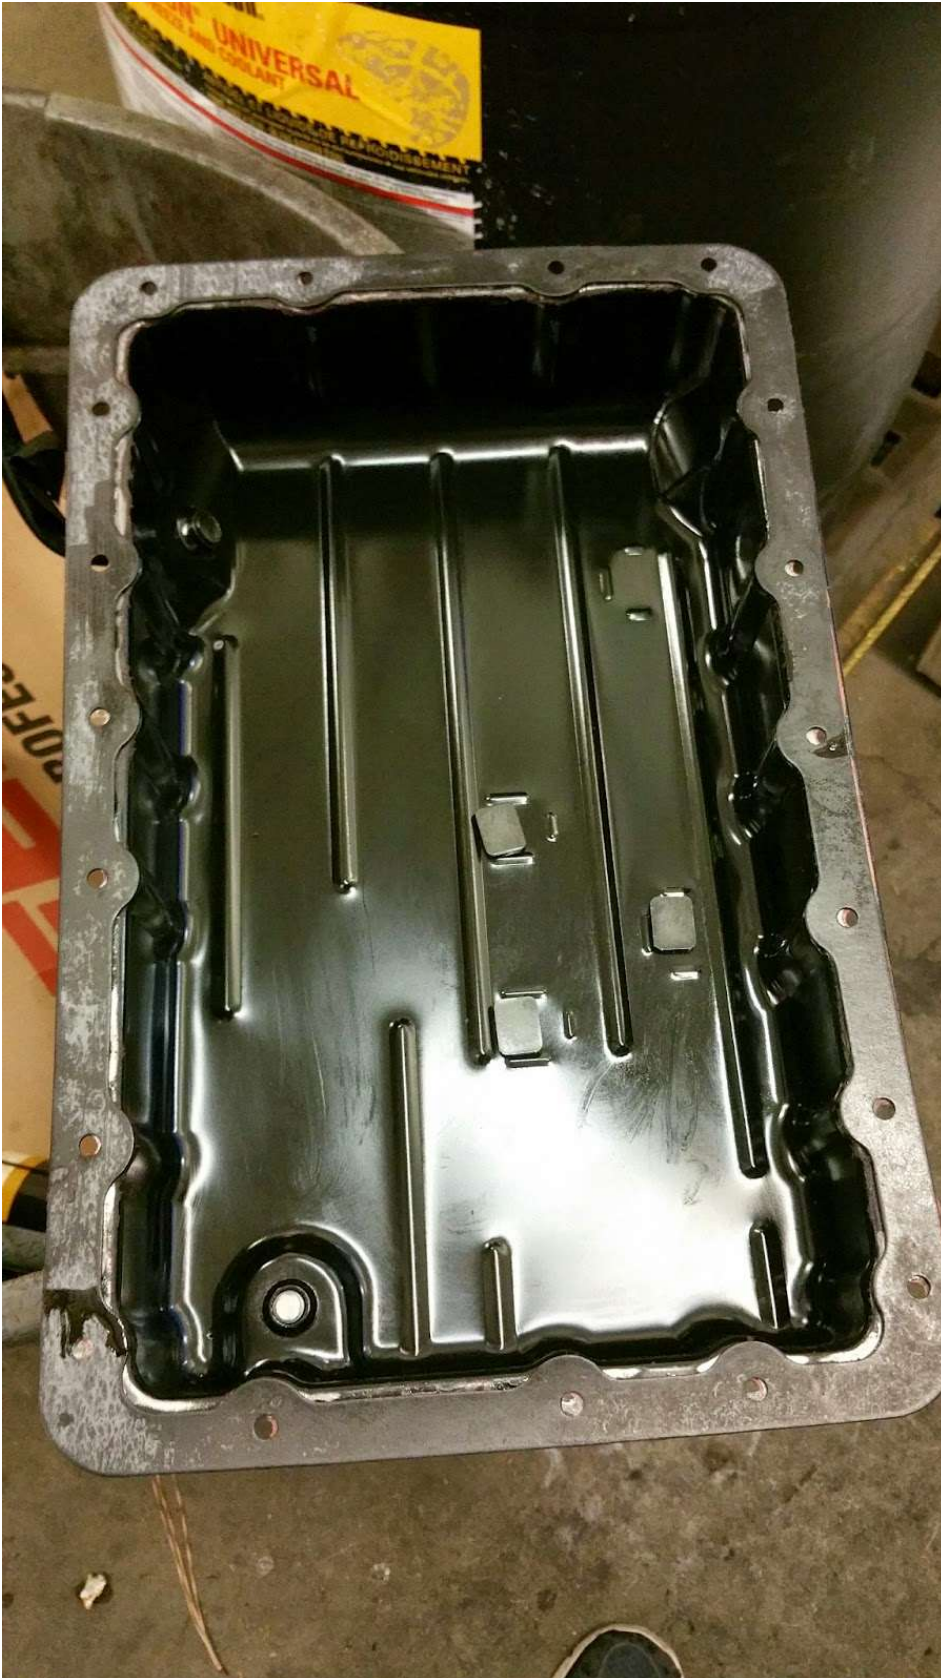
Installed a new transmission filter as well.

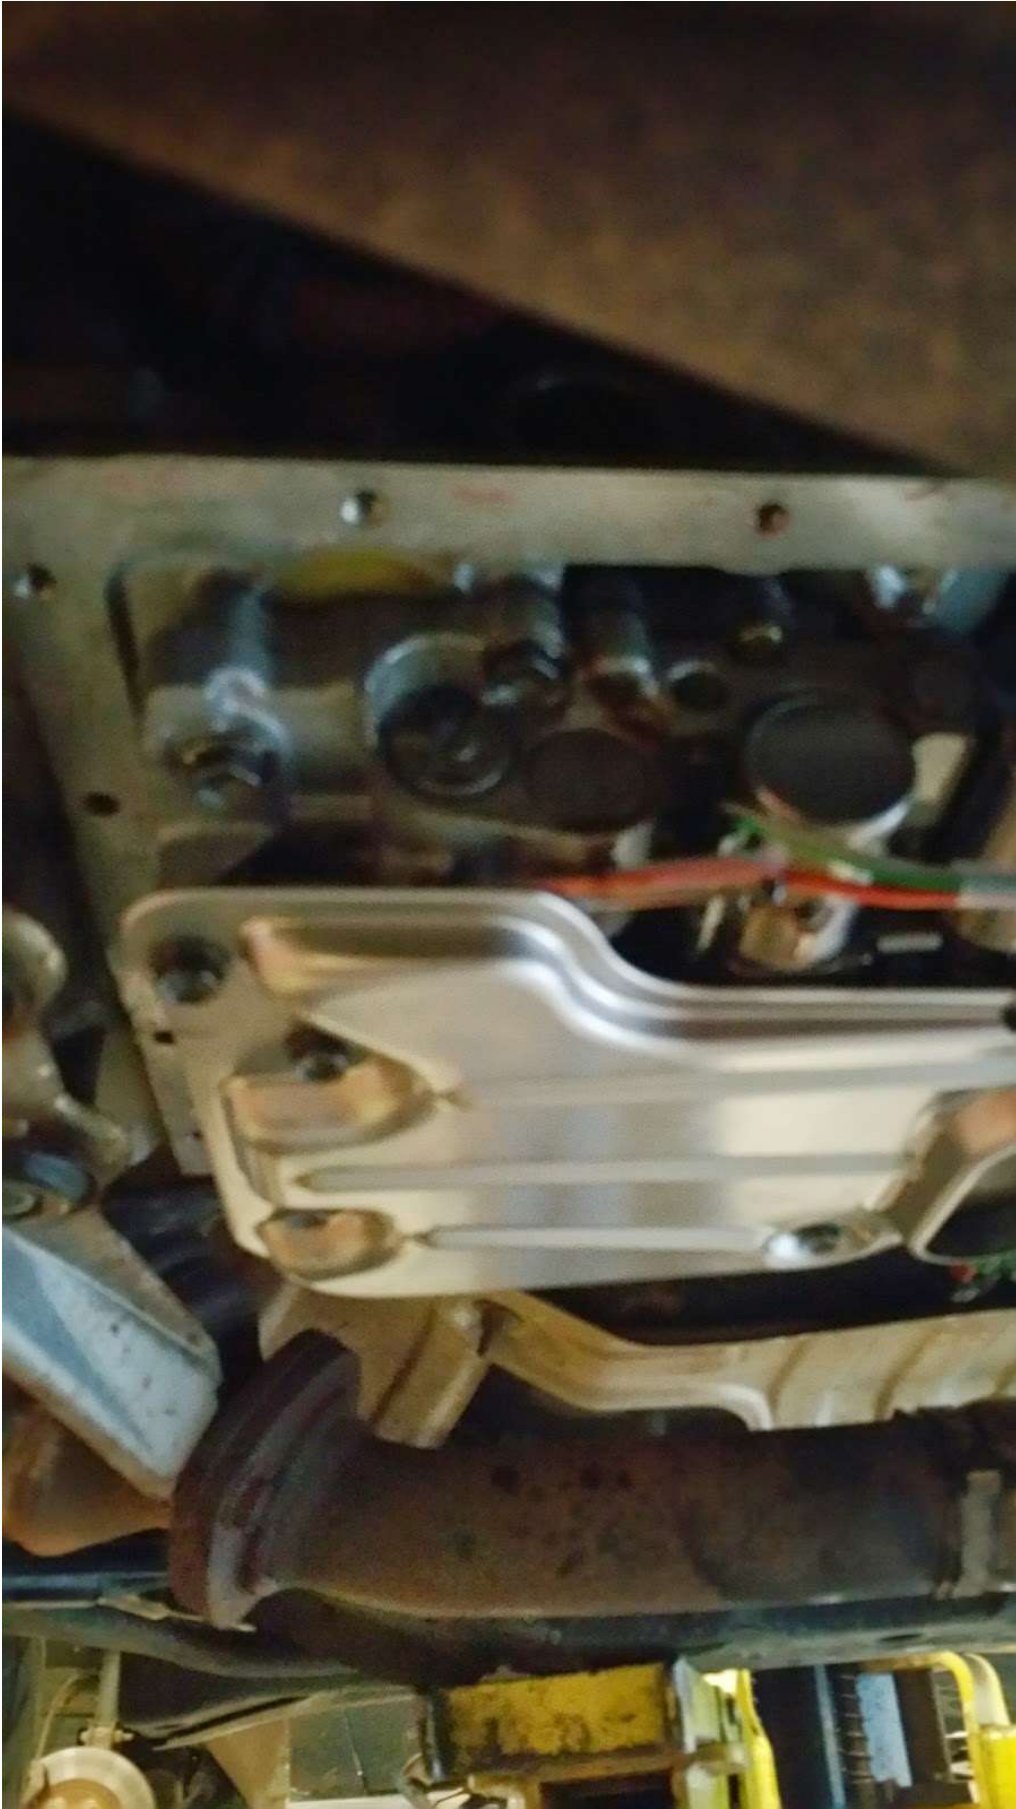
Also adjusted the pressure regulator on the tranny so it shifts faster. The pic shows the factory setting but pressing it in and turning it clockwise to the third setting increases the pressure resulting in faster shifts. Firmer faster shifts result in longer tranny life and has been well documented on Club Lexus.

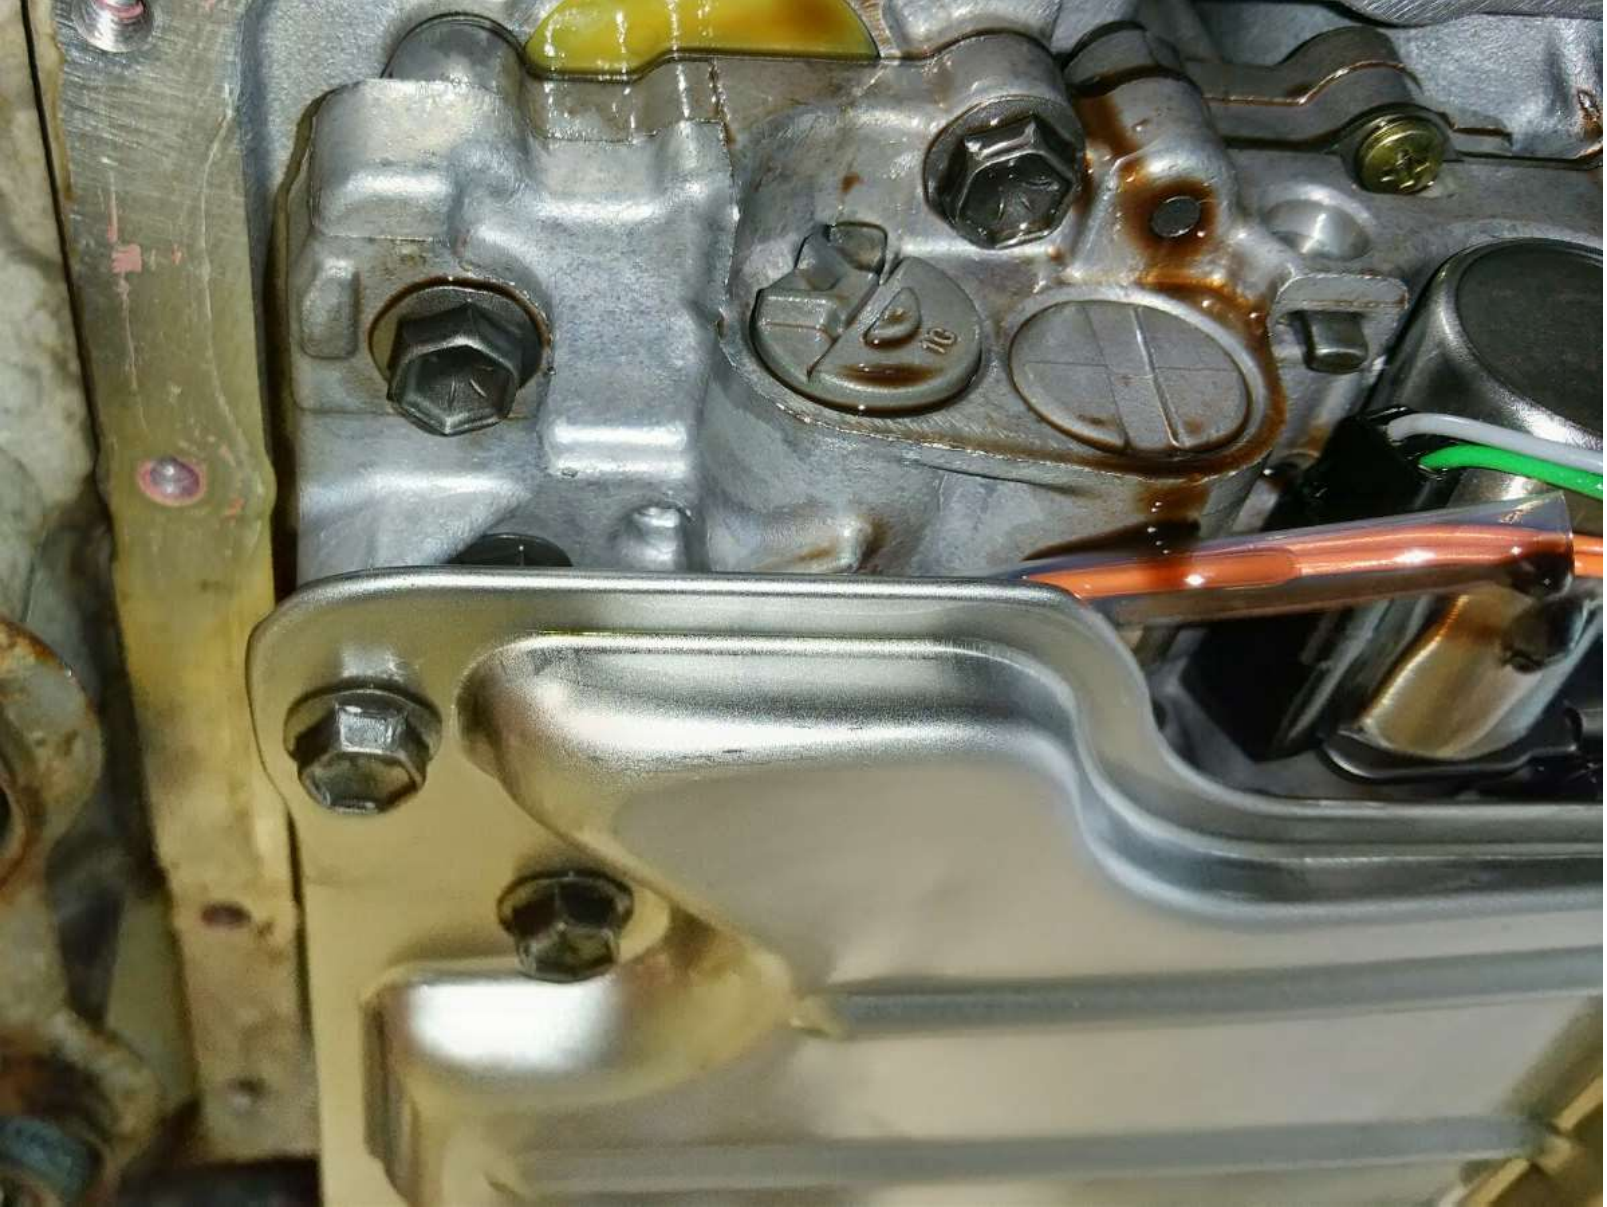
With the pan back in place filled fresh ATF through the dip stick. Just the 3.5 quarts that came out of the pan.
