Repair Manual Supplement: Vehicle Pulling to One Side

Market USA

TSIB SUPERSESSION NOTICE

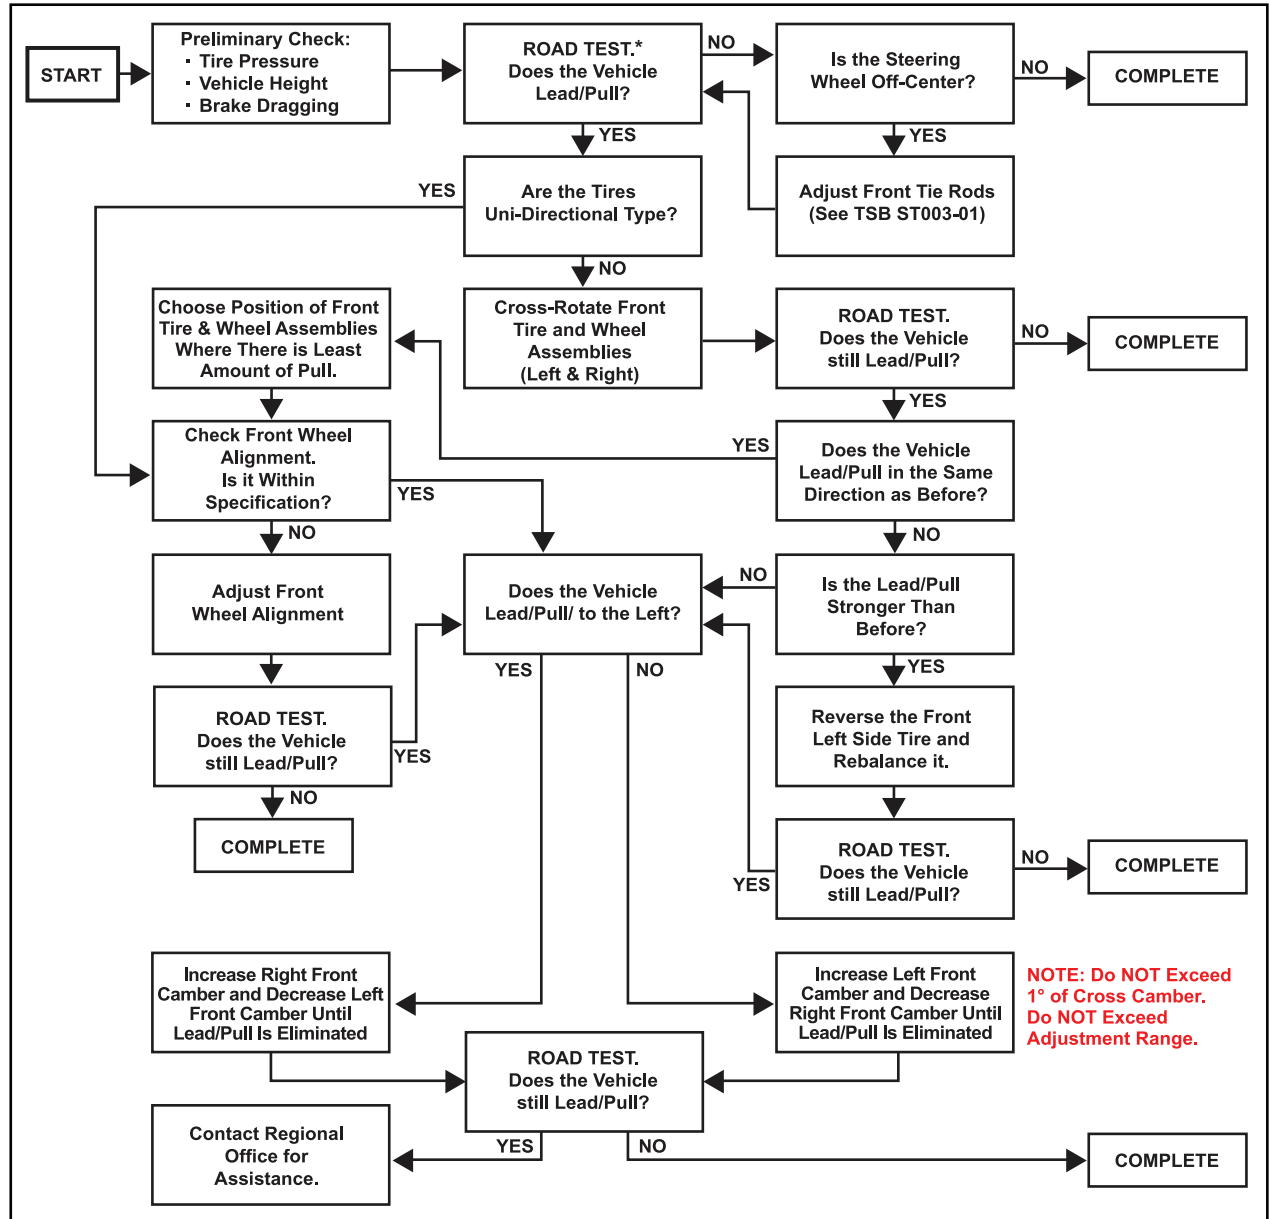
Figure 5.

* Select a flat road where the vehicle can be driven in a straight line for 109 yards (100 meters) at a constant speed of 35 mph (56 km/h). Please confirm safety and set the steering wheel to its straight position. Drive the vehicle in a straight line for 109 yards (100 meters) at a constant speed of 35 mph (56 km/h) without exerting steering effort on the steering wheel.

- Steering Off Center: The vehicle goes straight but the steering wheel has some angle.
- Steering Pull: The vehicle does NOT go straight.

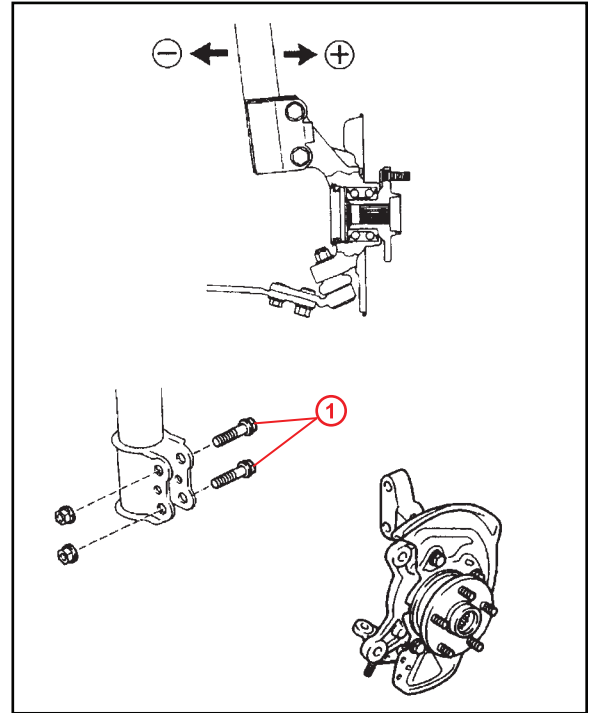
Figure 14.

1	Nuts
----------	-------------

- B. Remove the two nuts on the lower side of the shock absorber.

- C. Coat the threads of the nuts with engine oil.
- D. Temporarily install the two nuts.
- E. Adjust the camber by pushing or pulling the lower side of the shock absorber in the direction in which the camber adjustment is required.
- F. Tighten the nuts.
Torque: 210 N*m (2150 kgf*cm, 155 ft*lbf)
- G. Install the front wheels.
Torque: 104 N*m (1050 kgf*cm, 77 ft*lbf)
