**Technical Service  
Information Bulletin**

**REPAIR MANUAL SUPPLEMENT:  
VEHICLE PULLING TO ONE SIDE**

'08 Lexus

SUSPENSION  
SU001-08

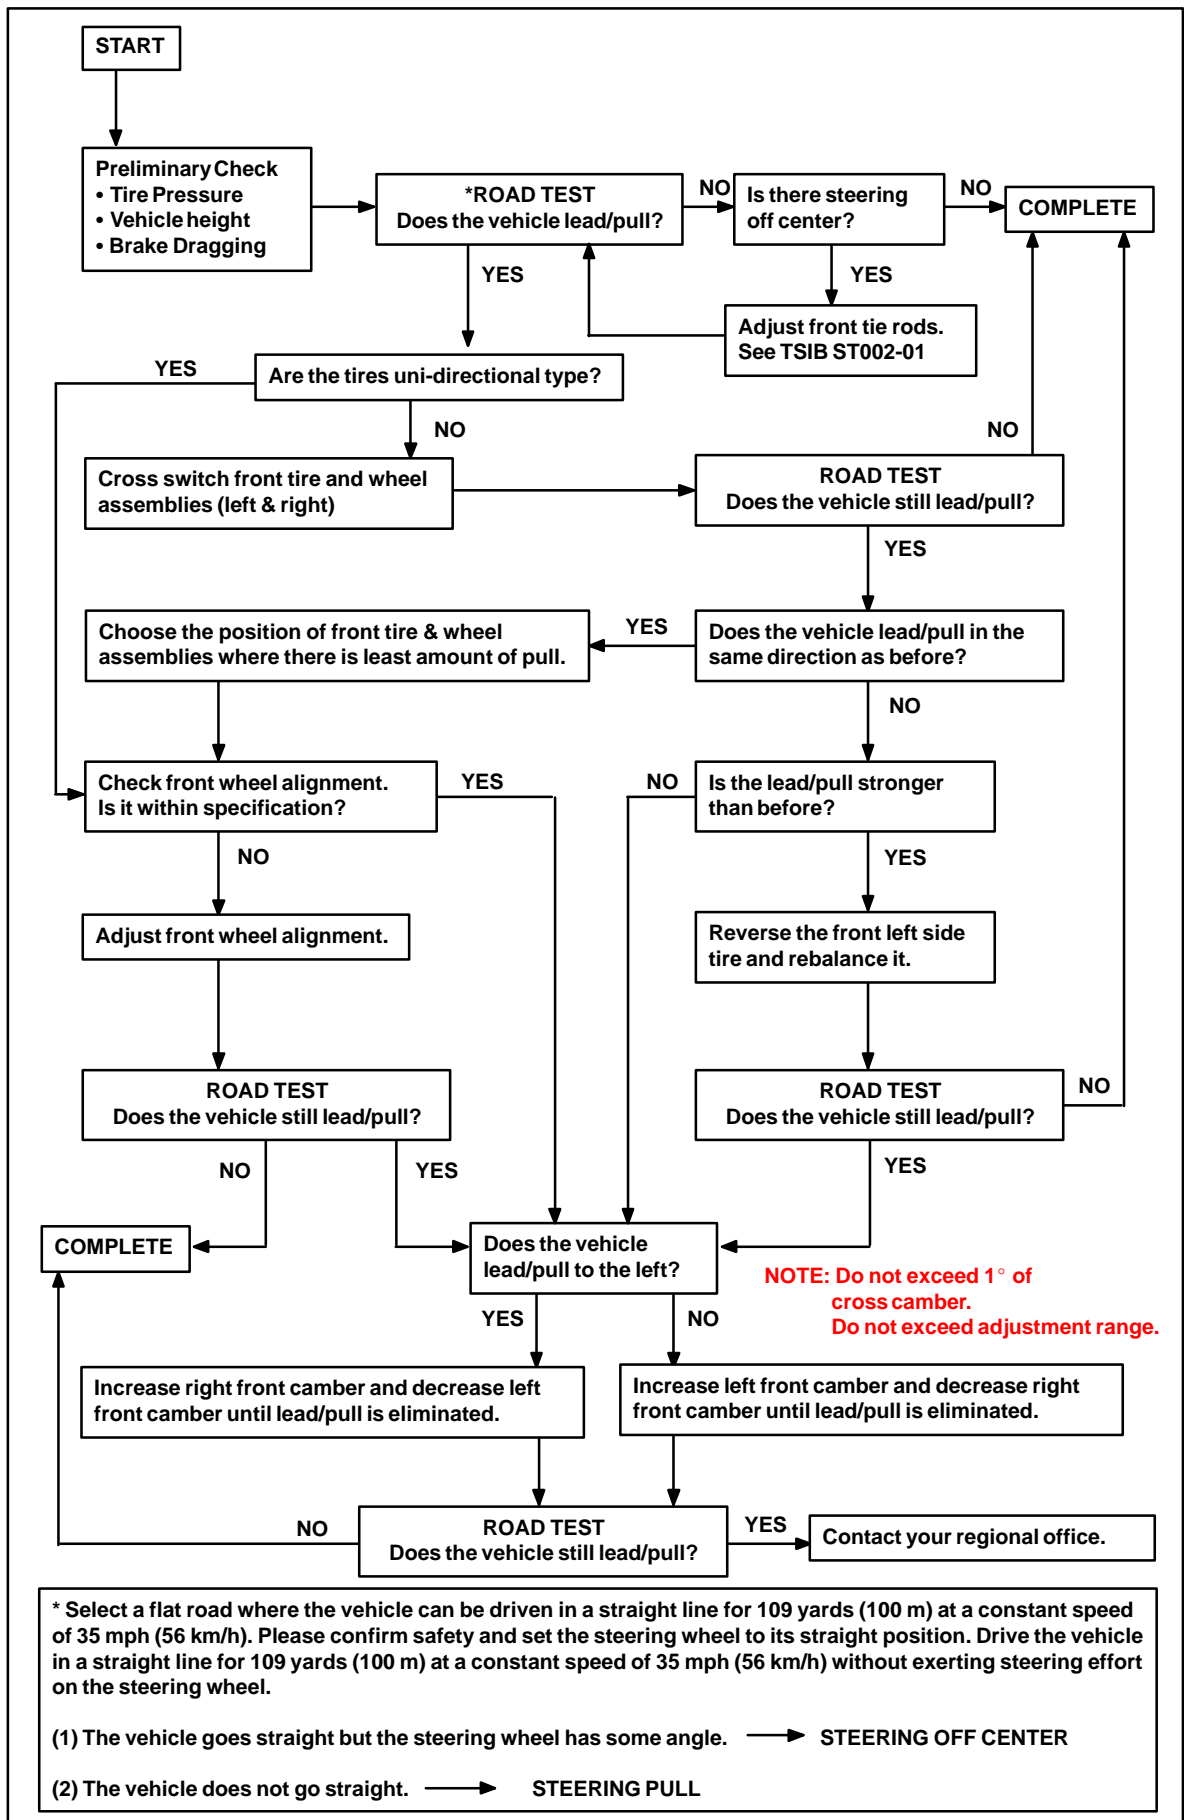
Repair Procedure Flow Chart

First determine whether vehicle pulling is caused by a wheel alignment problem or tire characteristics, then decide which repairs to make.

SYMPTOM	PROBABLE CAUSE	CORRECTIVE ACTION
No change in vehicle pulling condition	Front wheel alignment	Proceed to Repair Procedure 3. Vehicle pulling caused by Wheel Alignment (Page 7)
Vehicle pulling eliminated	Tire conicity	Repair complete. Vehicle Pulling Caused by Tire Conicity (Page 4 and 8)
Vehicle pulling direction is reversed	Tire conicity	Proceed to Repair Procedure 4. Vehicle Pulling Caused by Tire Conicity (Page 8)
