**Technical Service
Information Bulletin**

NOISE FROM REAR A/C UNIT

'04 GX 470

HEATING & AIR CONDITIONING
AC001-05

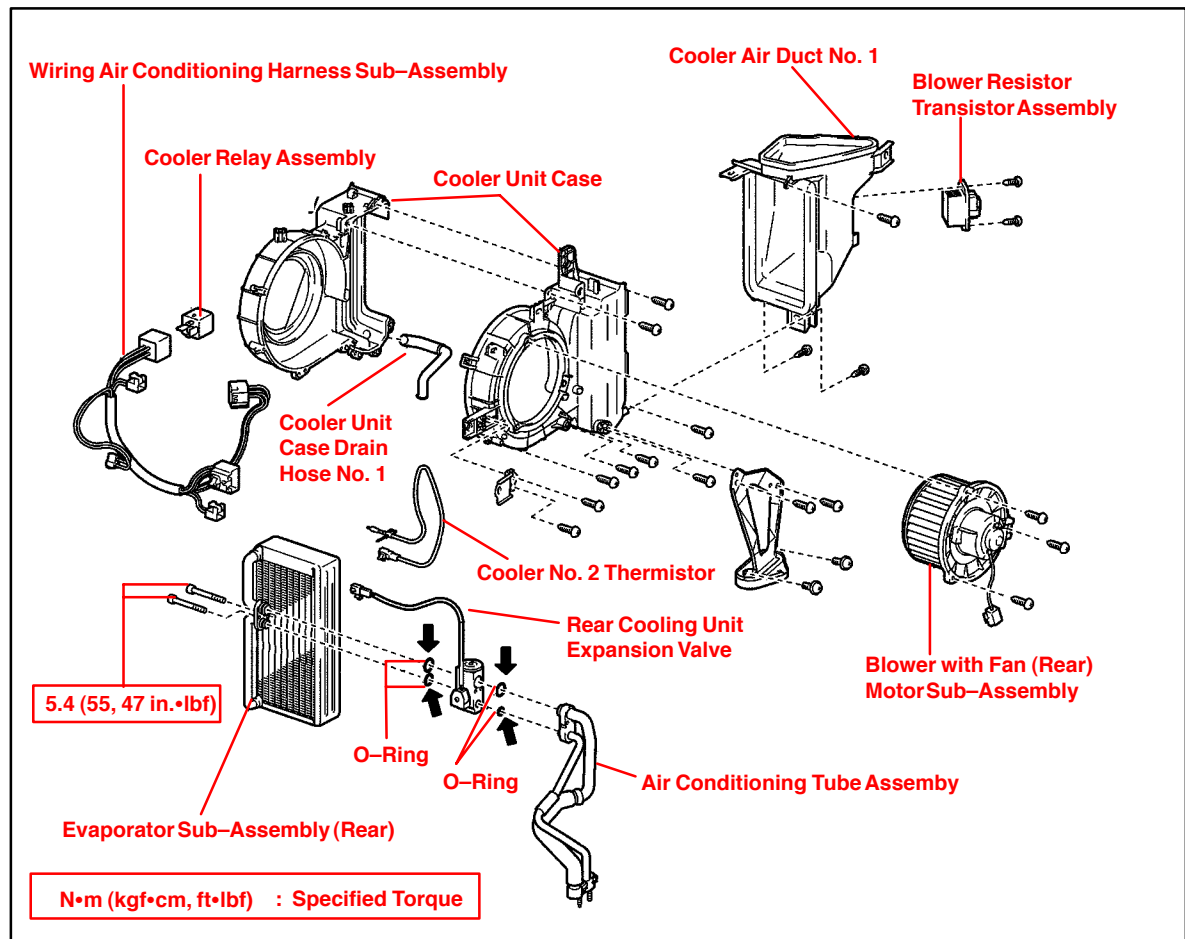
Components

Introduction Some GX 470 owners may experience a crackling/static type sound from the right rear HVAC assembly. This procedure provides a method to improve this condition.
