Vehicle Pull, Steering Wheel Off Center, and Alignment Best Practices

Service Category Suspension

Section Alignment/Handling Diagnoses

This Service Bulletin provides best practice procedures for vehicle pulling complaint, diagnosis, and repair for 2002 – 2021 model year Lexus vehicles.

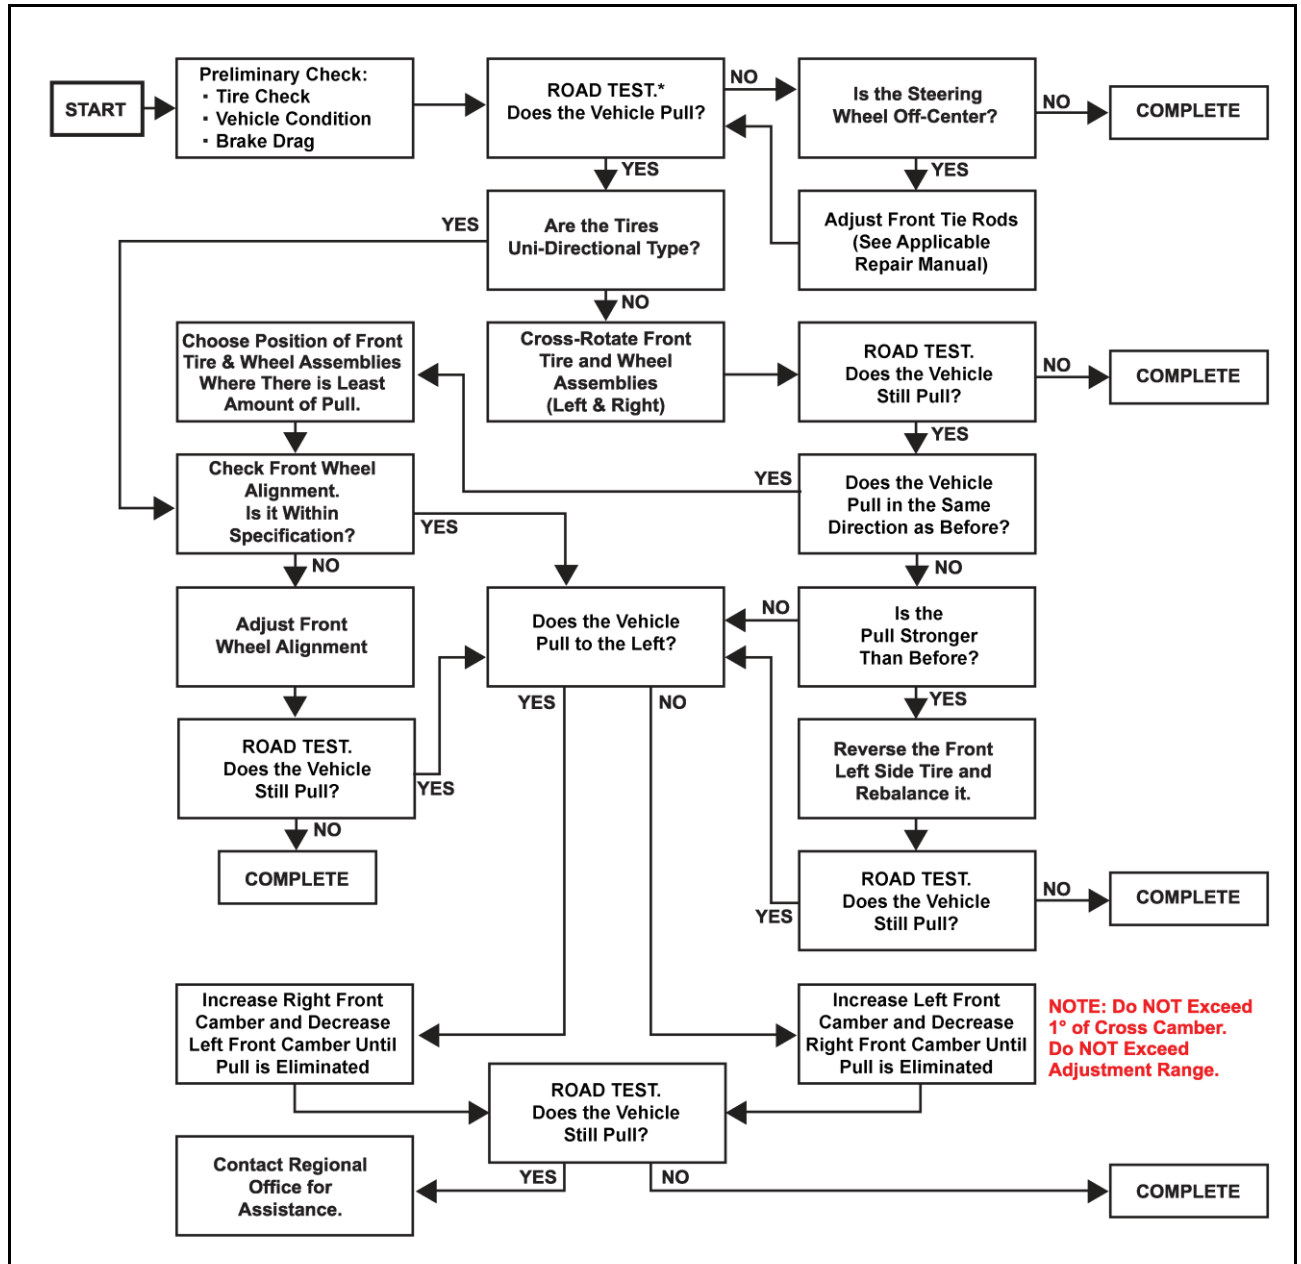
Figure 5.

Repair Procedure Flow Chart

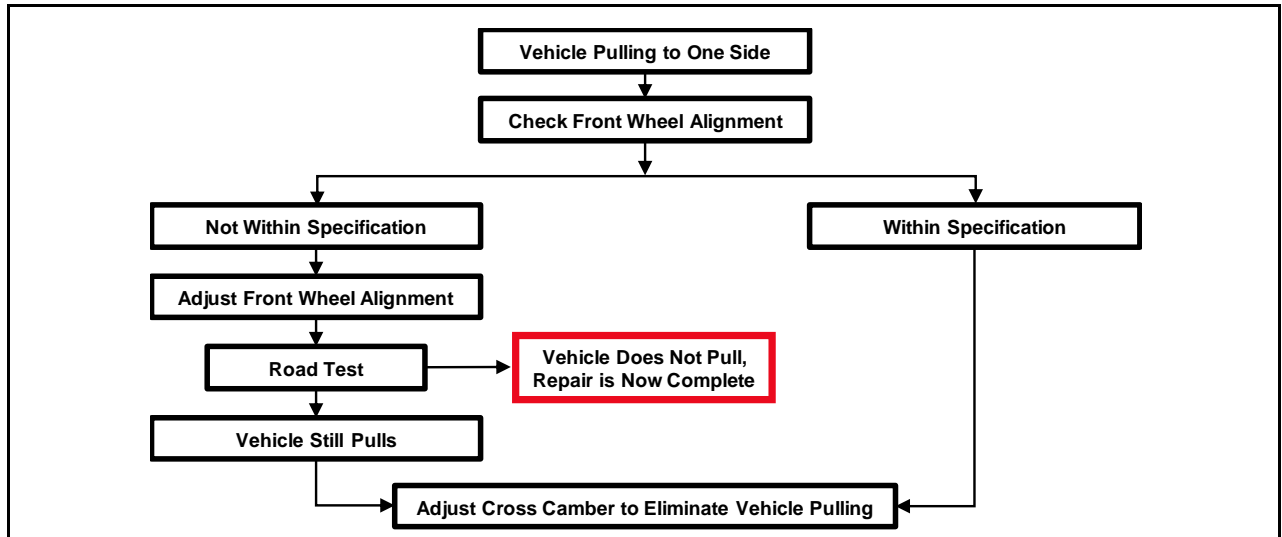
Figure 12.

Vehicle Pulling Caused by Wheel Alignment

When it is determined by troubleshooting that the vehicle pulling to one side is caused by wheel alignment, perform repairs according to the following procedure.

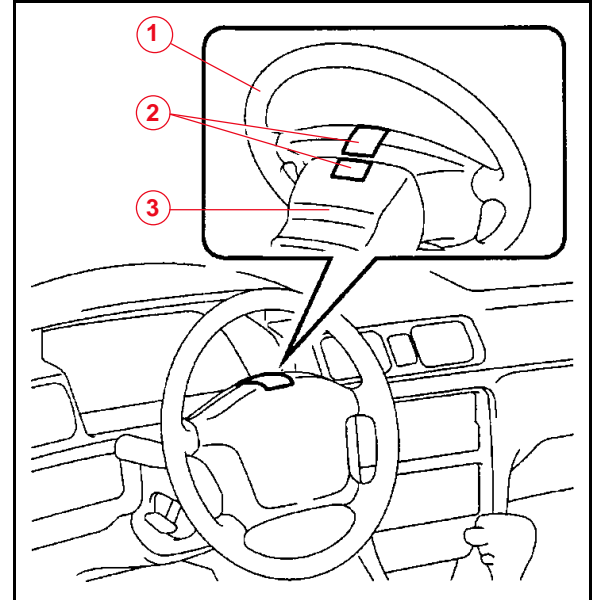
Figure 15.

1. Inspect steering wheel off center.
 - A. Apply masking tape to the top center of the steering wheel and steering column upper cover.
