**Technical Service  
Information Bulletin**

Title:  
**NAVIGATION SYSTEM  
DOOR REPLACEMENT**

Models:  
**'02 – '05 SC 430**

**BODY**  
**BO011-04**

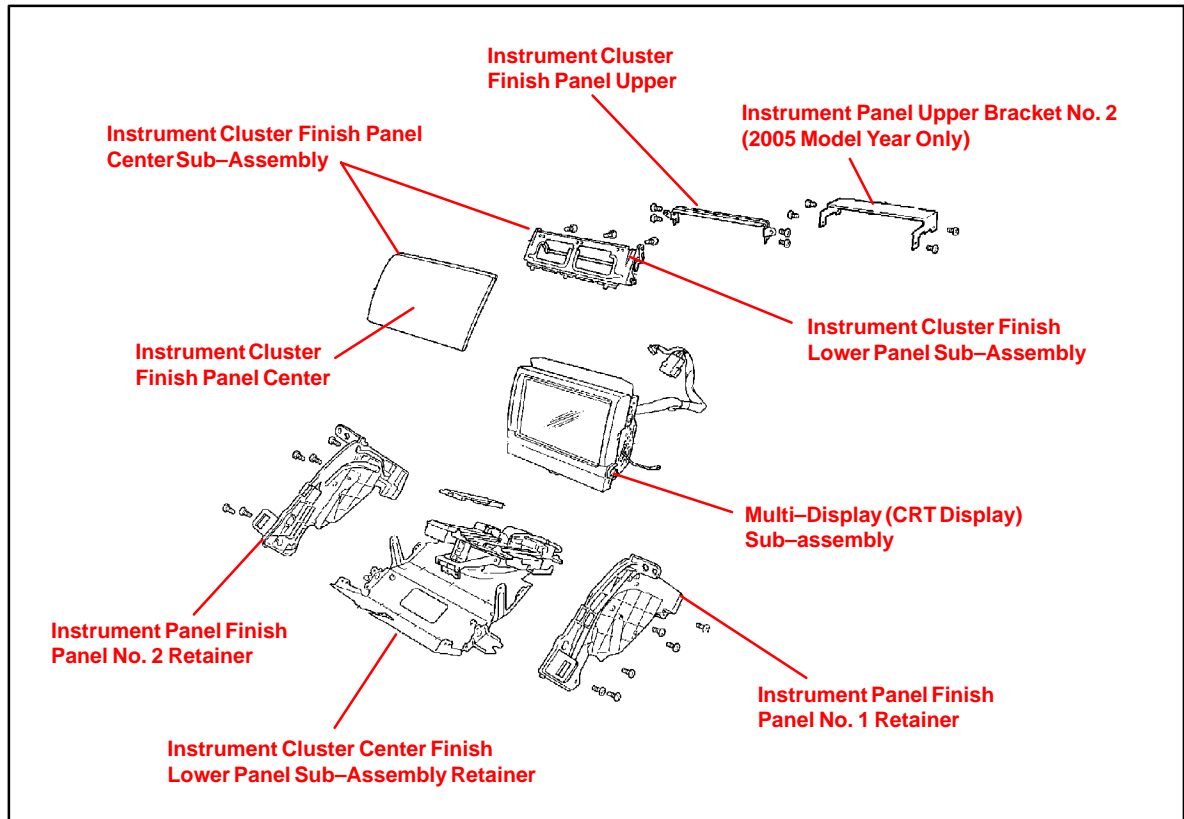
**Components**

**Introduction** The navigation system door can now be replaced without having to replace the complete instrument cluster with multi-display unit. Use the following procedures to replace the navigation system door.
