DTC P0705: PARK/NEUTRAL POSITION SWITCH MALFUNCTION

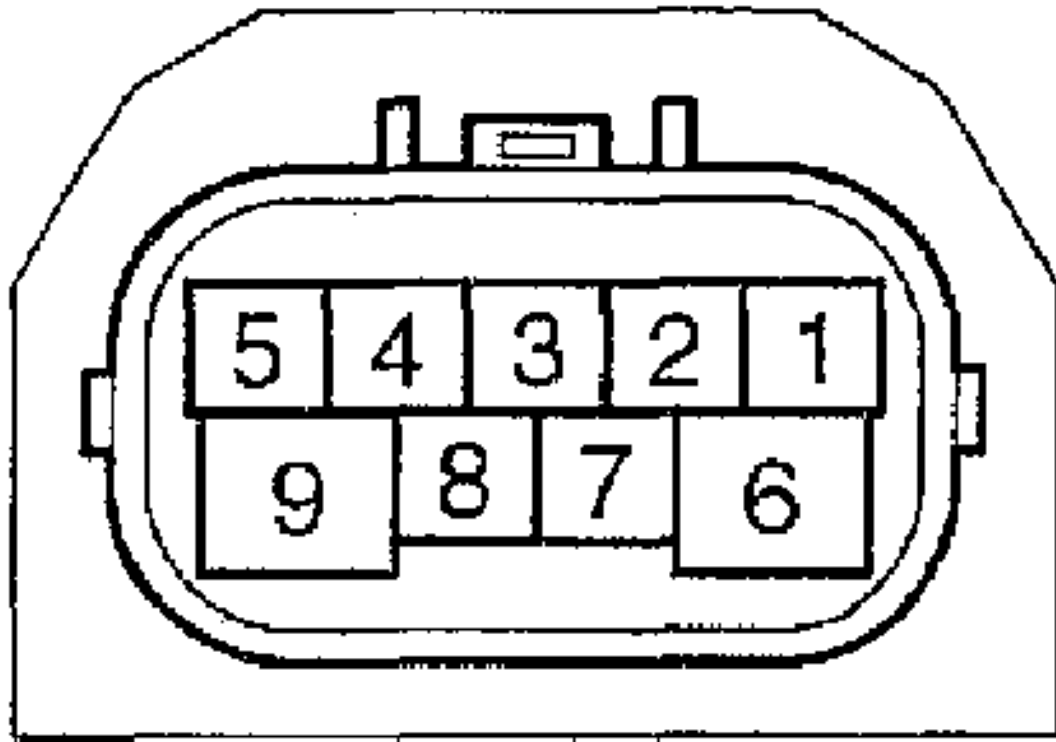
G00244960

Fig. 88: Identifying Park/Neutral Position Switch Connector Terminals
Courtesy of TOYOTA MOTOR SALES, U.S.A., INC.

1. Jack up the vehicle. Disconnect the park neutral position switch connector. Check continuity between each terminal. See [Fig. 88](#) . See **PARK/NEUTRAL POSITION SWITCH CONTINUITY CHECK** table. Replace switch as necessary. If switch is okay, go to next step.

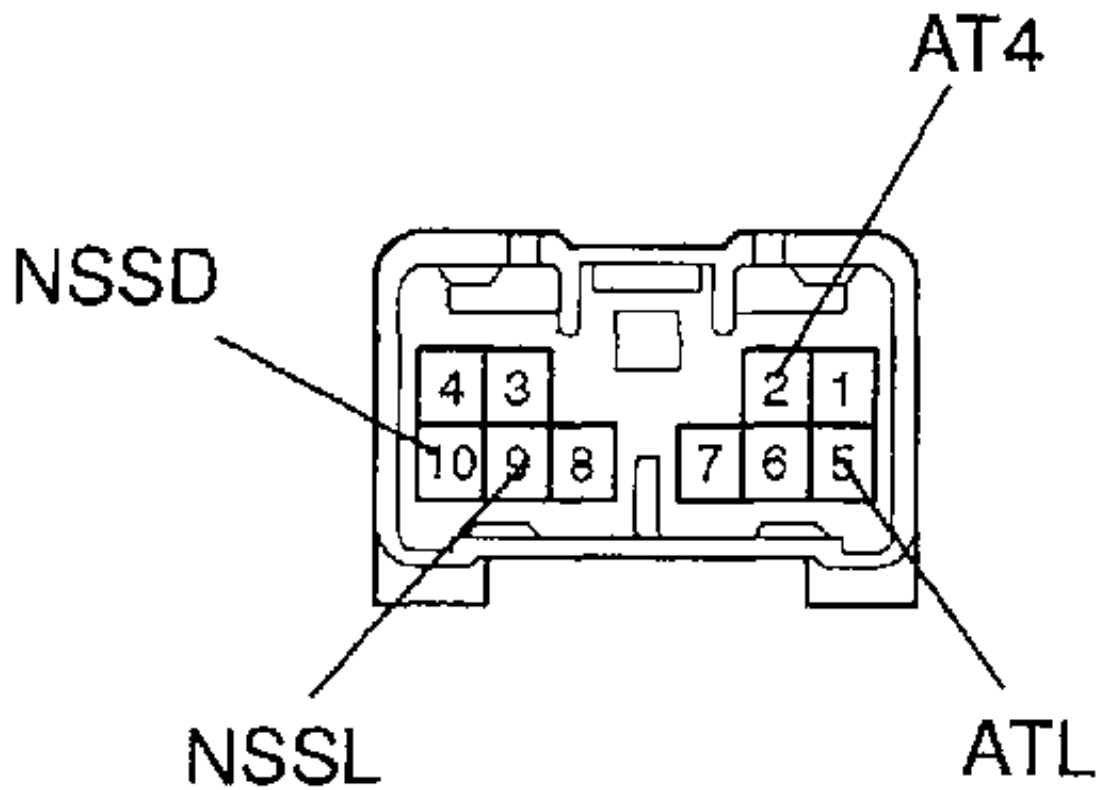
G00244961

Fig. 89: Identifying Shift Lock Control Unit Connector Terminals

2. Reconnect park neutral position switch connector. Disconnect the shift lock control unit connector. See [Fig. 89](#) . Check continuity between each terminal of shift lock control unit connector. See **SHIFT LOCK CONTROL UNIT CONNECTOR CONTINUITY CHECK** table. Replace control unit as necessary. If okay, go to next step.

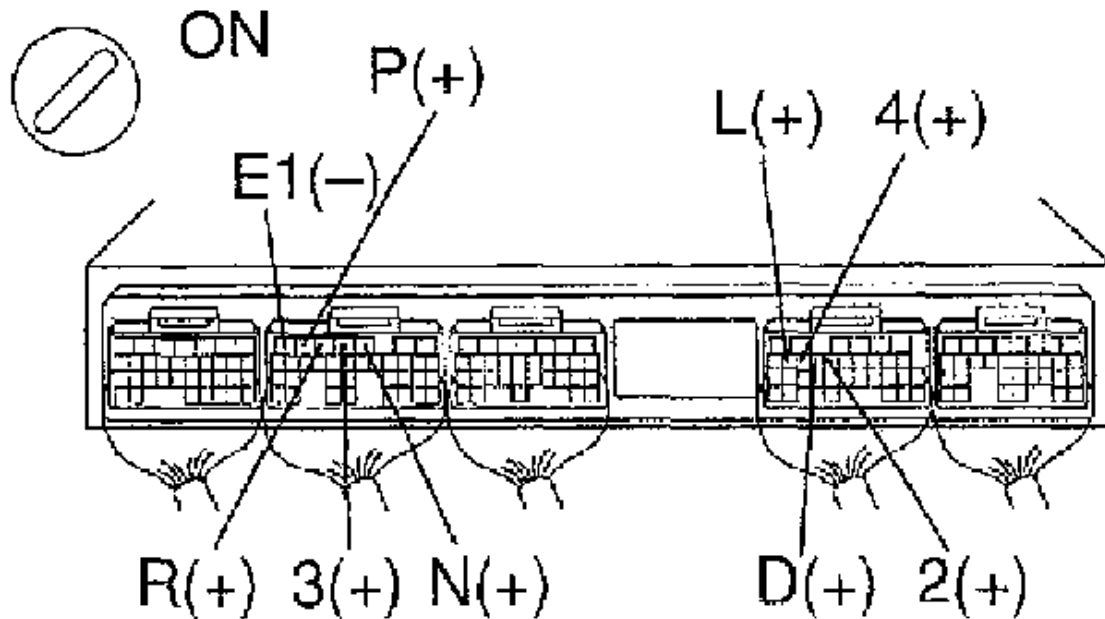
G00244962

Fig. 90: Identifying P, R, N, D, 4, 3, 2, L & E1 ECM Terminals

3. Connect the shift lock control unit assembly. Turn the ignition switch ON. Measure voltage between each terminal P, R, N, D, 4, 3, 2 and L, and E1 of ECM when the shift lever is shifted to the following positions. See [Fig. 90](#) . See **IDENTIFYING ECM CONNECTORS & TERMINALS** table. Battery voltage should exist at all terminals. If voltage is not as specified, repair harness or connector as necessary. If okay, replace ECM.
