Intermittent Battery Discharge

Service Category Power Source/Network

Section Battery/Charging

Some 2013 – 2015 model year Lexus ES, GS, and IS vehicles may exhibit an intermittent discharged battery occurring with no apparent source of discharge found. One possible cause may be the Network Gateway Computer not properly going into sleep mode at key OFF. This can result in excessive parasitic draw and a discharged battery condition. Follow the procedure in this bulletin to identify and address this condition.

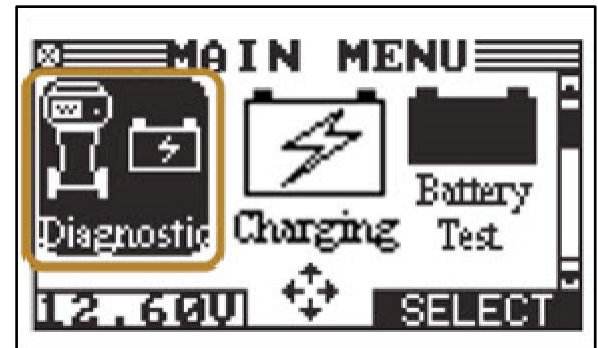
Figure 1.

1. Load test the battery with the GR8 Battery Diagnostic Station.
 - A. Select Diagnostic from the Main Menu.

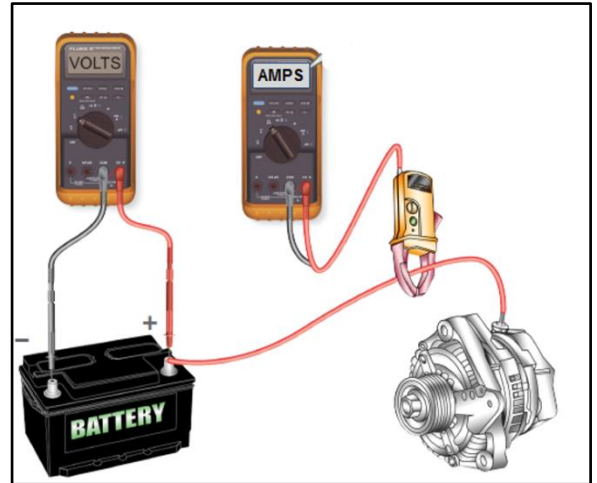
Figure 3.

- B. With the engine running at 2,000 RPM, turn the high beam headlights ON and turn the heater blower switch to the "HI" position. Verify that the voltage and amperage are within specification:

Standard amperage: 30 A or more

Standard voltage: 13.2 to 14.8 V

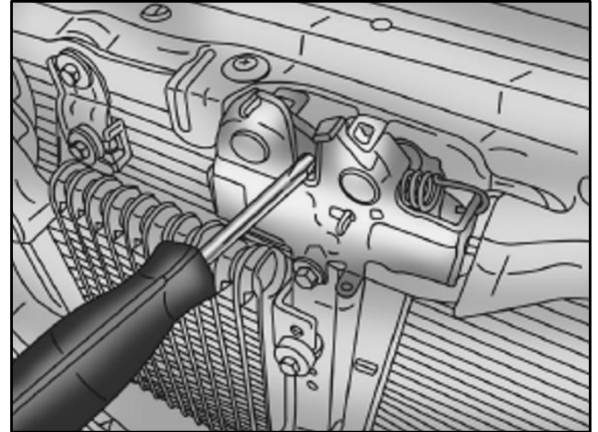
Figure 4.

3. Loosen the negative (-) battery cable so it will be easy to remove for the test.
 - A. Lock the hood latch using a screwdriver and roll the driver's window down.

This closes the hood latch switch and enables the theft deterrent system in case it is the source of the parasitic draw.

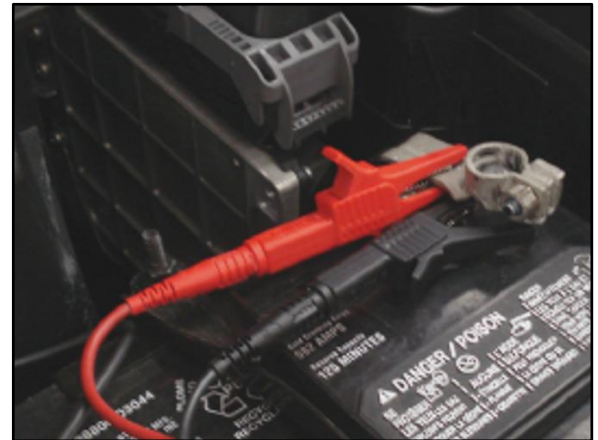
Figure 5.

- B. Turn the ignition ON and then OFF.
- C. Turn OFF all electrical loads, close and lock the doors, then wait for the ECUs to go into sleep mode. This may take anywhere from 10 minutes to 2 hours dependent upon which vehicle is being serviced and what equipment is installed in the vehicle.
- D. Attach the negative (-) lead of the ammeter to the negative (-) battery post and the positive lead of the ammeter to the negative (-) battery cable end.

- Place leads without disconnecting the battery cable.
- If the ammeter leads become disconnected from the battery post or battery cable during the test, reconnect the battery and restart the test from step B.
- If the ammeter leads become disconnected from the battery post or battery cable during the test refer to the applicable repair instructions on TIS for initialization procedures necessary when the battery terminal is disconnected/reconnected.
- Average milliamp setting should be used. Disregard Minimum and Maximum values for this test.

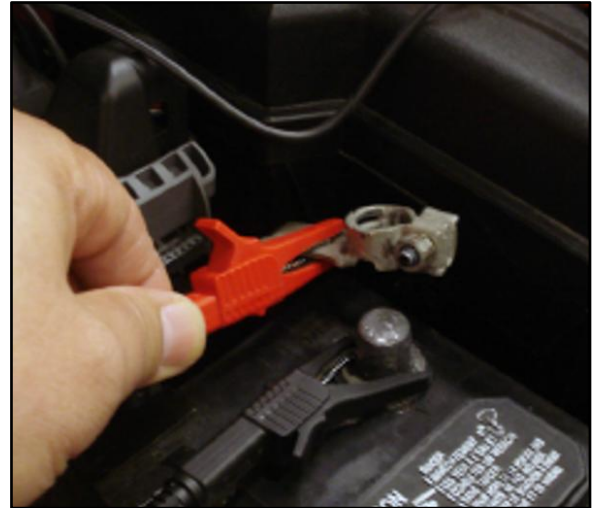
Figure 6.

- E. Remove the negative (–) battery cable without breaking the circuit between the battery and vehicle, and record the meter reading.

**Standard average parasitic draw:**

Less than 50 milliamps average (0.050 amp)
